1. DESCRIPTION OF WORKS AND PHOTOGRAPHIC REPORT

Listed below are all the works carried out by **3RS GESTIÓN** for the Urban Solid Waste Collection Service, Street Cleaning and Maintenance of the Green Areas of the urban entity "Hacienda del Álamo Golf Resort", in **NOVEMBER 2025**.

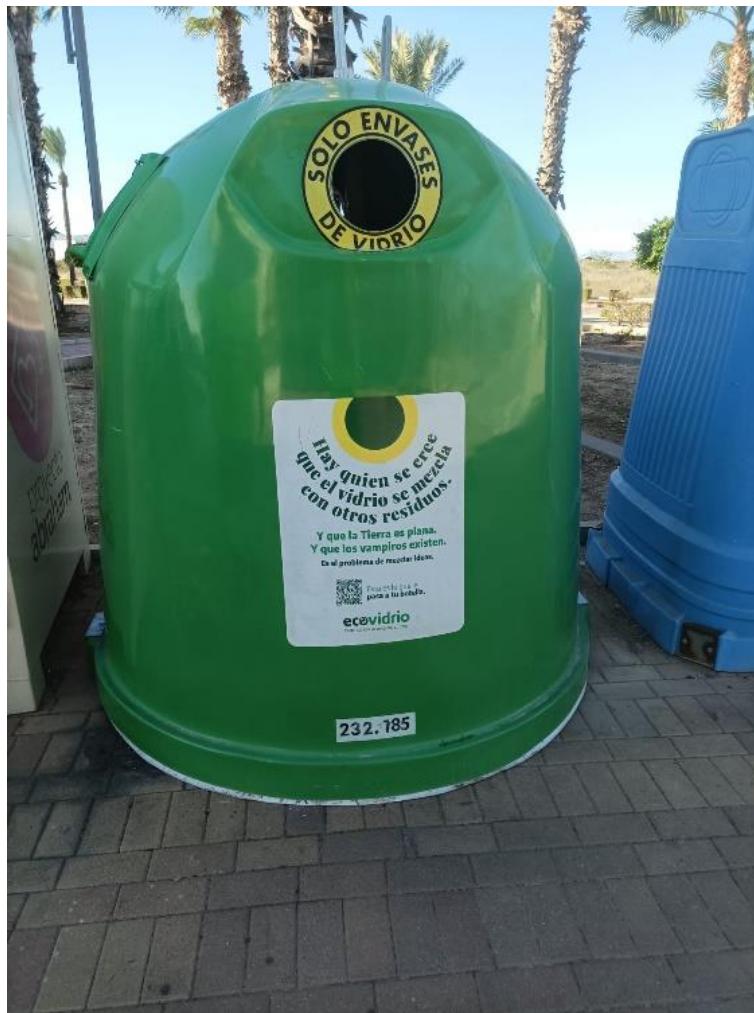
Replacement work on two (2) glass containers in Phase 1 (C/ Germany) and in Phase 6 (C/ Georgia); due to breakage caused by their poor condition:

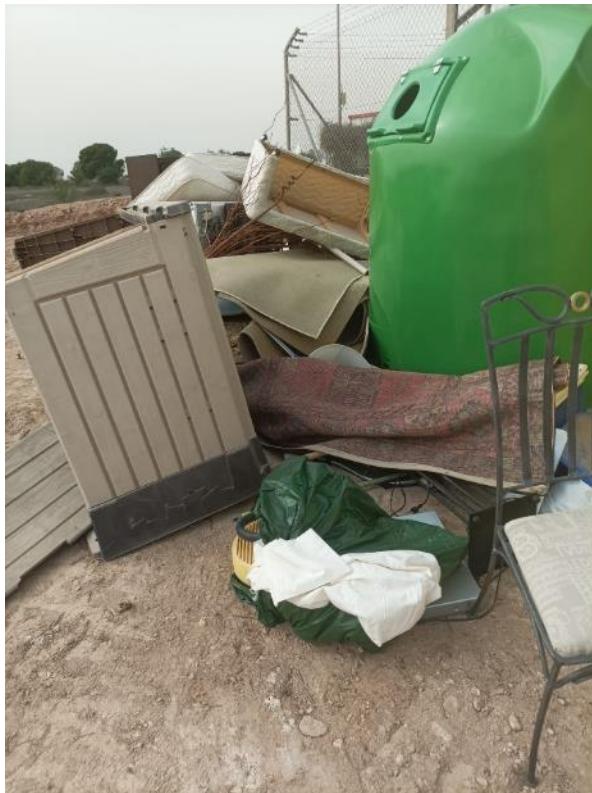
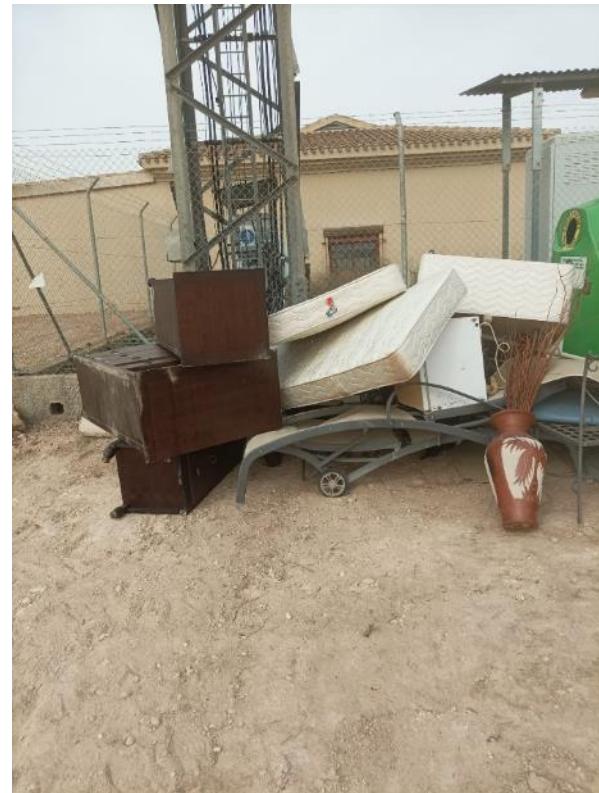
Resolution of an ACT OF VANDALISM due to the appearance of a large quantity of bulky waste and belongings deposited outside the Maintenance Zone. The EUC and SECURITY have been notified.

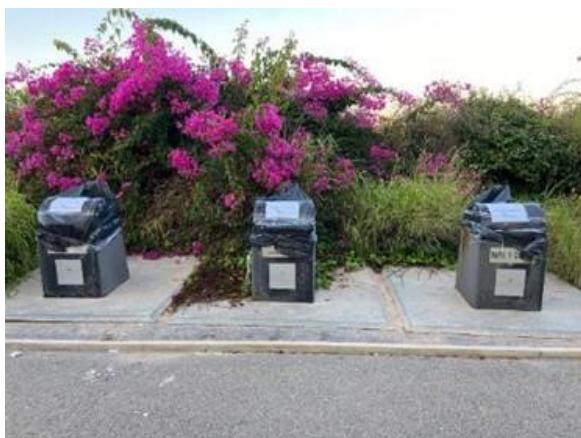
Before (west side)

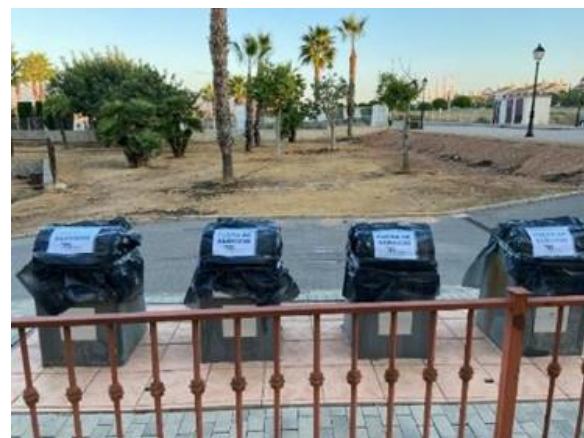
Before (north side)

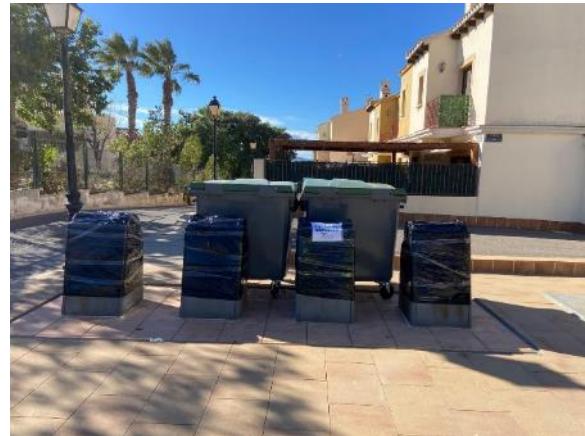
Newly sealed (south side)

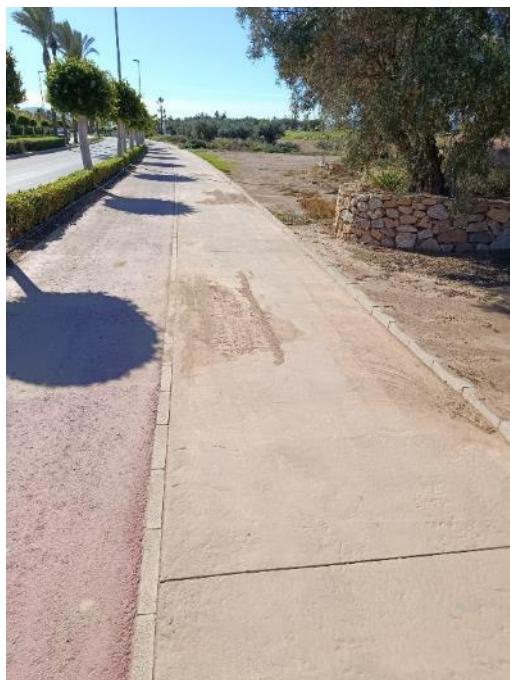
Manual cleaning work of soil runoff caused by heavy rain on the bike lane of the Main Road, from the Phase 6 roundabout (Olivos) to the Phase 1 roundabout (EUM)

Before

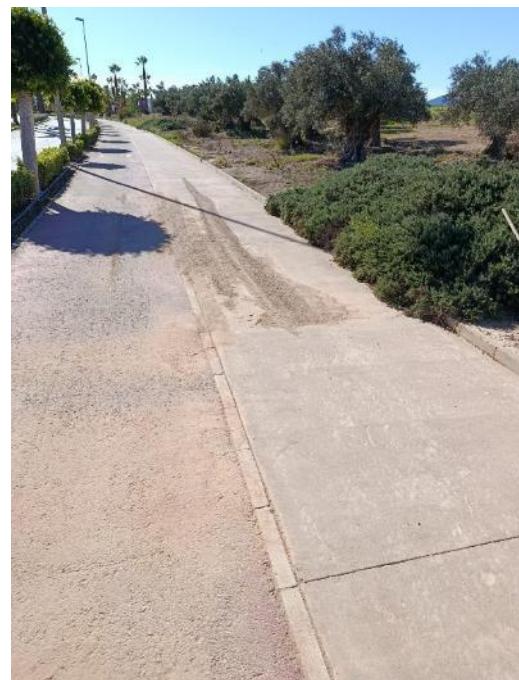
Before

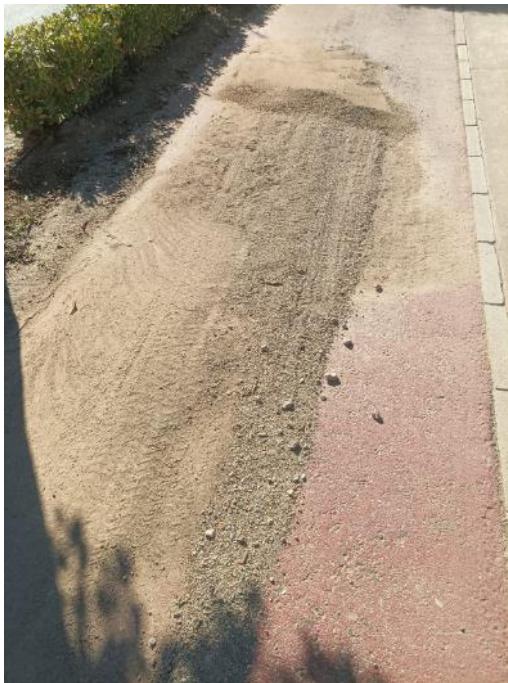
Before

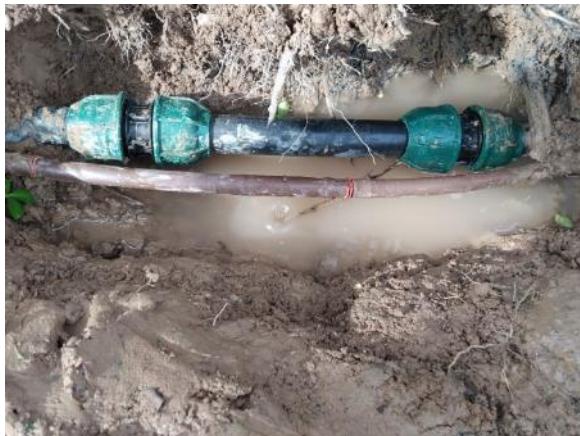
Main road right, maintenance height (0,5 ml PE Ø32 and 2 links)

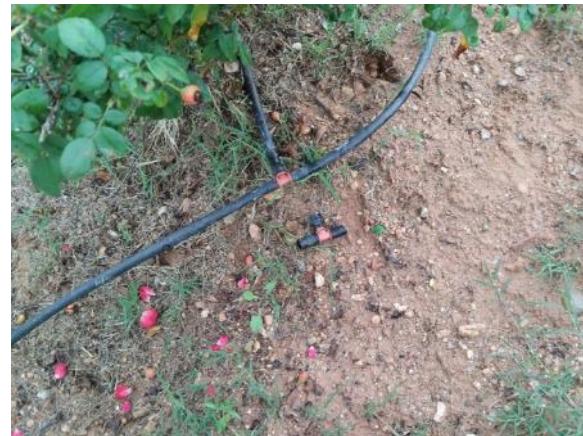
Back Garden Phase 6 (T Ø16 mm)

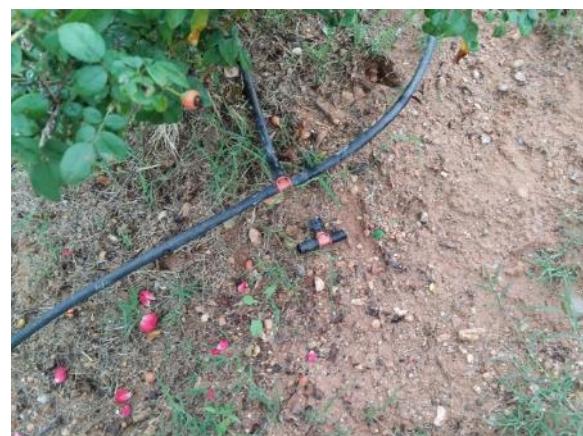
Back Garden Phase 6 (T Ø16 mm)

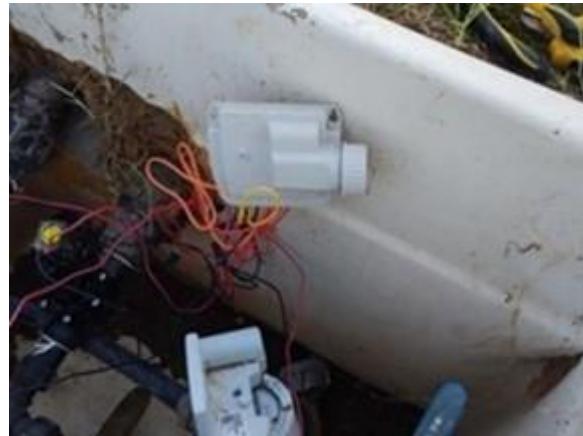
Phase 6 groundabout (change programmer
Solem 4 stations and 1 solenoid valve 1")

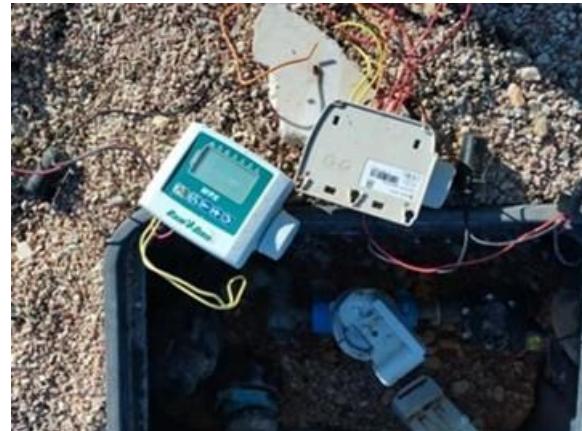
**Final roundabout C/ Bahamas (broken
RainBird programmer change for used
Solem)**

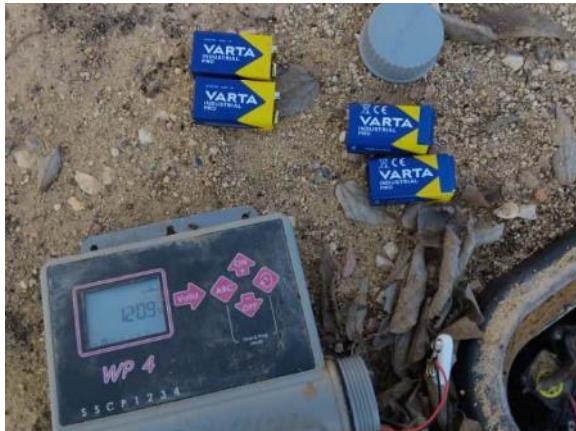
**C/ Bélgica 11 – front of mailboxes (double
battery change)**

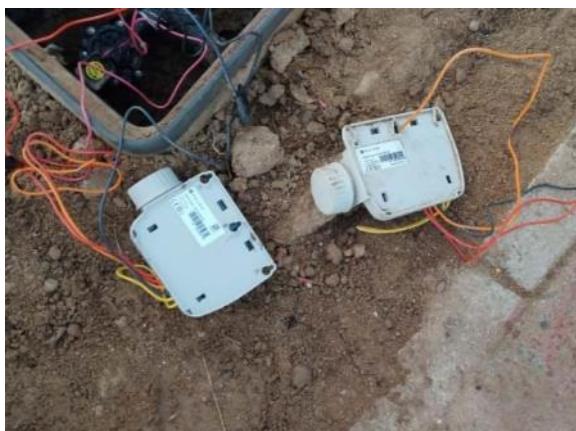
**Main right-hand road in front of hotel
(change of broken Solem programmer with
new Solem)**

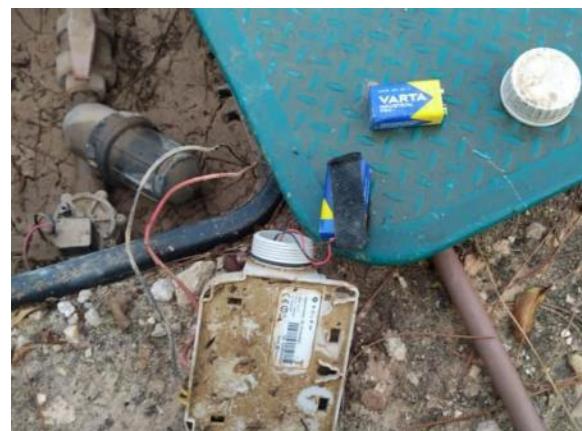
**Pueblo Español Entrance - left drain box
(battery change)**

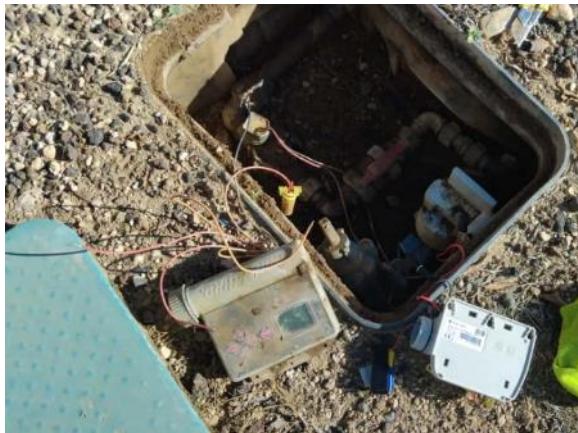
Main road right next to Golf School (replace broken RainBird programmer with a new Solem)

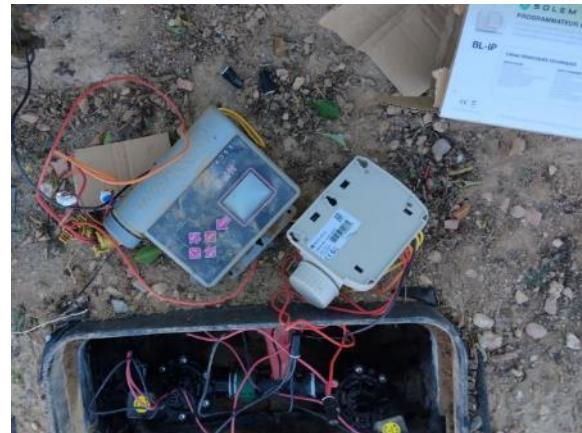
Main road right next to football field (replace broken RainBird programmer with a new Solem)

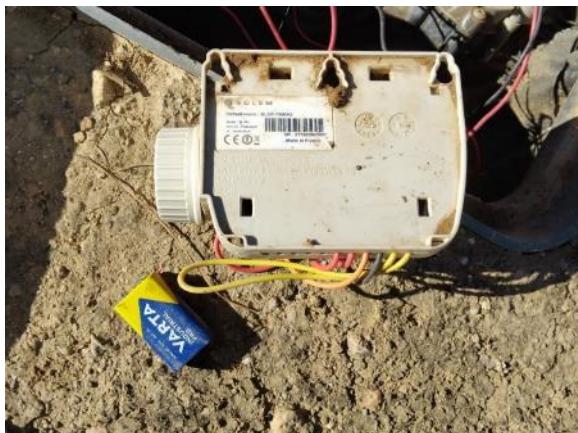
Main road, right, in front of the hotel (battery change)
