1. DESCRIPTION OF WORKS AND PHOTOGRAPHIC REPORT

Listed below are all the works carried out by **3RS GESTIÓN** for the Urban Solid Waste Collection Service, Street Cleaning and Maintenance of the Green Areas of the urban entity "Hacienda del Álamo Golf Resort", in **DECEMBER 2025**.

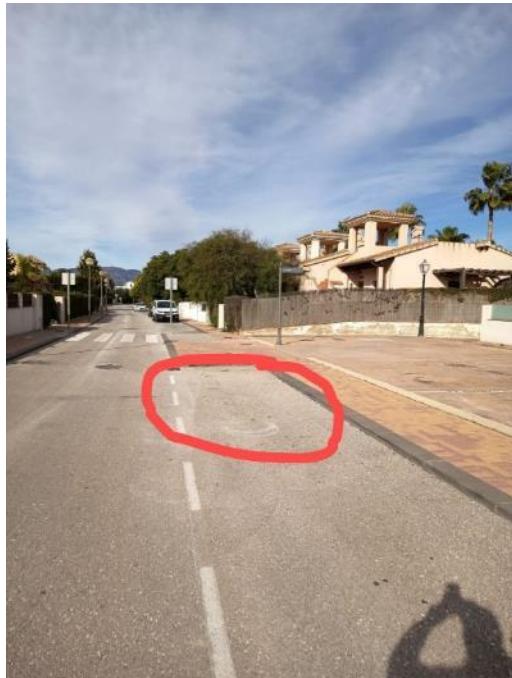
Alemania St.

Resolution of an ACT OF VANDALISM for the disappearance of a general waste container on Alemania Street, which was found in front of a house on Alaska Street. The homeowner was caught red-handed dumping all kinds of waste, including construction debris. The EUC and SECURITY have been informed.

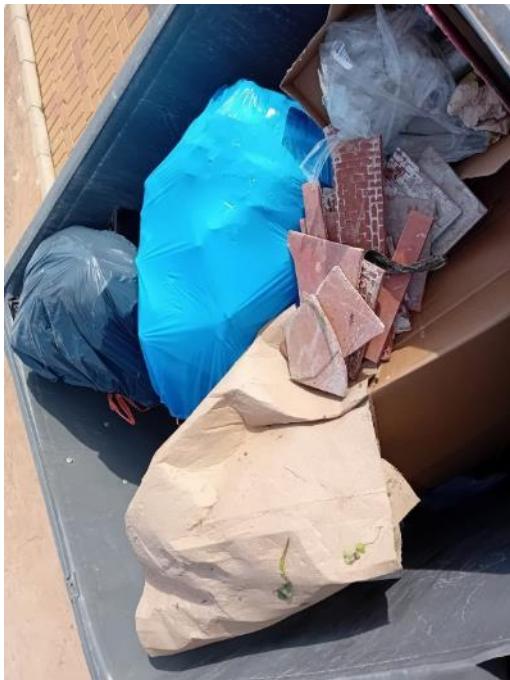
Debris

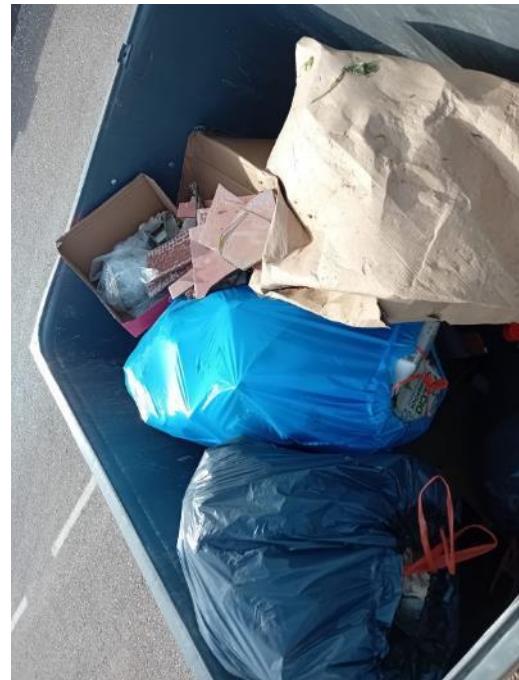
Waste mixture

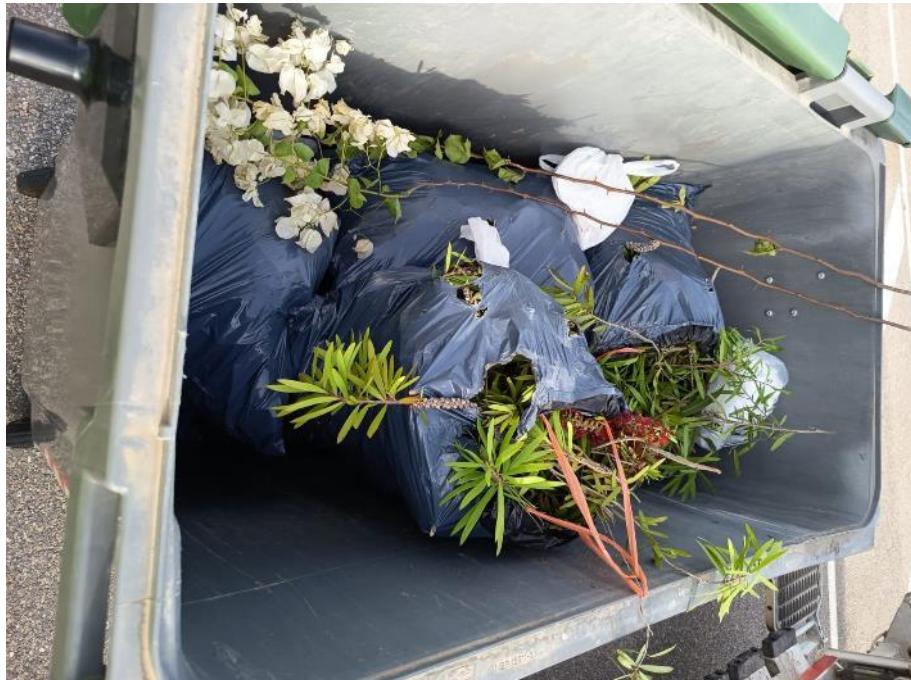
Resolution of an ACT OF VANDALISM caused by the appearance of pruning debris at the end of Bahamas Street. The EUC and SECURITY have been informed.

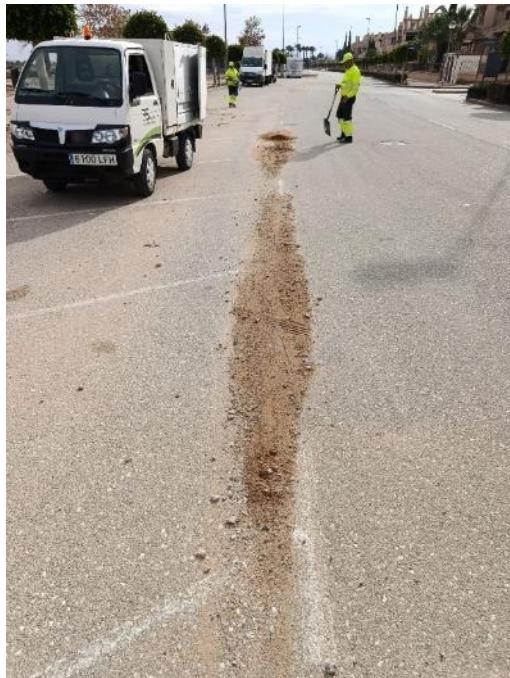
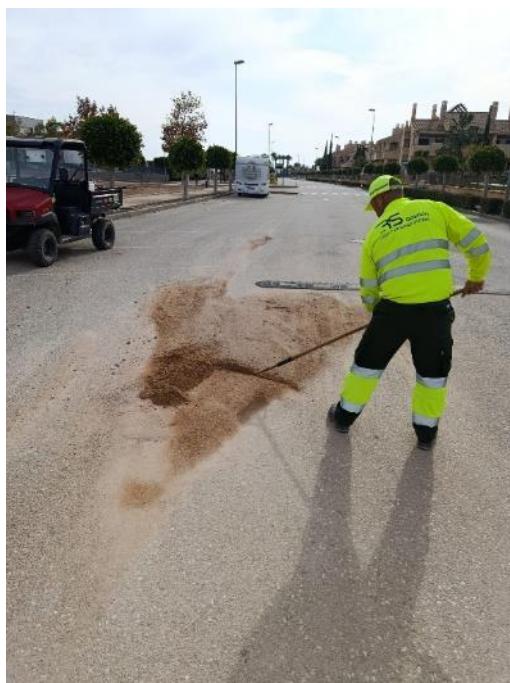
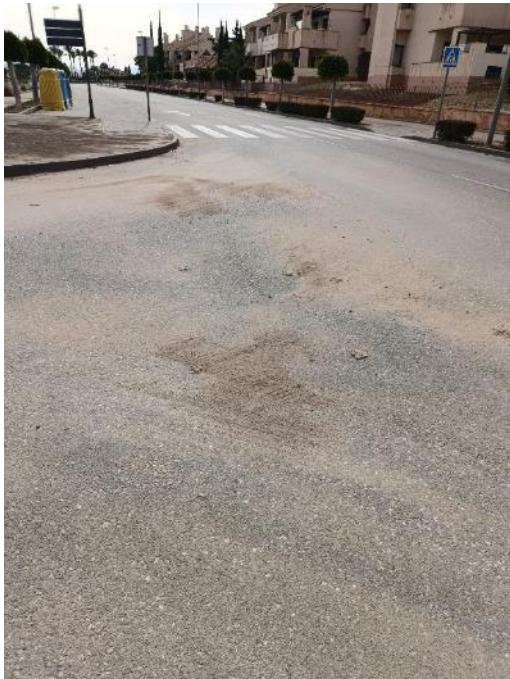
Manual cleaning work of soil erosion caused by runoff during heavy rains in Paseo Alameda (Phase 7)

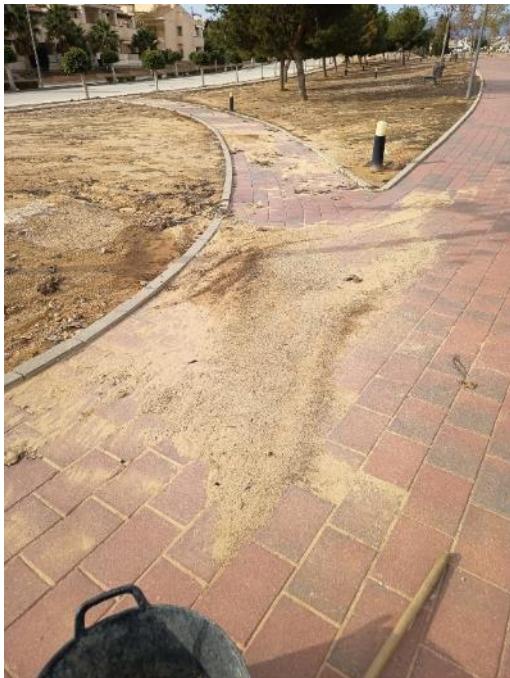
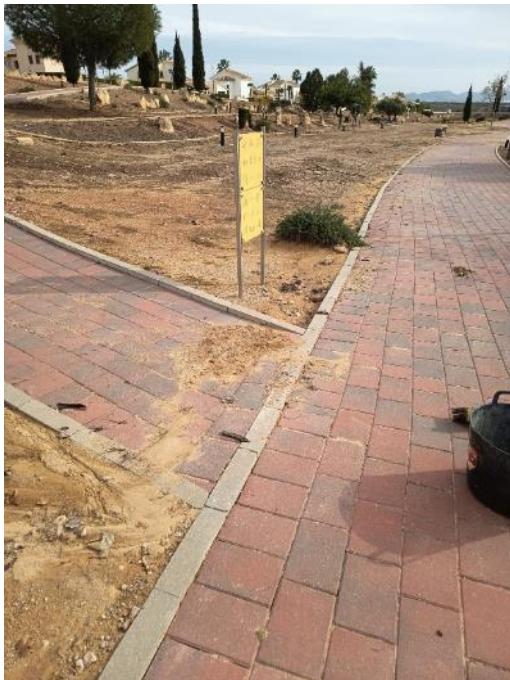
Manual cleaning work of soil erosion caused by runoff during heavy rains in Parque Rambla Mediterránea:

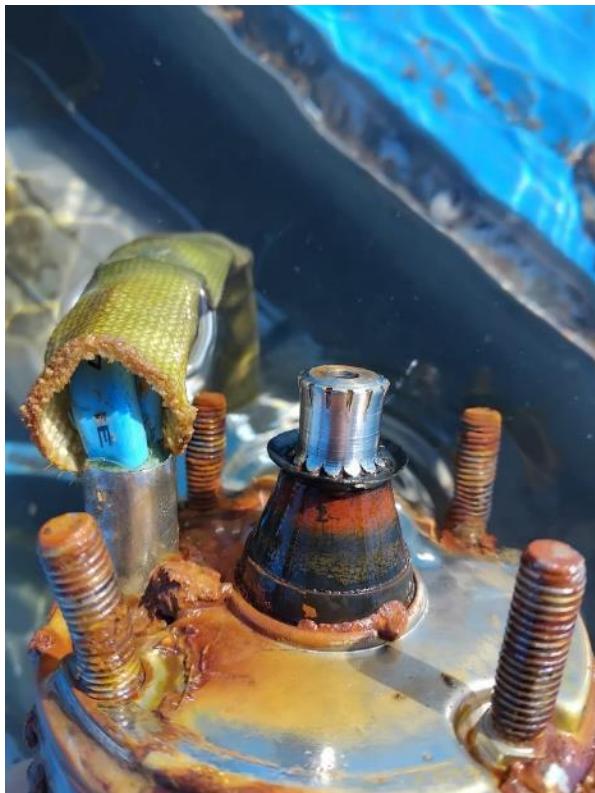
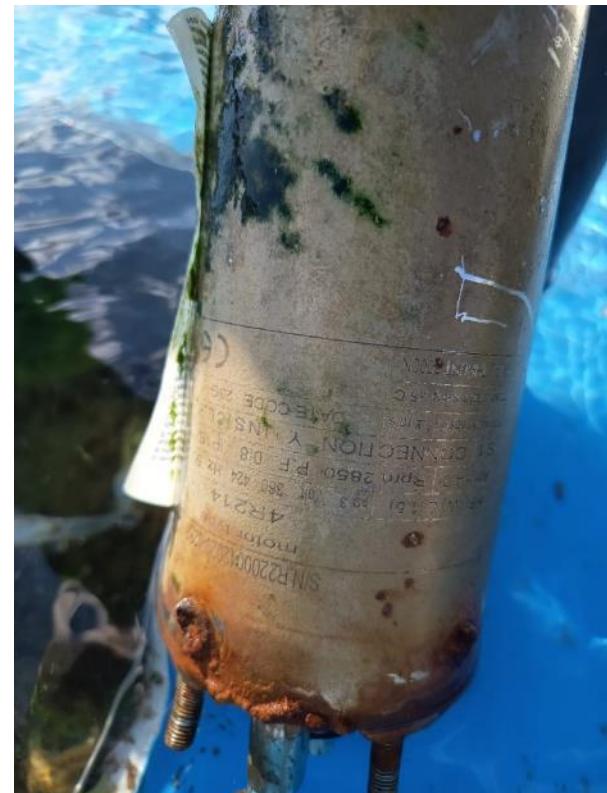
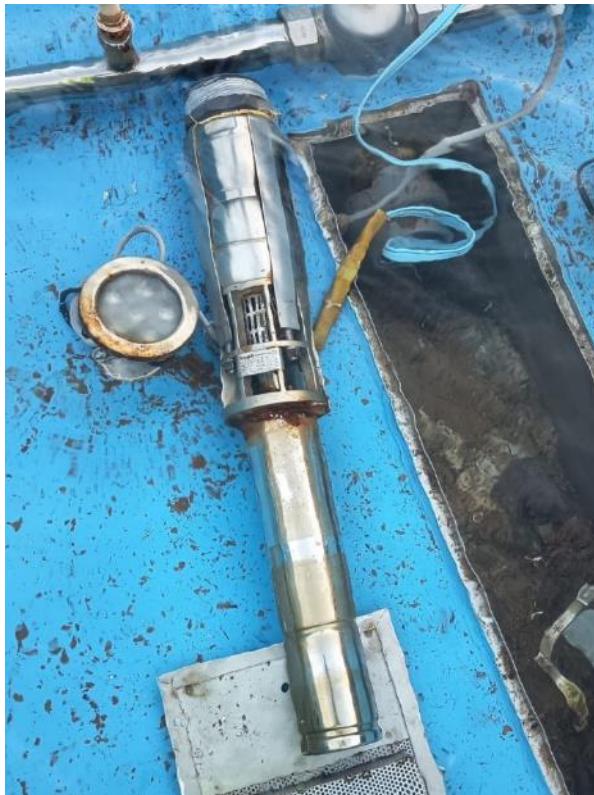
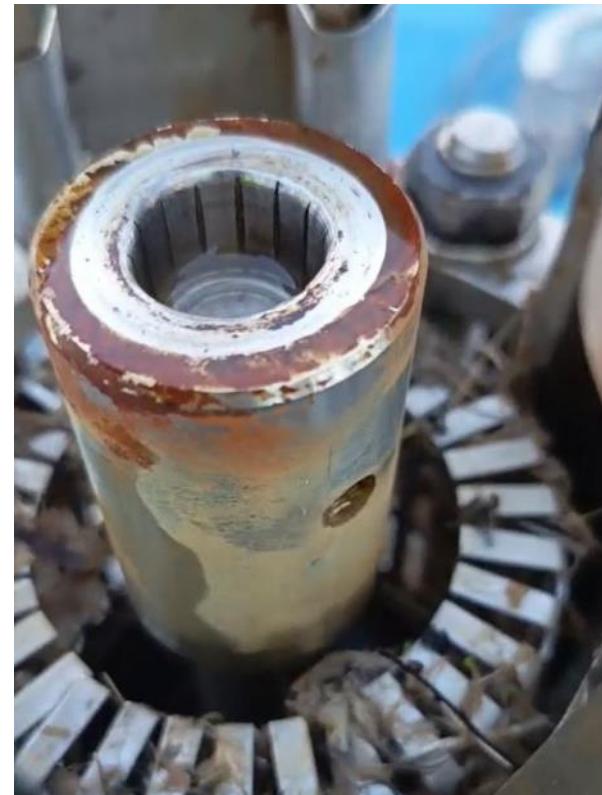
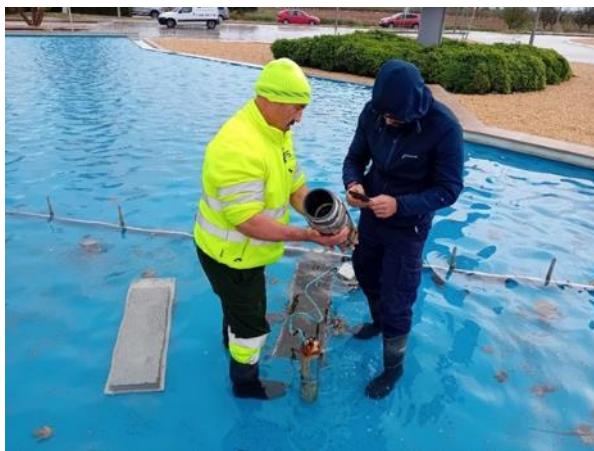
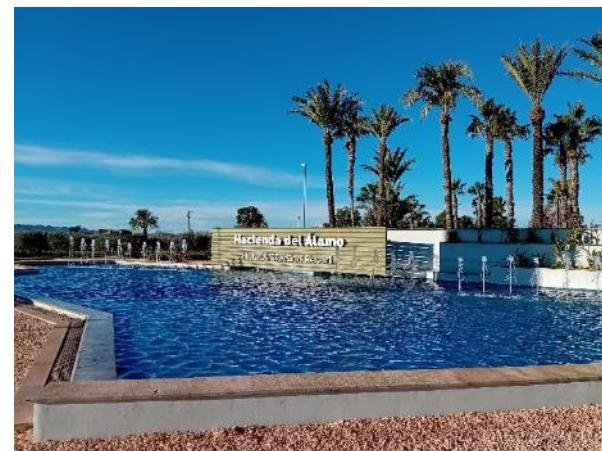
Repair of the entrance fountain by replacing the pump and hydraulic body. The pump pinion was completely worn out due to vibrations transmitted to the hydraulic body. This caused hydraulic losses in the manifold, forcing the pump to operate outside its optimal range and accelerating the wear of both components. This problem persisted for an extended period until the fountain system finally stopped working.

The repair process involved replacing the following components:

1. **Hydraulic body, model SS636/01**, designed for the distribution and flow of water in ornamental fountain systems. Manufactured from high-strength, corrosion-resistant stainless steel, it is especially suitable for continuous operation in humid environments with the constant presence of water and chemical agents used in fountain treatment (chlorine, algaecides, pH regulators). The assembly acts as a hydraulic manifold, allowing for the orderly connection of the supply, return, and branch lines to the nozzles.

2. **Submersible motor-pump, model L4A-15T**, with a nominal power of 2 HP, specifically designed for water pumping in ornamental fountains and decorative hydraulic systems. Robust construction using corrosion-resistant materials, suitable for continuous operation under total immersion. Equipped with a sealed electric motor, with a protection rating suitable for prolonged submerged operation, guaranteeing reliability, low vibration levels, and quiet operation. Prepared for installation in valve boxes, fountain basins, or technical tanks, with easy access for maintenance, inspection, or replacement.
