## 1. DESCRIPTION OF WORKS AND PHOTOGRAPHIC REPORT

Listed below are all the works carried out by **3RS GESTIÓN** for the Urban Solid Waste Collection Service, Street Cleaning and Maintenance of the Green Areas of the urban entity "Hacienda del Álamo Golf Resort", in **OCTOBER 2026**.

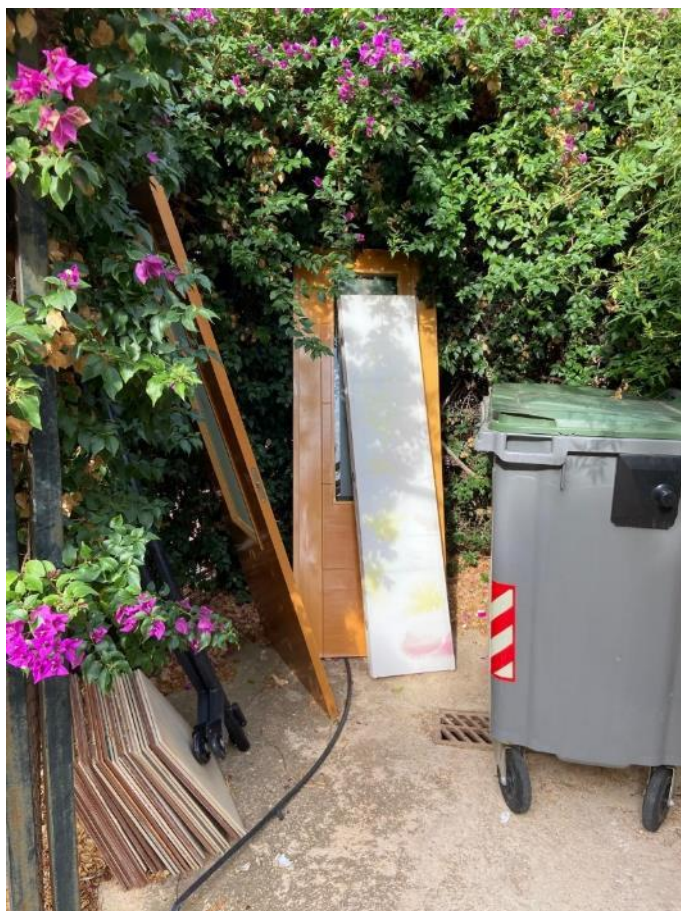
**ACT OF VANDALISM:** Dumping of construction debris (surplus building materials, specifically tiles) next to the waste container located at 7 Madagascar, in El Oasis. The EUC has been notified.

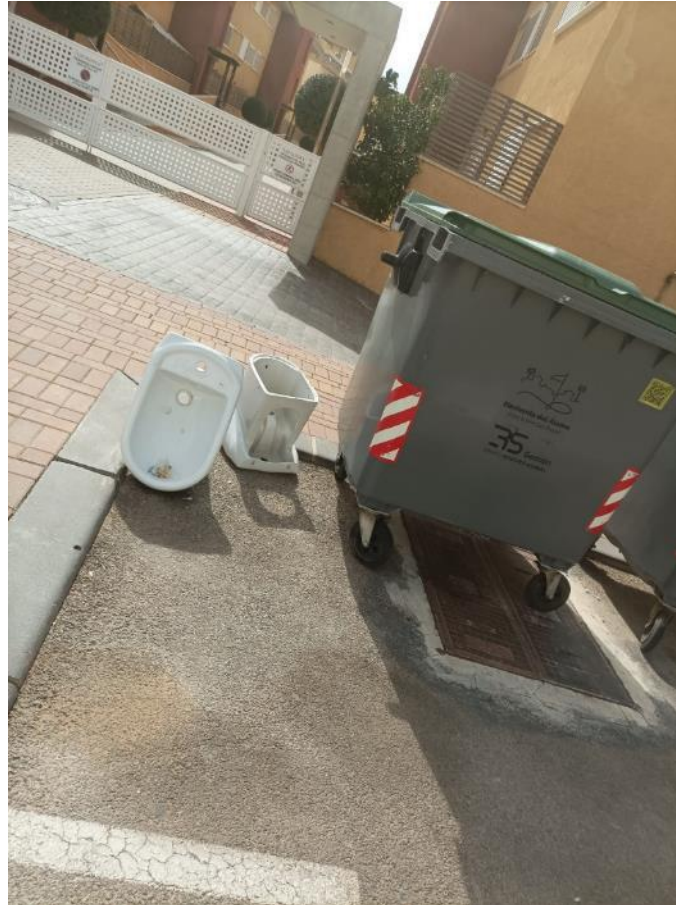
**INCIDENT:** Dumping of construction debris (specifically a toilet and a bidet) next to the waste containers located on Georgia Street in Los Olivos. The EUC has been notified.

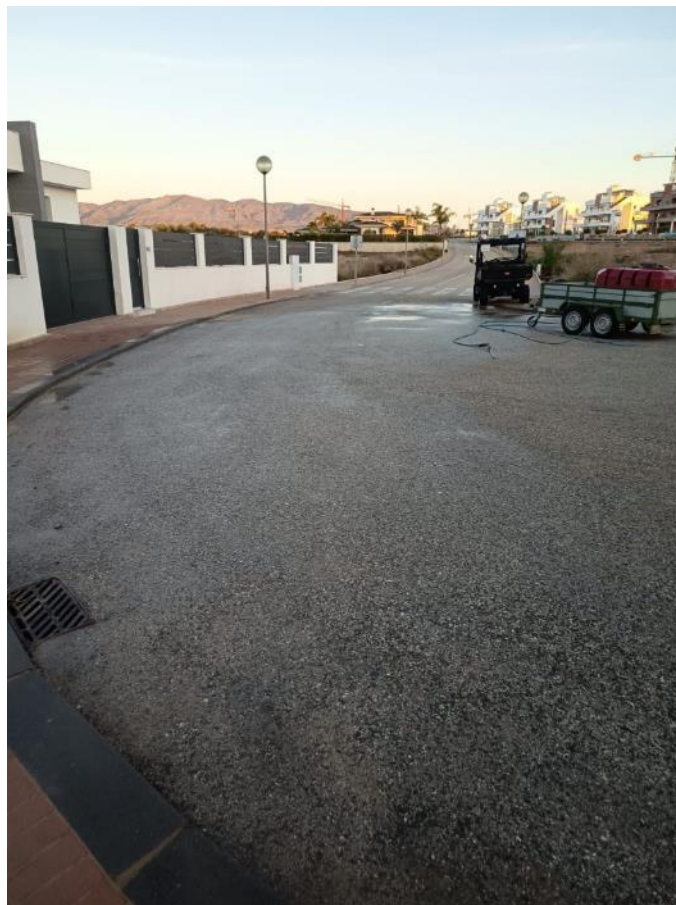
**Resolution of an INCIDENT involving debris washed down to the end of Letonia Street due to recent torrential rains.**
