1. DESCRIPTION OF WORKS AND PHOTOGRAPHIC REPORT

Listed below are all the works carried out by **3RS GESTIÓN** for the Urban Solid Waste Collection Service, Street Cleaning and Maintenance of the Green Areas of the urban entity "Hacienda del Álamo Golf Resort", in **FEBRUARY 2026**.

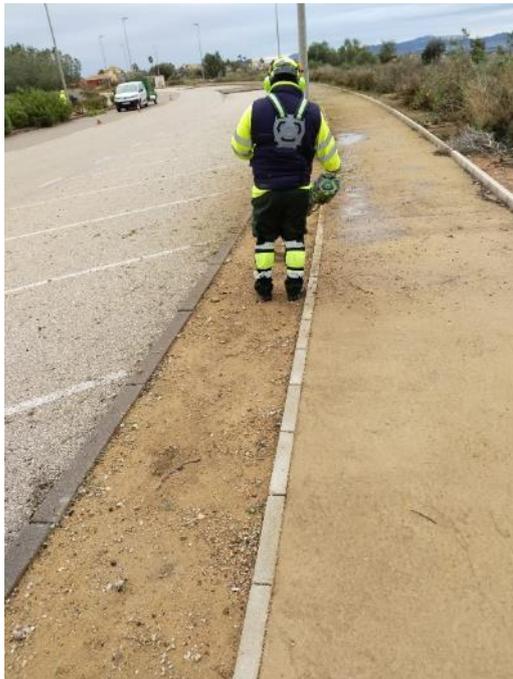
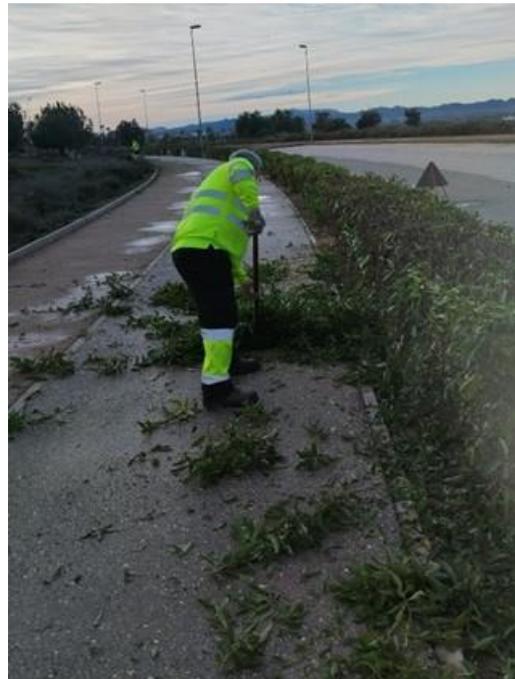
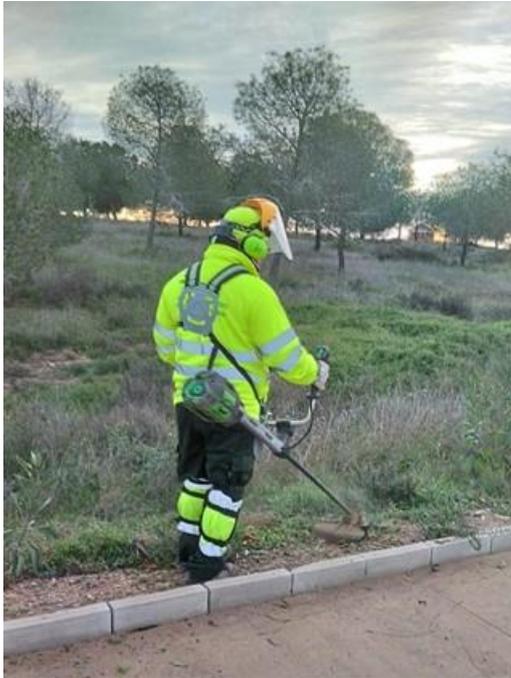
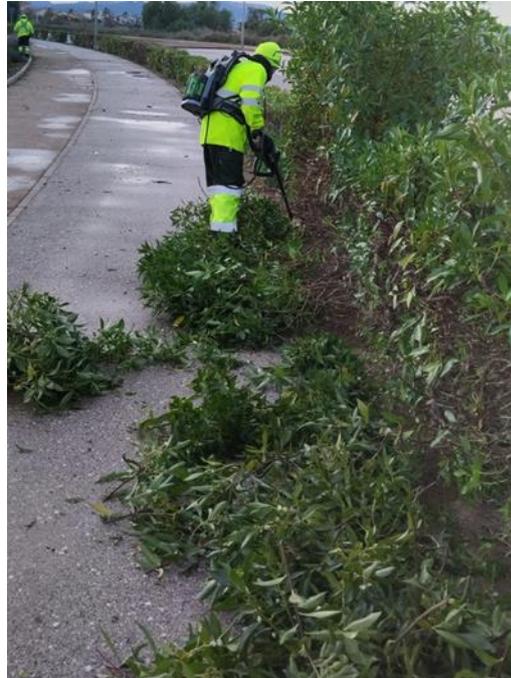
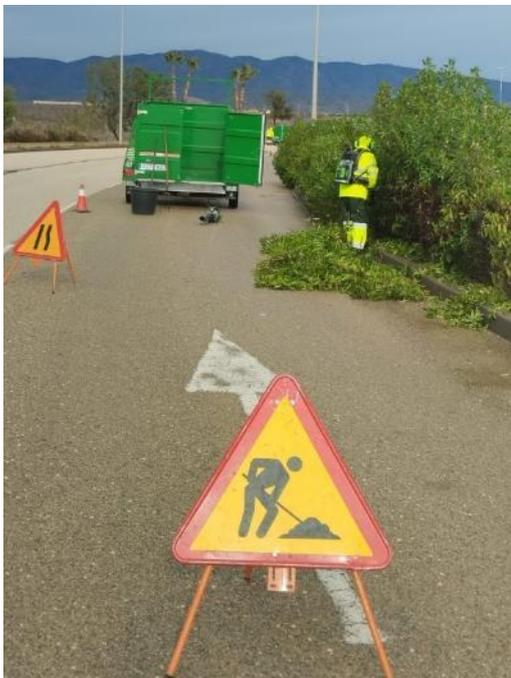
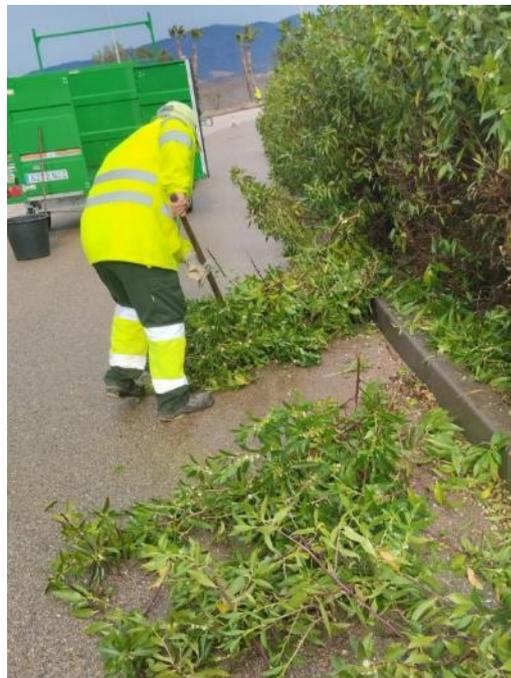
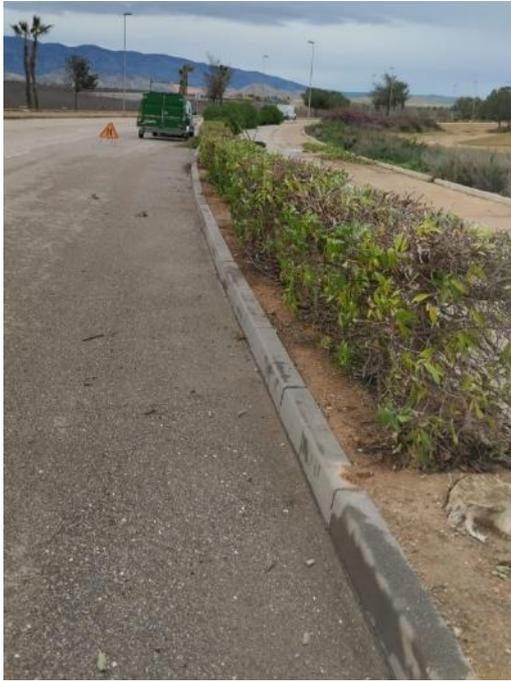
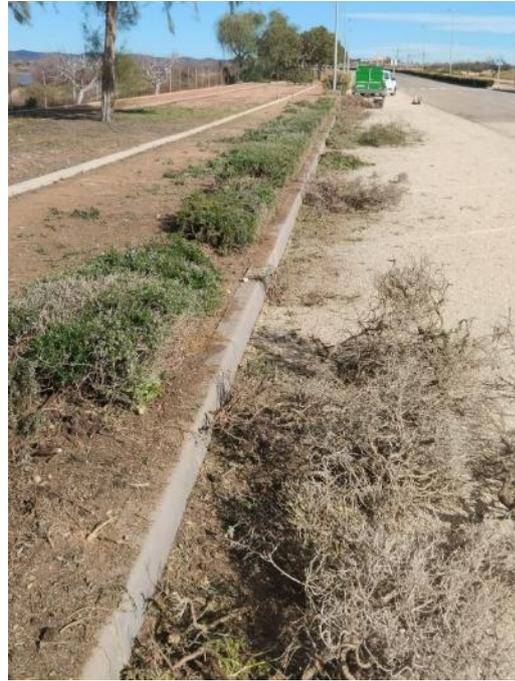
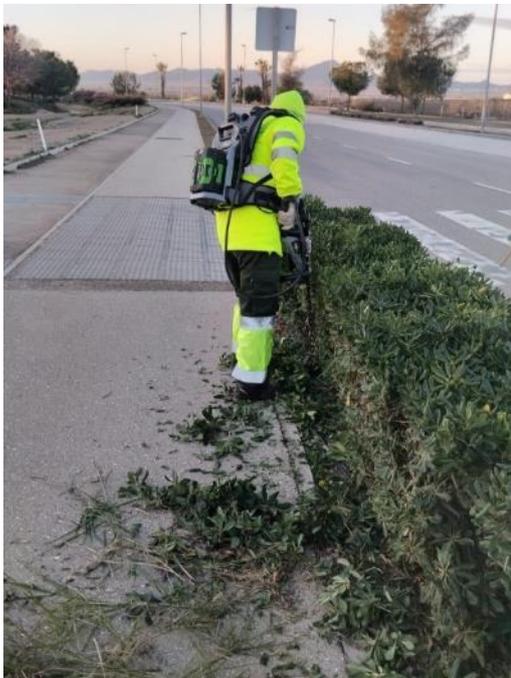
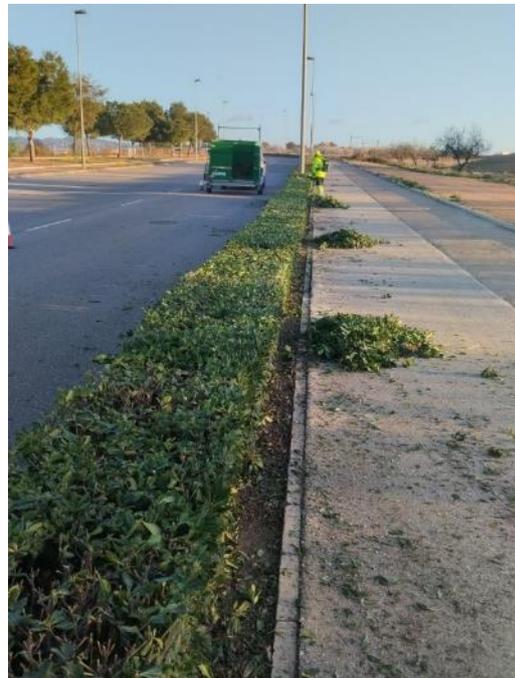
Weeding and trimming of hedges along road B, between sectors C/ Hungría and C/ Francia

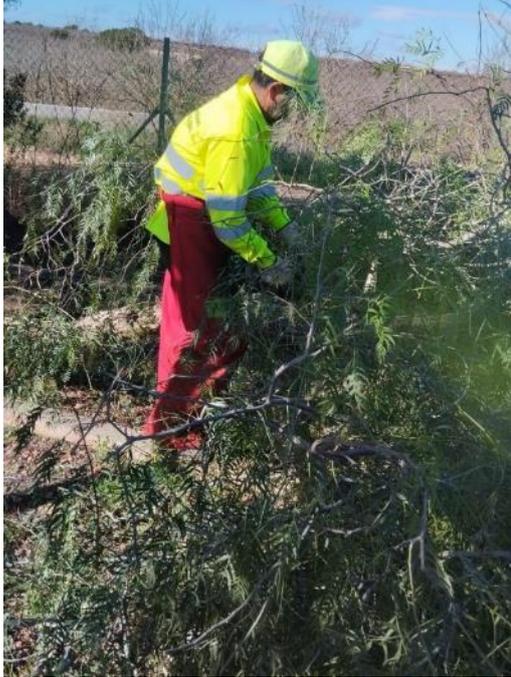
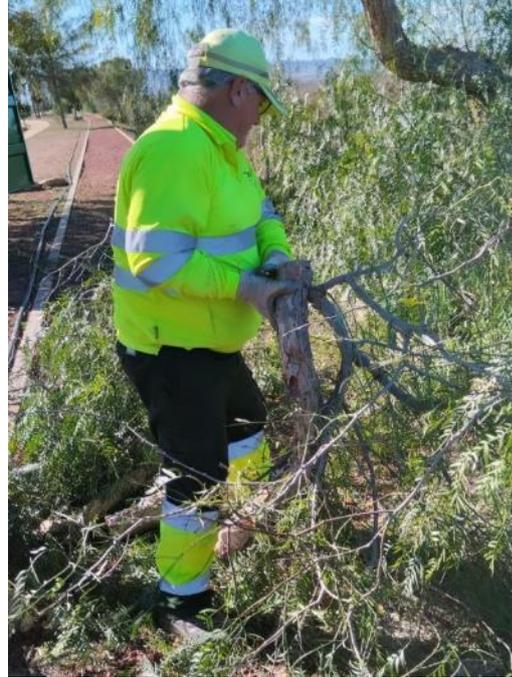
Cutting, collecting and cleaning of a tree (false pepper tree) fallen by the wind on Vial B at the height of C/ Francia

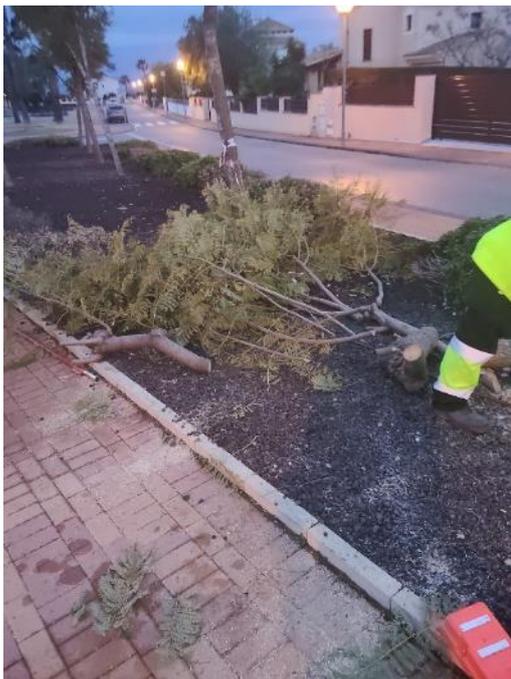
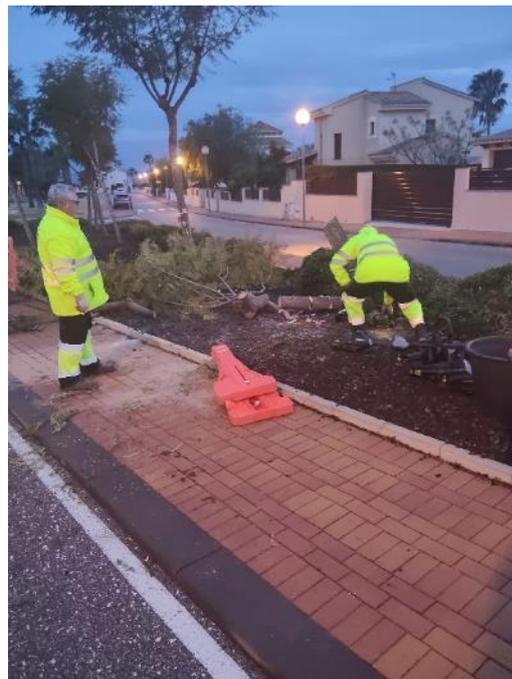
Cutting, collecting and cleaning of a tree (pine) fallen by the wind on Vial B at the Alemania Place

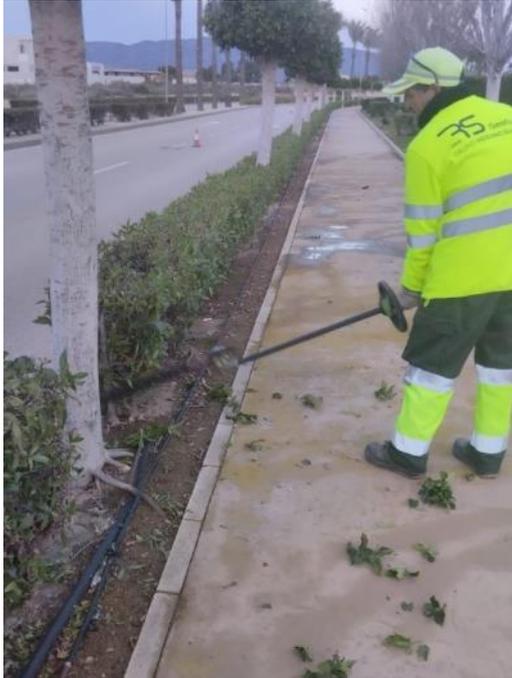
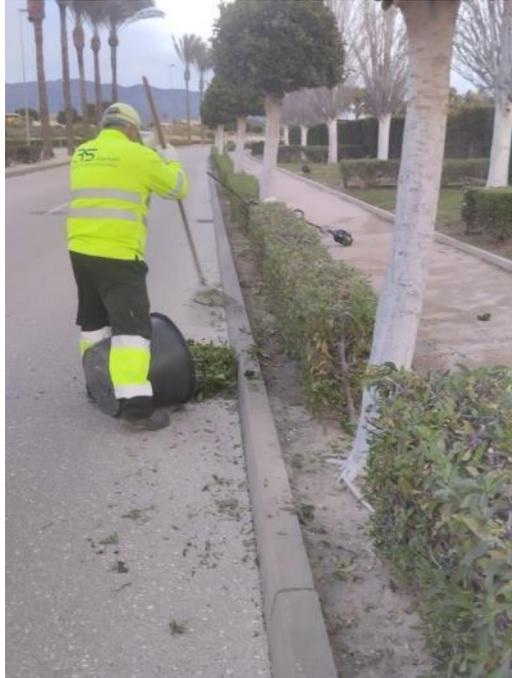
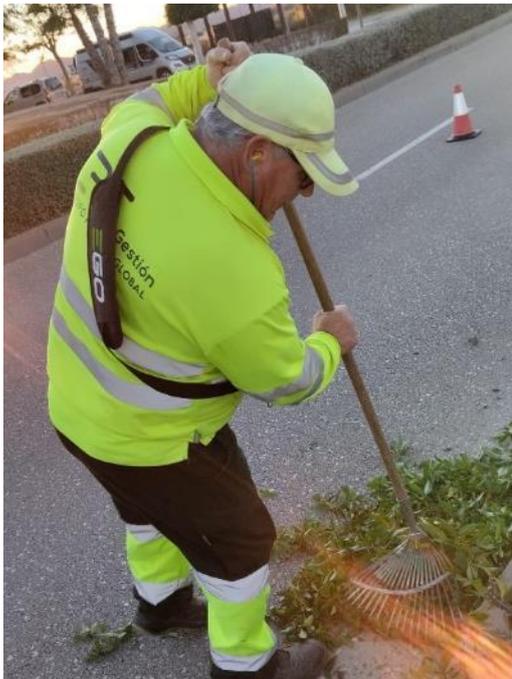
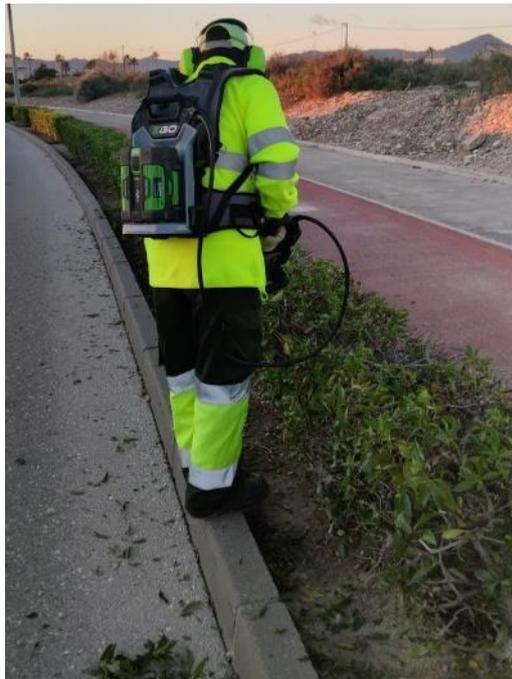
Trimming of evergreen hedge on Main Road, section from entrance to Phase 6 The Olives

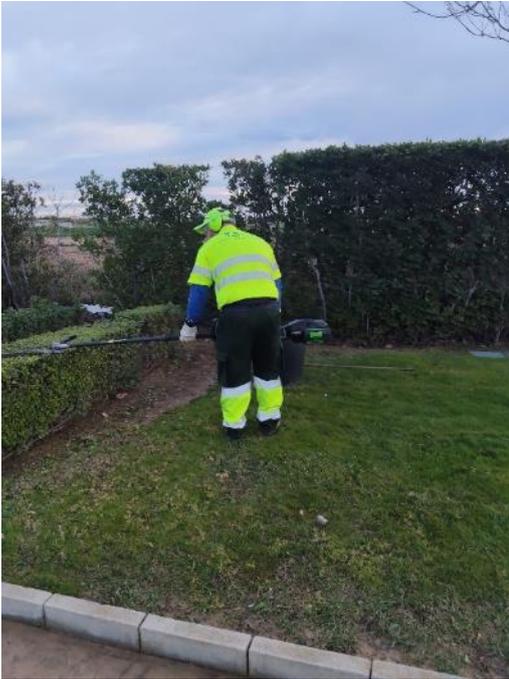
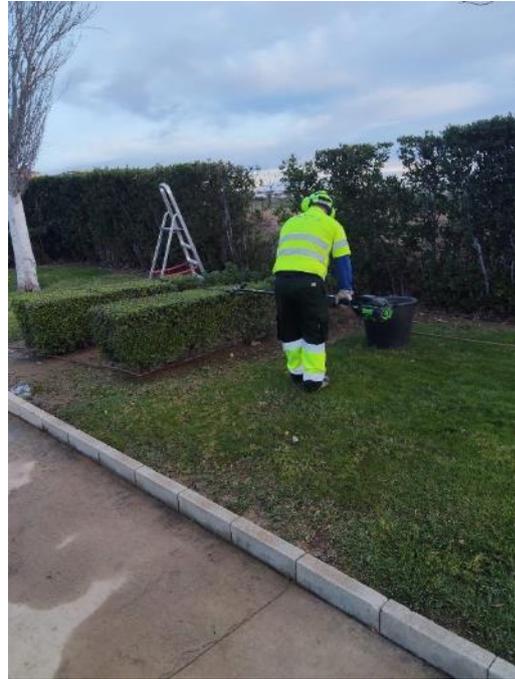
Trimming, collecting and cleaning of garden hedges of squares and laurel screen hedge

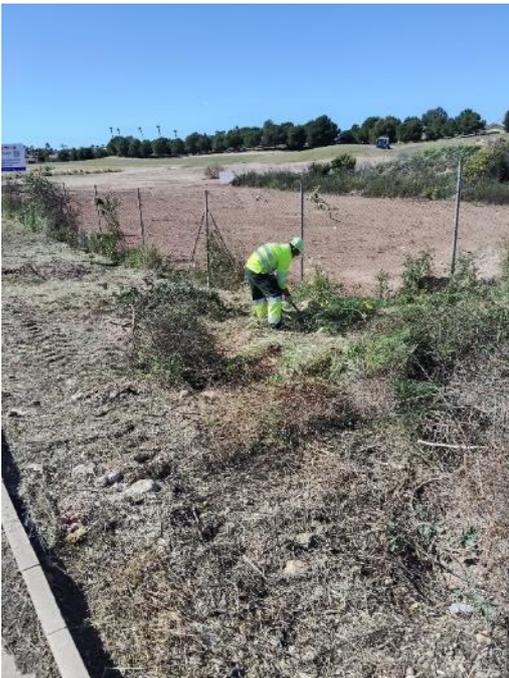
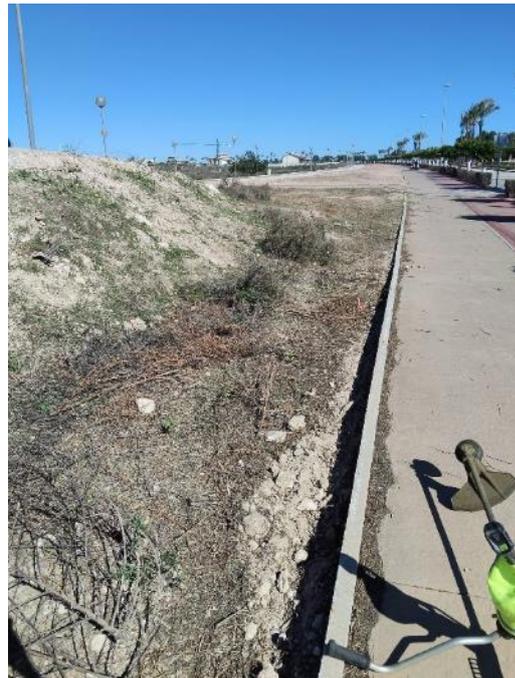
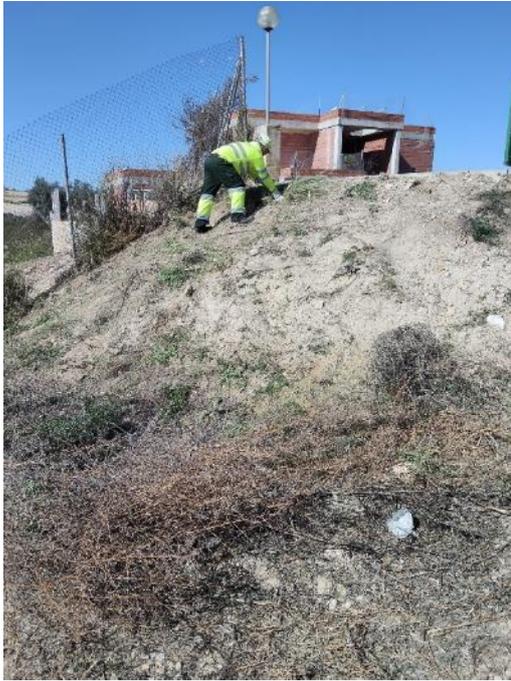
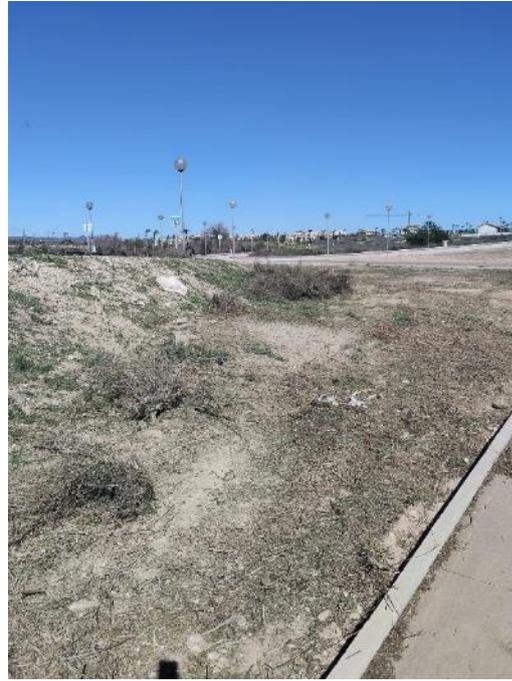
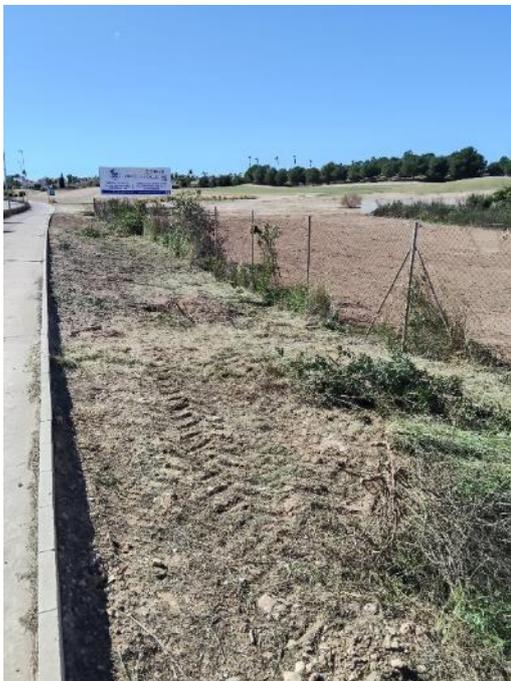
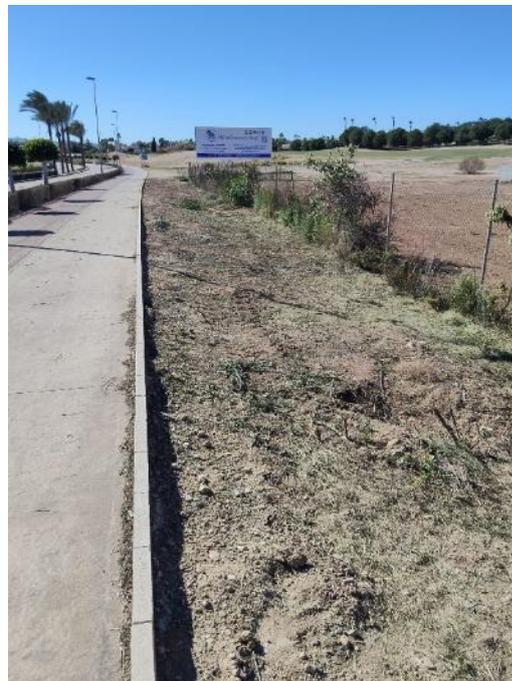
Weeding and cleaning of the slope and fence area next to the cul-de-sac of C/ Vistas al Green

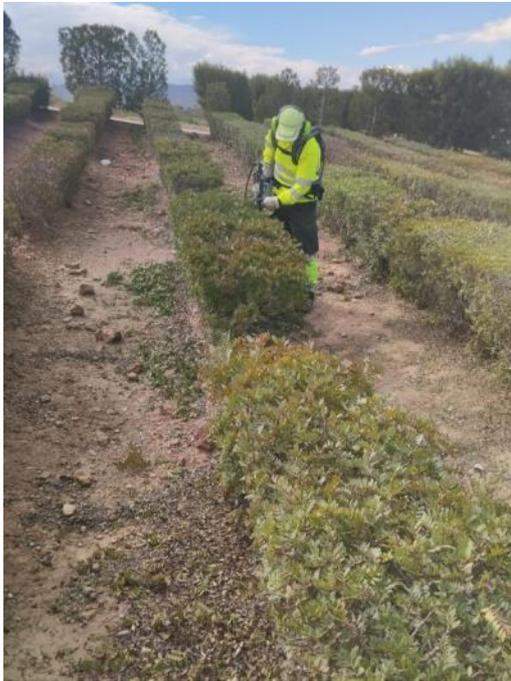
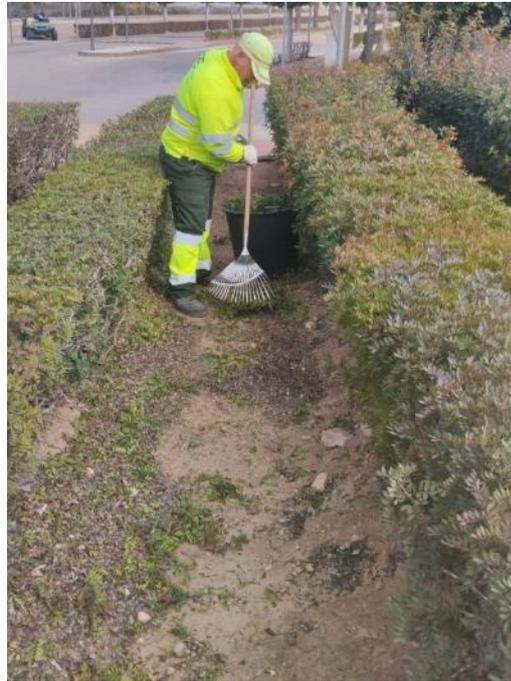
Hedge trimming, weeding and cleaning in the right-hand area of the entrance to the Maintenance Zone

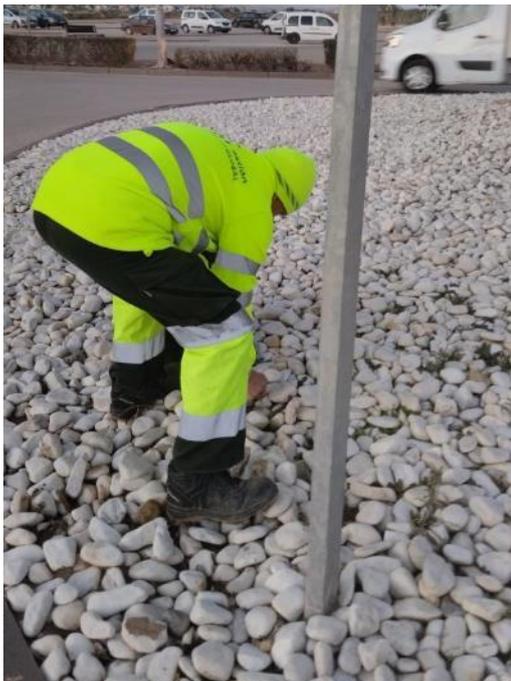
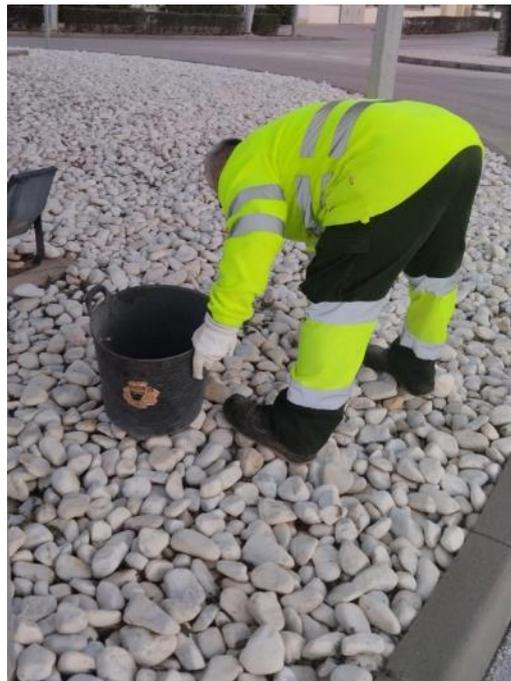
Manual weeding at the entrance roundabout of the Casa Club on the main road

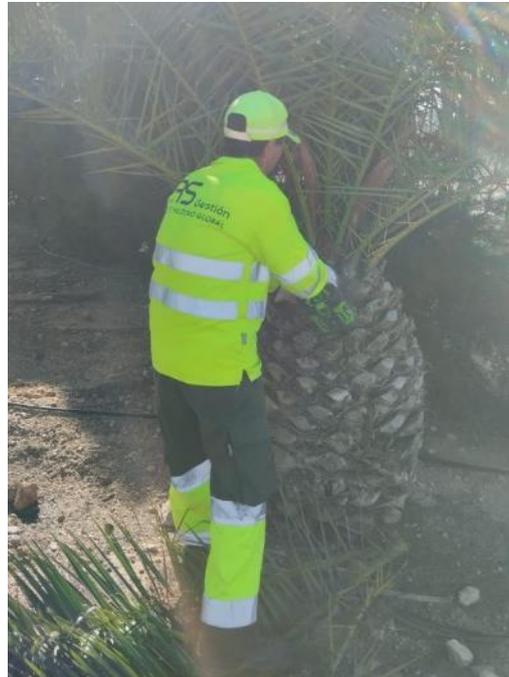
Pruning and cleaning of palm trees in the left garden at the entrance to the Maintenance Zone

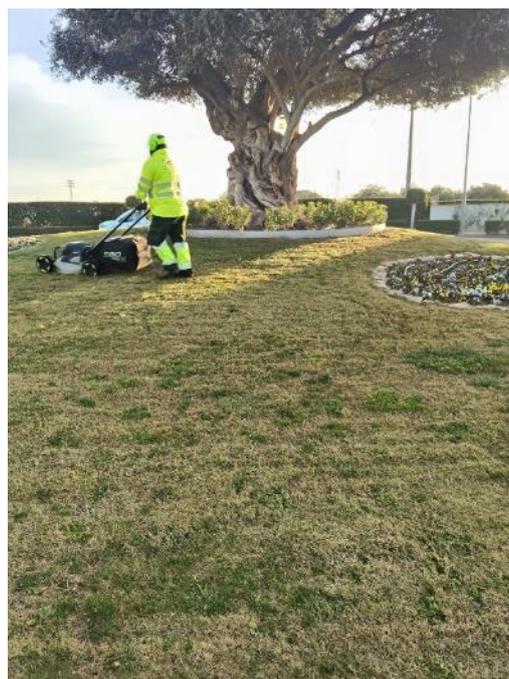
Mowing of the lawn at the entrance, the square garden, the entrance roundabout, the Phase 6 roundabout and the Phase 1 roundabout:

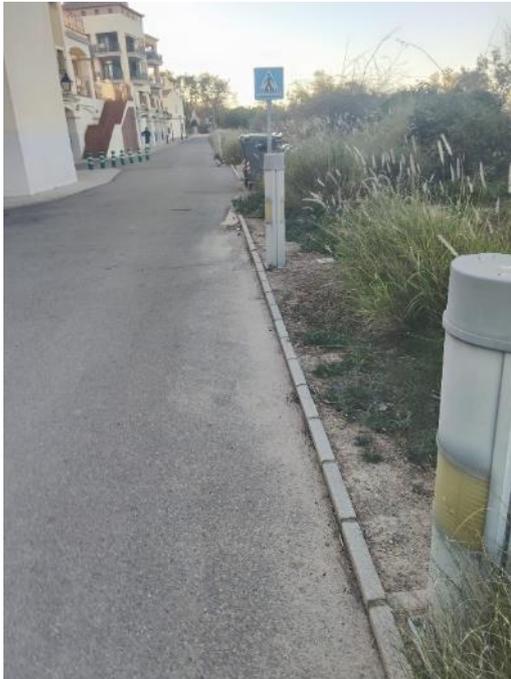
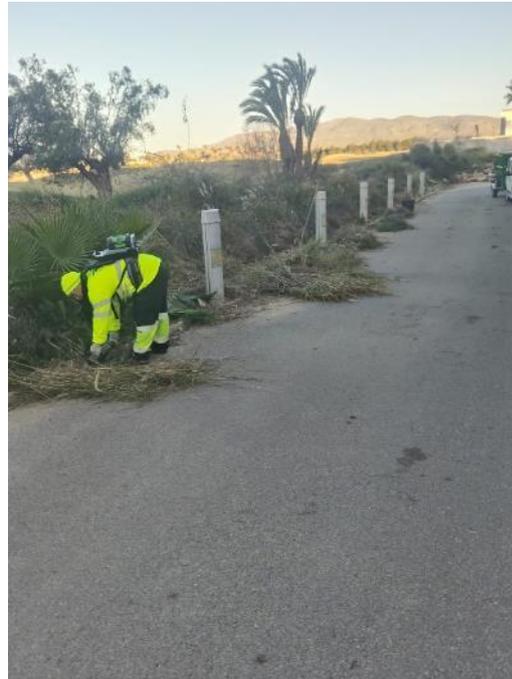
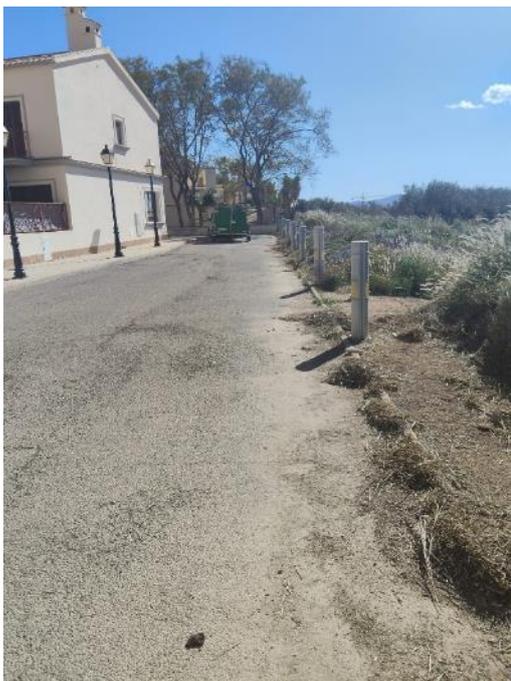
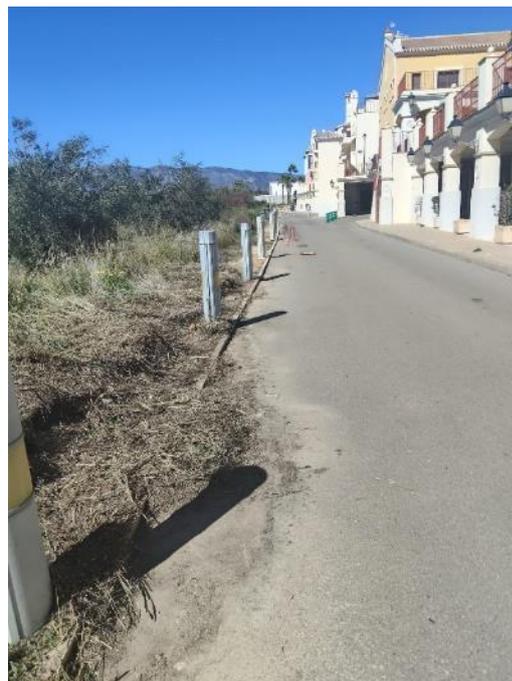
At the request of the EUC, the weeding and cleaning of C/ Morella, between Pueblo Español and the Golf Course, is being carried out

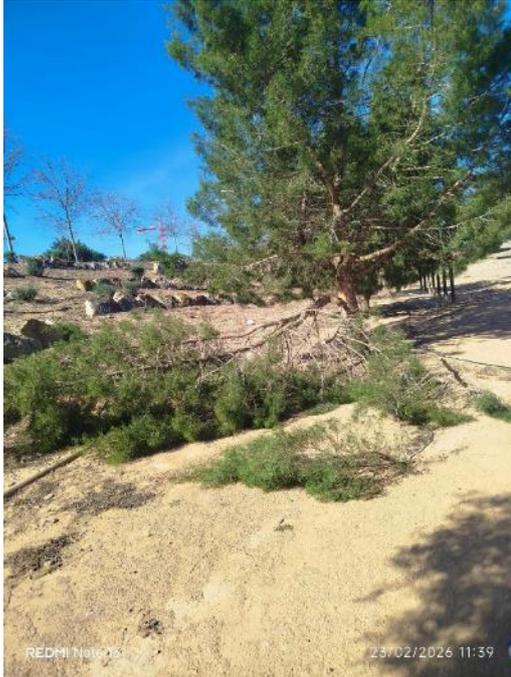
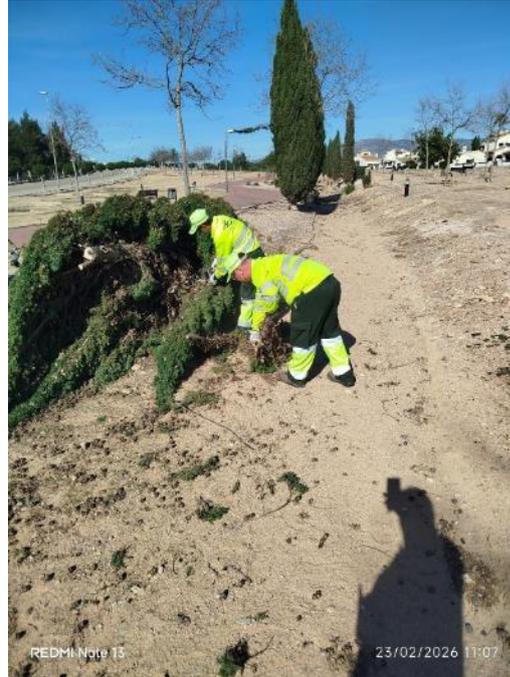
Cutting, collecting and cleaning fallen trees in Rambla Mediterránea Park (a pine branch and a 6-meter cypress)

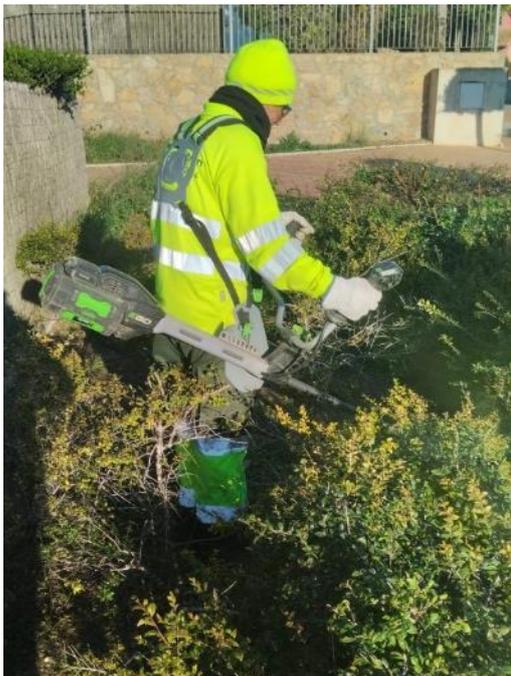
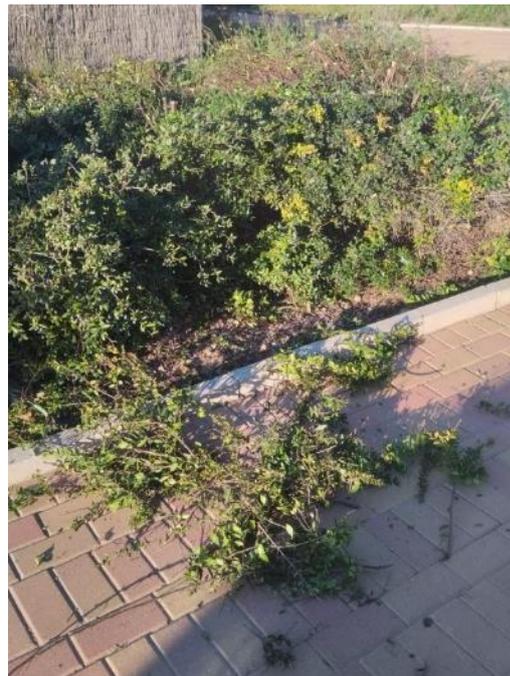
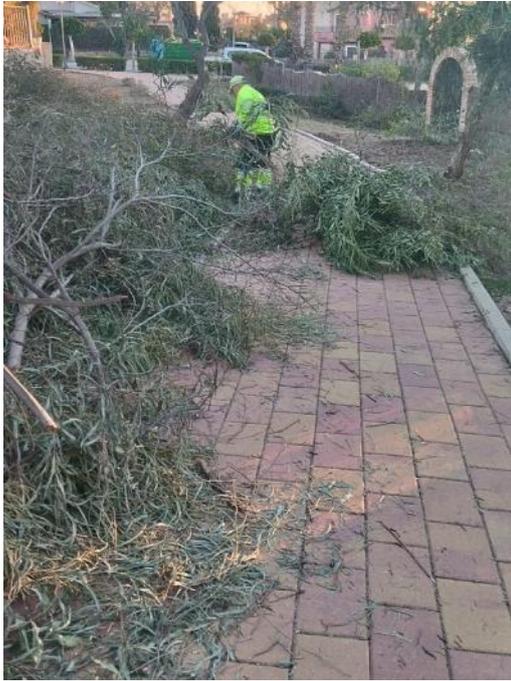
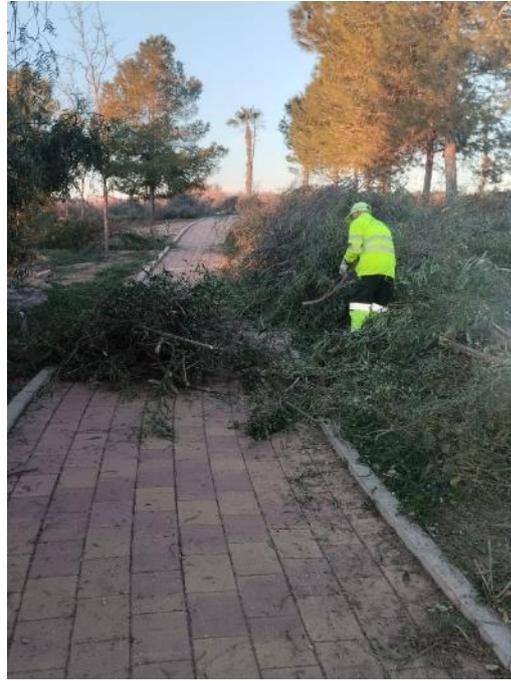
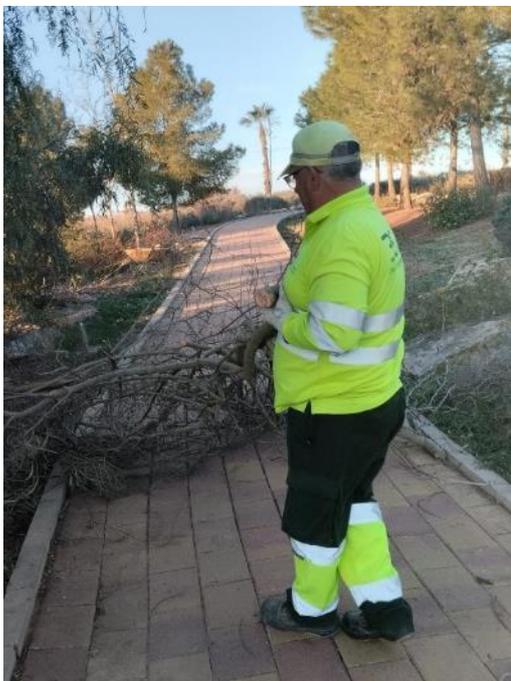
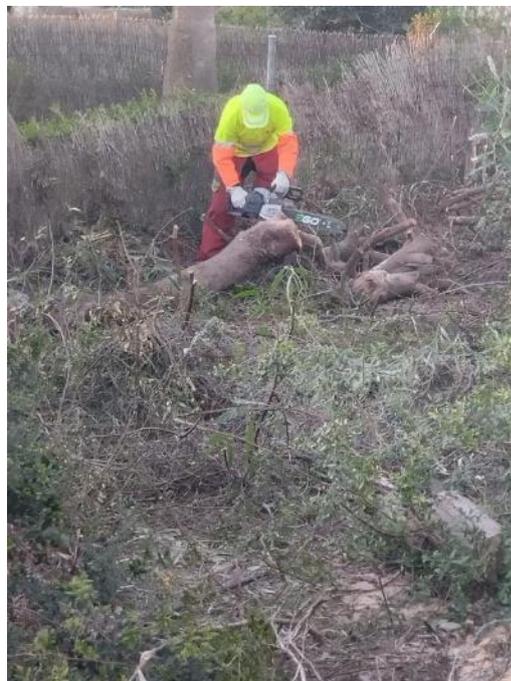
At the request of the EUC, the weeding and cleaning of the path that connects Canada Street and the Golf Academy parking, is being carried out

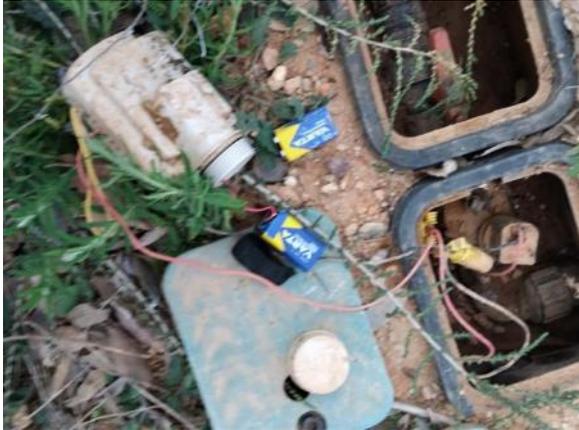
**Brasil St., 30 - Roundabout garden
(programmer battery replacement)**

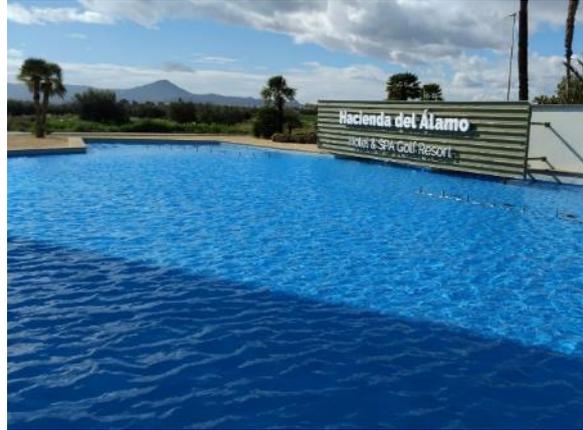
**Entrance Fountain - Legionella control
(emptying, cleaning with brush and pressure
washer, disinfection and filling; sampling
after 15 days)**

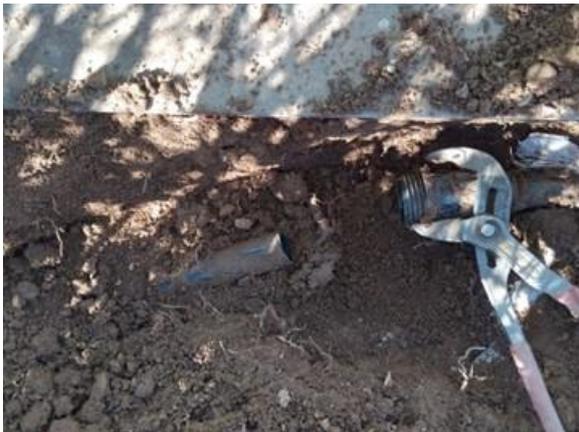
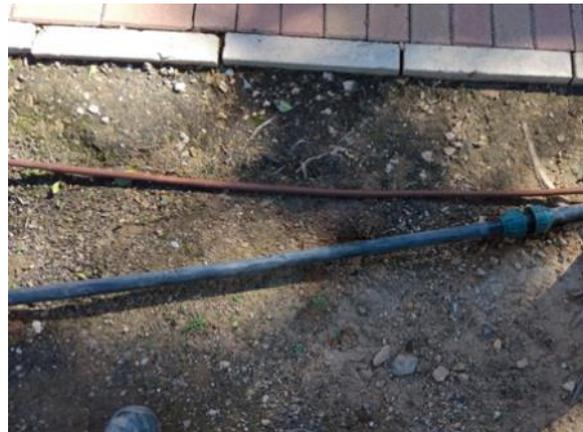
Bélgica St., 29 (3 ml PE Ø32 y 2 links)

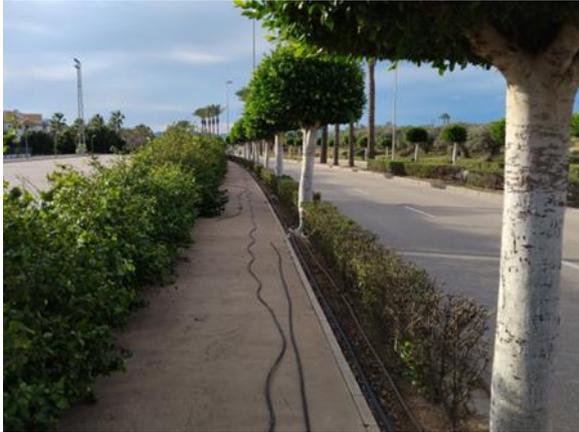
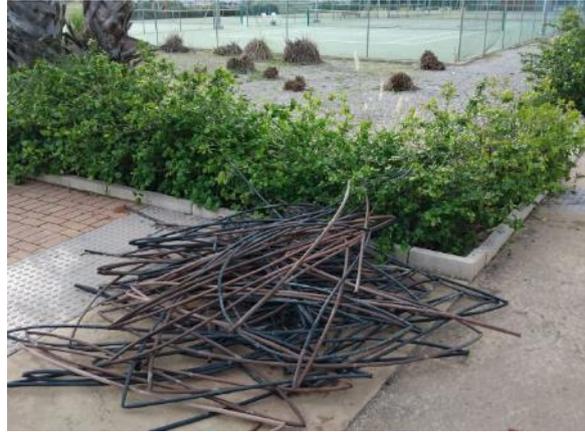
Main road both sides - From Phase 1 roundabout to Phase 6 roundabout (950 ml PE Ø16 and 10 links)

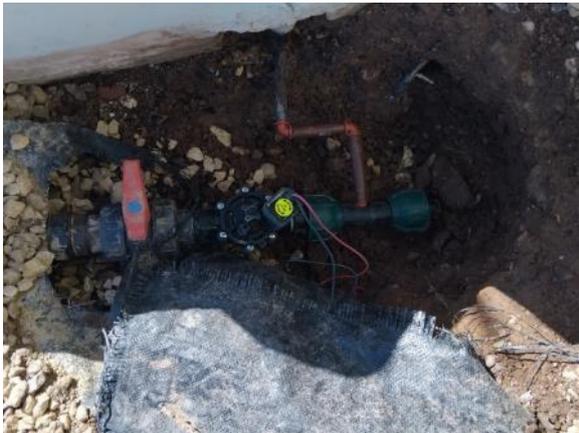
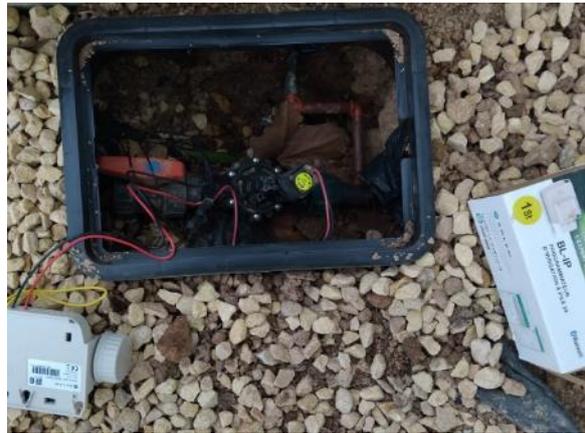
Entrance Fountain - New installation (new valve box, 1" solenoid valve and Solem 1E programmer)

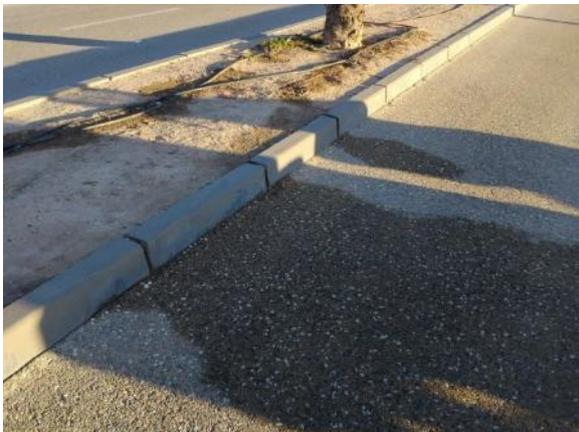
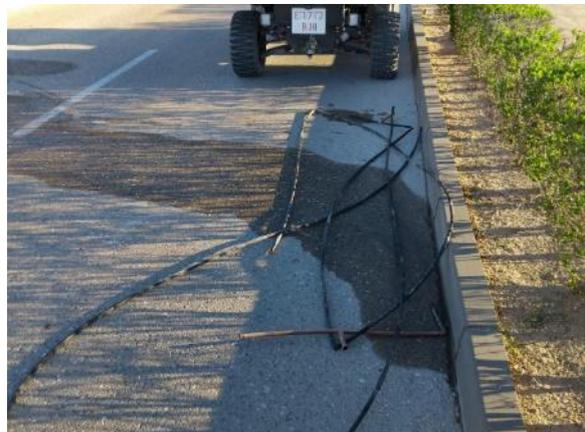
Main Road median (20 ml PE Ø16 and 2 links)

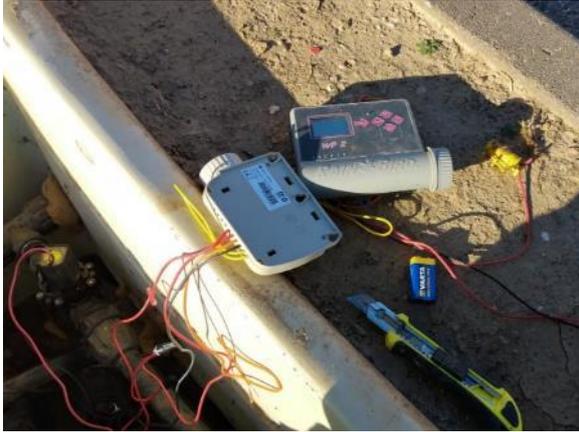
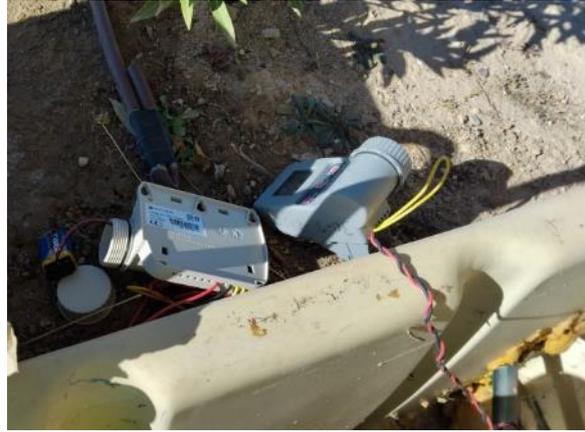
Main road median - in front of Hotel (Rain Bird programmer replaced with Solem 2E)

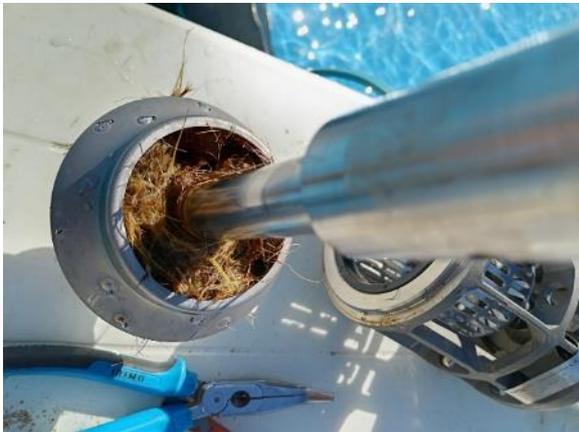
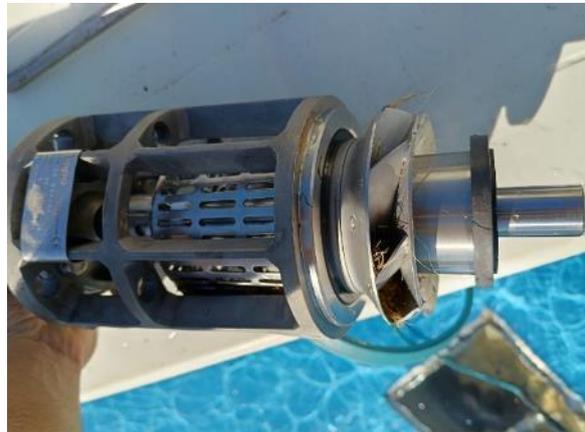
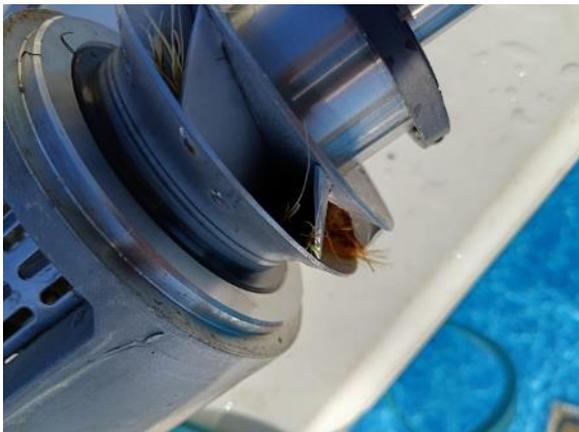
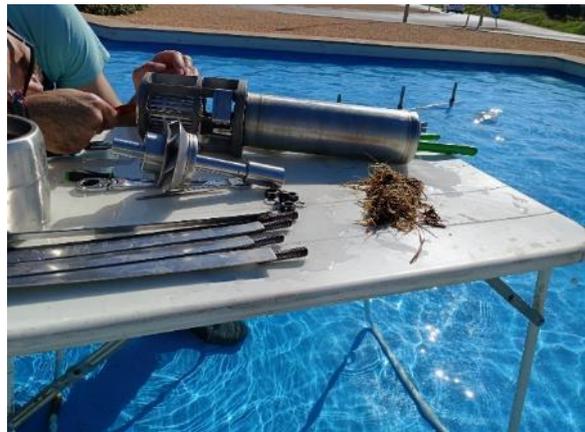
Entrance Fountain - Cleaning due to accumulation of solid waste in hydraulic body nozzle
