## 1. DESCRIPTION OF WORKS AND PHOTOGRAPHIC REPORT

Listed below are all the works carried out by **3RS GESTIÓN** for the Urban Solid Waste Collection Service, Street Cleaning and Maintenance of the Green Areas of the urban entity "Hacienda del Álamo Golf Resort", in **SEPTEMBER 2026**.

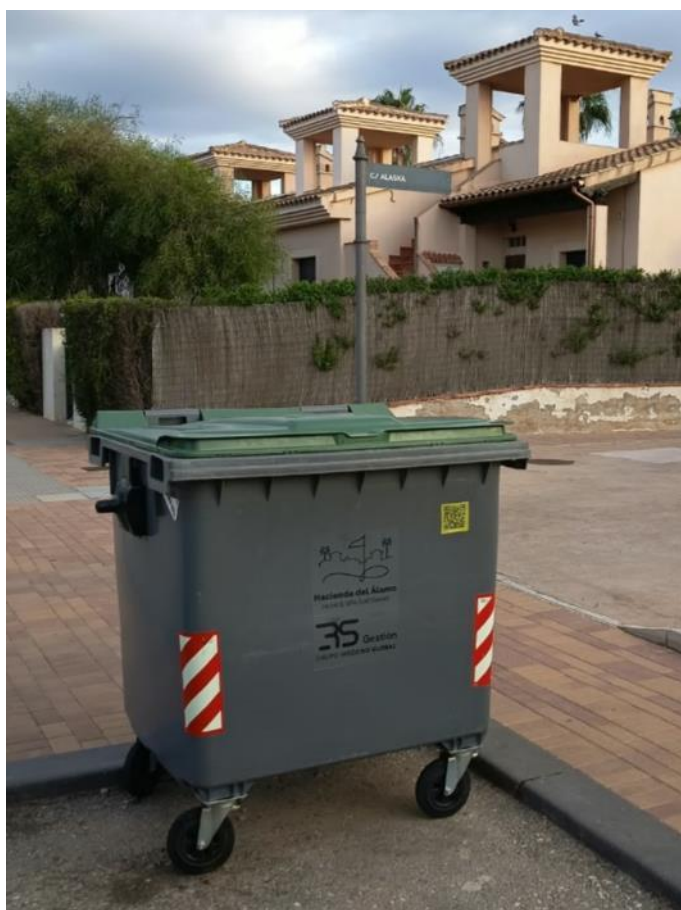
Resolution regarding an act of vandalism involving the replacement of a 1,100L trash container broken due to repeated dumping of rubble at 31 Alemania Street. The EUC has been notified.

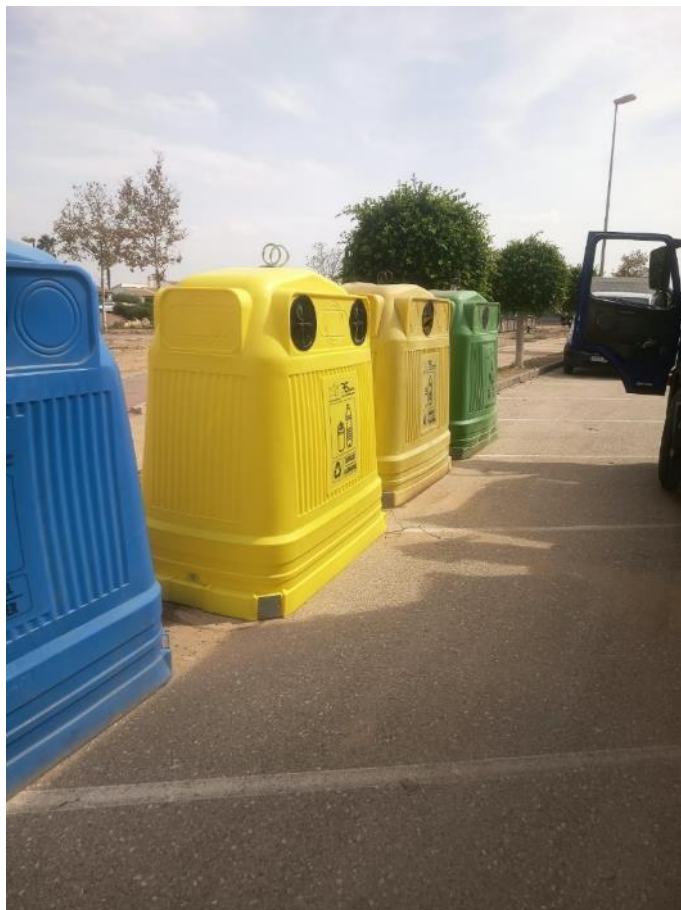
- 1 Uds. recycling container 3.200-liter (yellow, for packaging) opposite the Oasis residential complex, Paseo Alameda:

At the request of the EUC, and given the increased fill levels observed in some containers, the following is being installed:

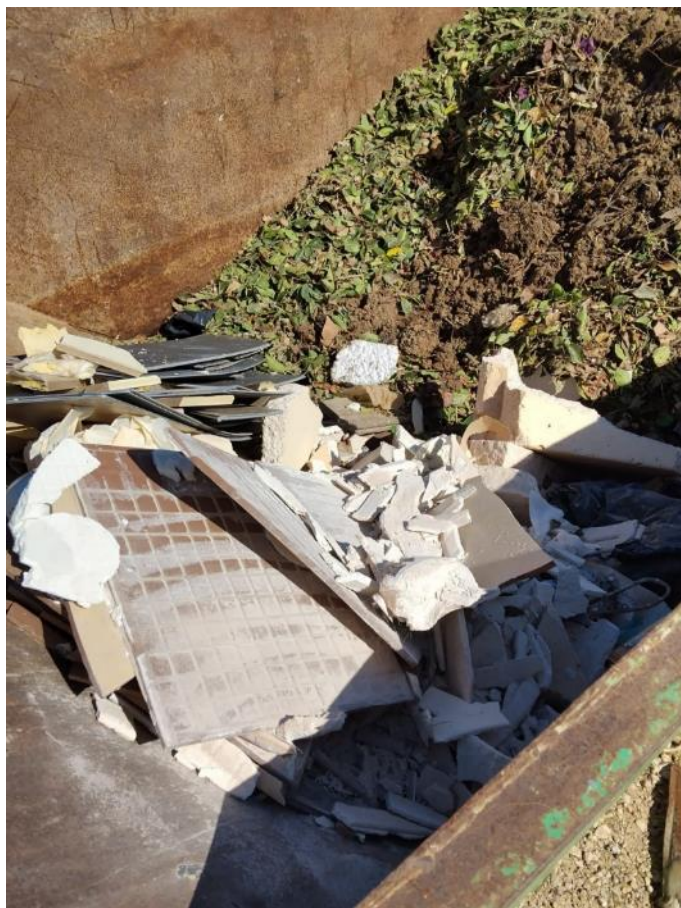
**ACT OF VANDALISM** involving the dumping of rubble into the container located within the pruning waste storage área, a container reserved for emptying the street sweeper.

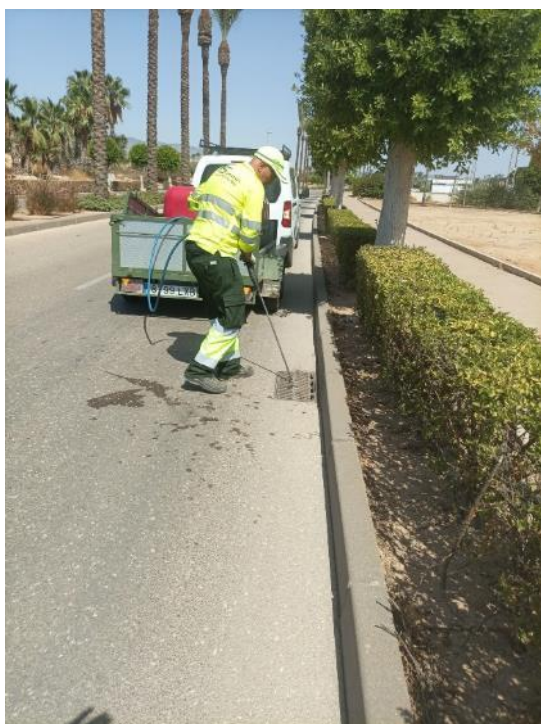
**Main Road**

**Cleaning and disinfection of storm drains in the rainwater collection network throughout the entire residential development:**

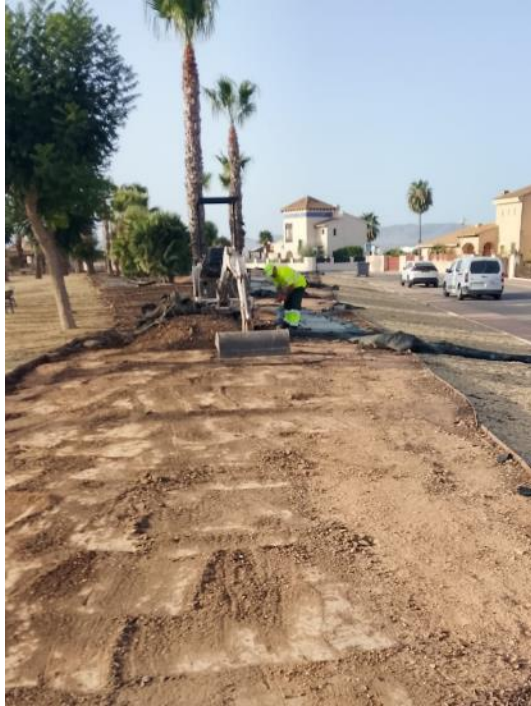
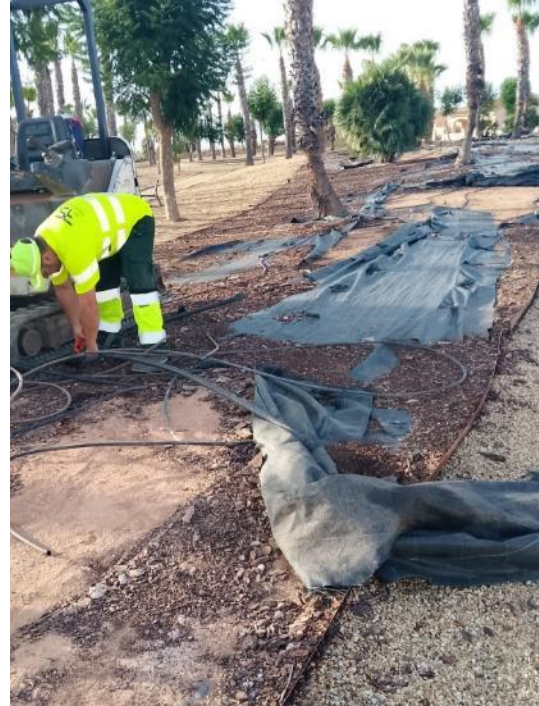
**Mechanical cleaning of the pine-bark flowerbeds at Plaza Alemania using a mini-backhoe, removing broken pipes, bark, and damaged geotextile sheeting.**

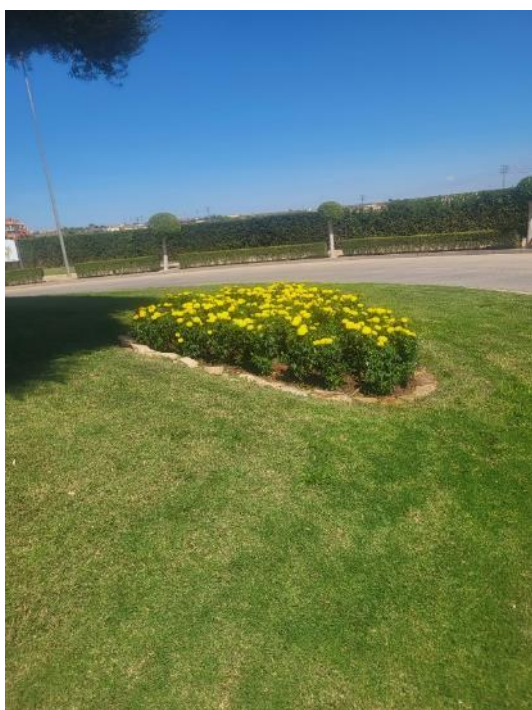
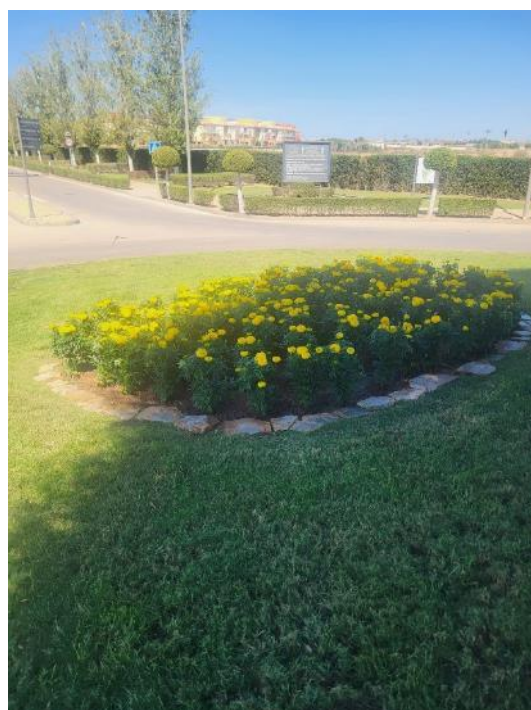
**New flower planting at the entrance roundabout. Removal of existing withered plants, addition of organic matter, soil cultivation, and new autumn planting consisting of yellow Tagetes (M12 size)**

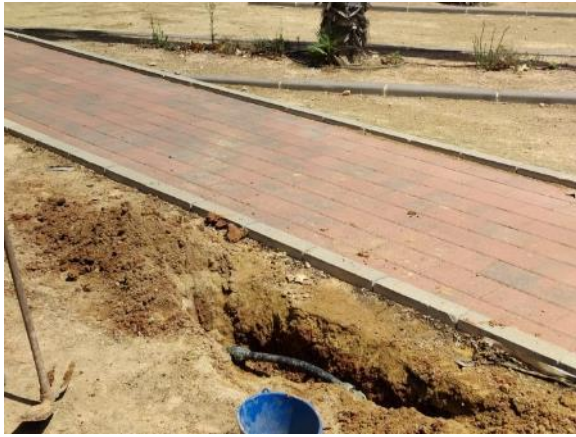
Phase 6 - Olivos B Garden (repair of 1 ml Ø32 PE pipe, 2 links)

Review of the irrigation network, opening manholes and checking controllers, solenoid valves, and emission points, detecting and repairing each of the incidents detected at the following locations:
