1. DESCRIPTION OF WORKS AND PHOTOGRAPHIC REPORT

Listed below are all the works carried out by **3RS GESTIÓN** for the Urban Solid Waste Collection Service, Street Cleaning and Maintenance of the Green Areas of the urban entity "Hacienda del Álamo Golf Resort", in **NOVEMBER 2025**.

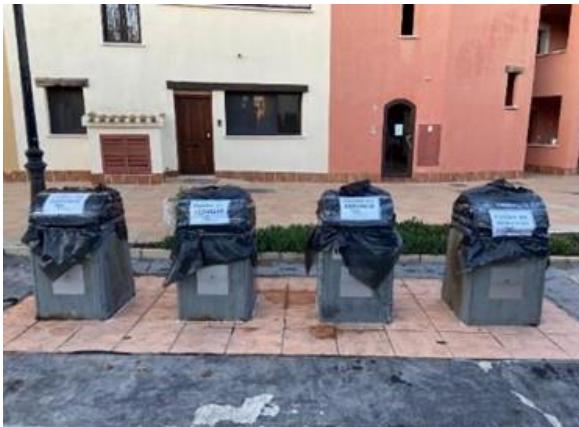
Before (east side)

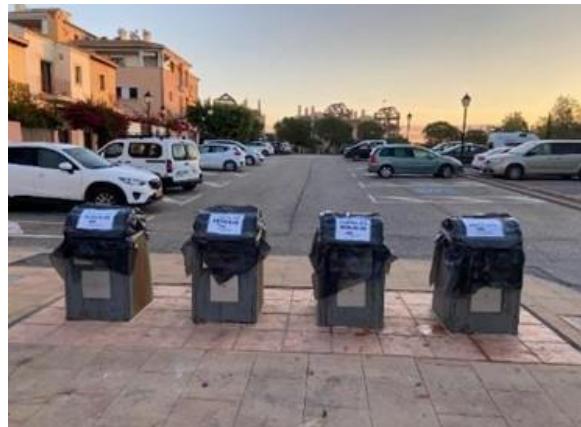
Before (south side)

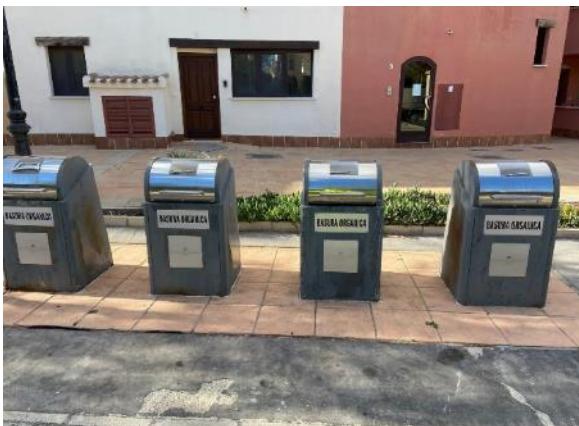
Pre-resolution state (east side)

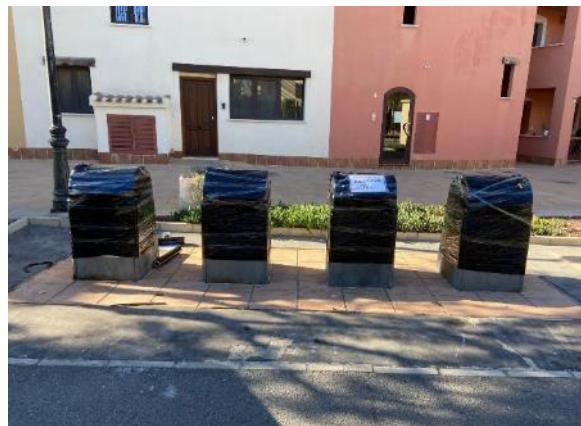
Newly sealed (east side)

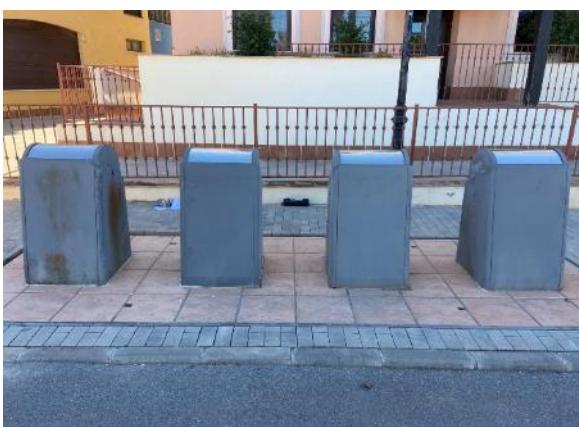
State prior to resolution (north side)

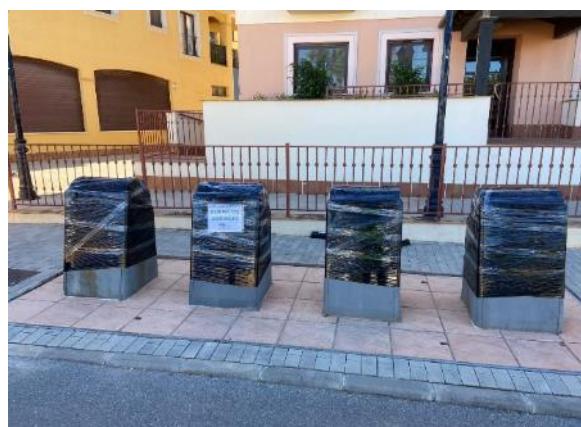
Newly sealed (north side)

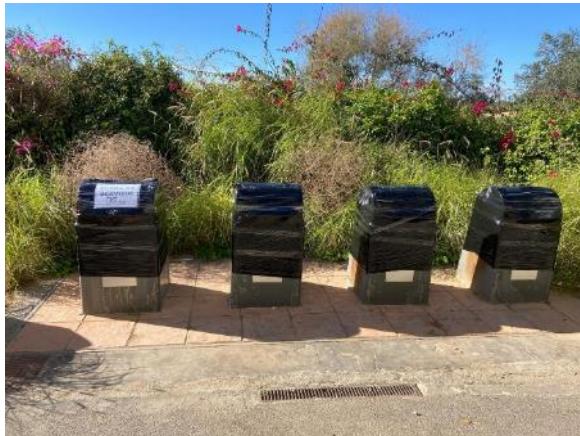
Newly sealed (west side)

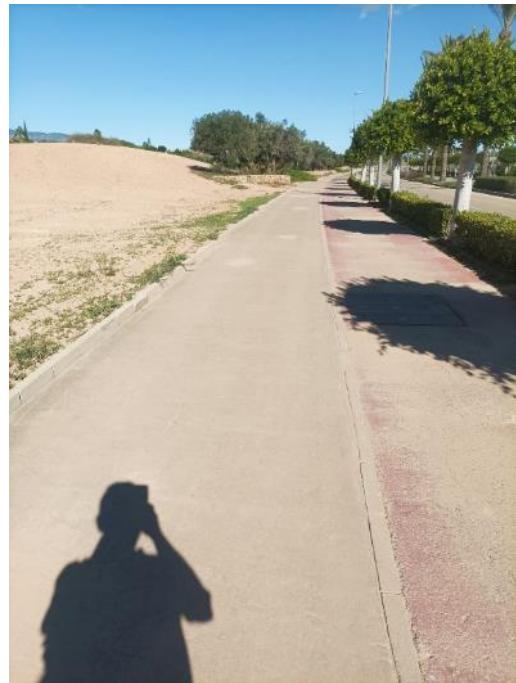
After

Manual cleaning work of soil runoff caused by heavy rain on the bike lane of the Main Road, from the Phase 6 roundabout (Olivos) to the Phase 1 roundabout (EUM)

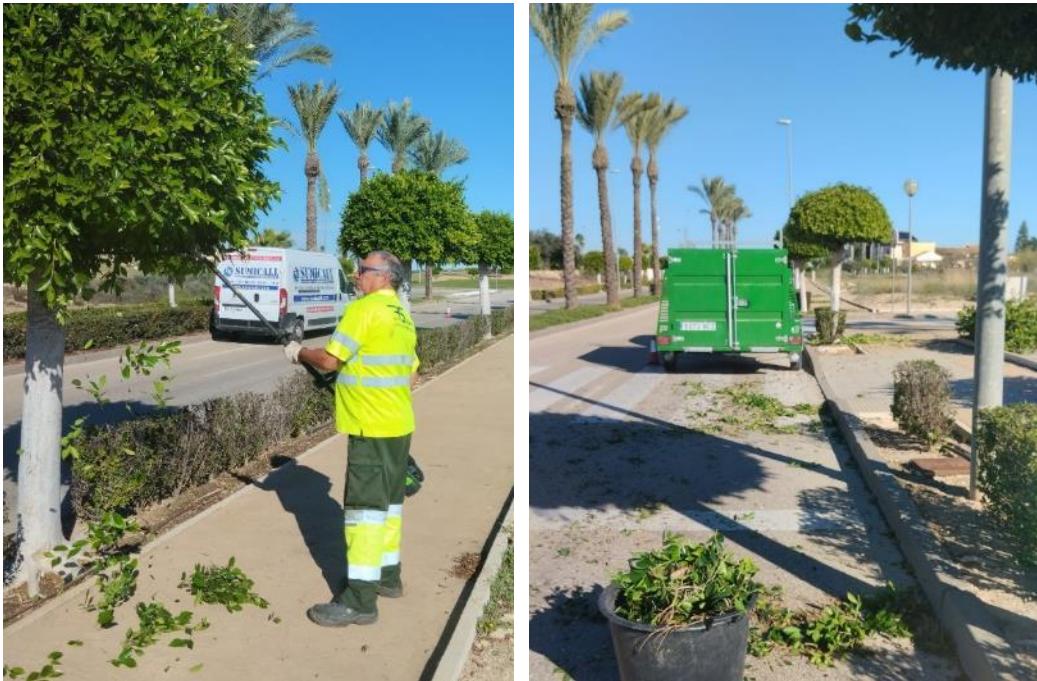
Weeding and trimming of hedges and ficus trees along the main road from the entrance to the EUM (right/left)

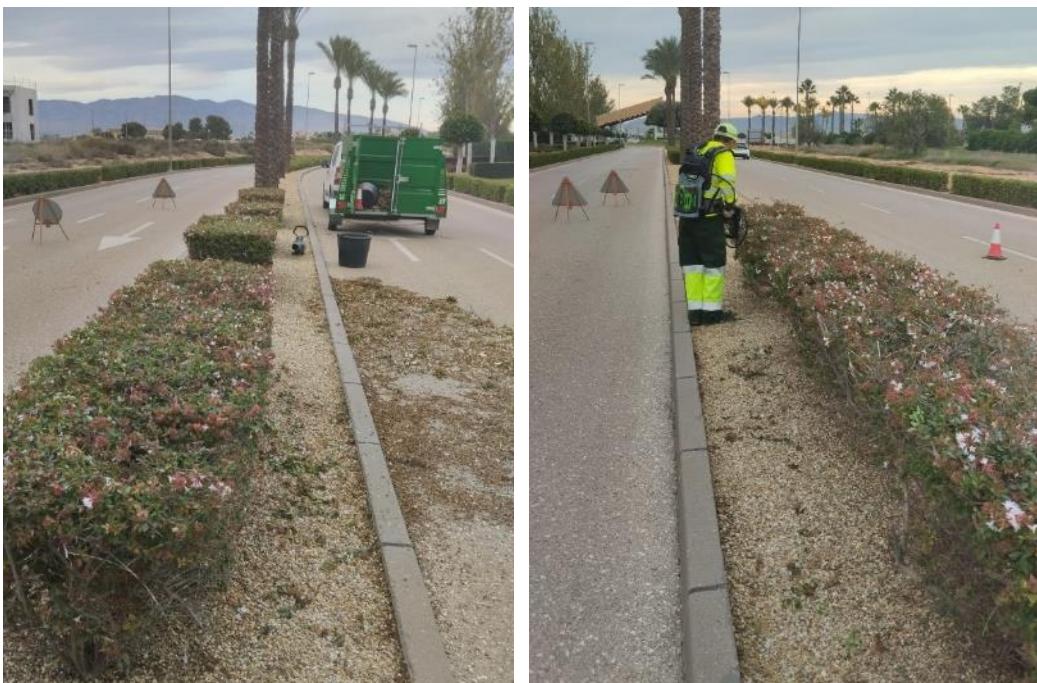
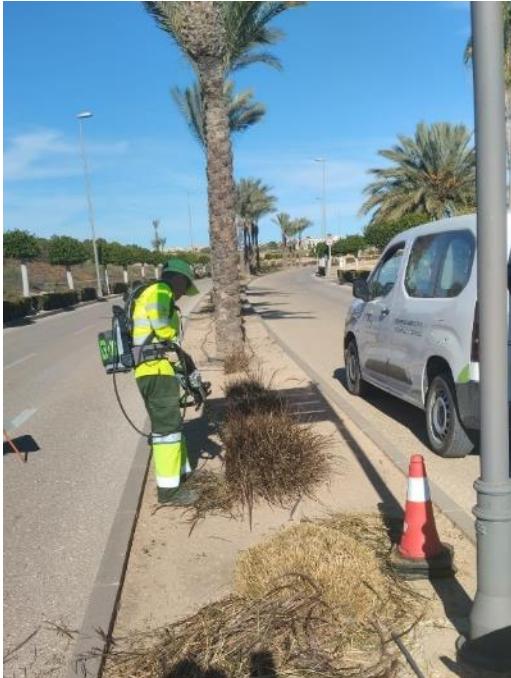
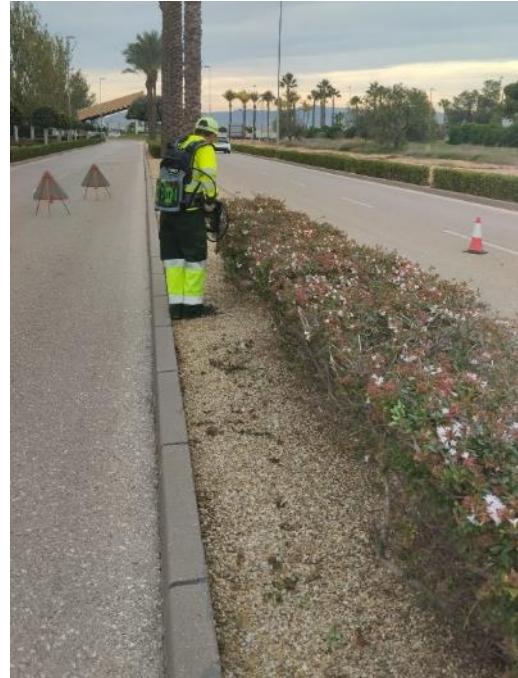
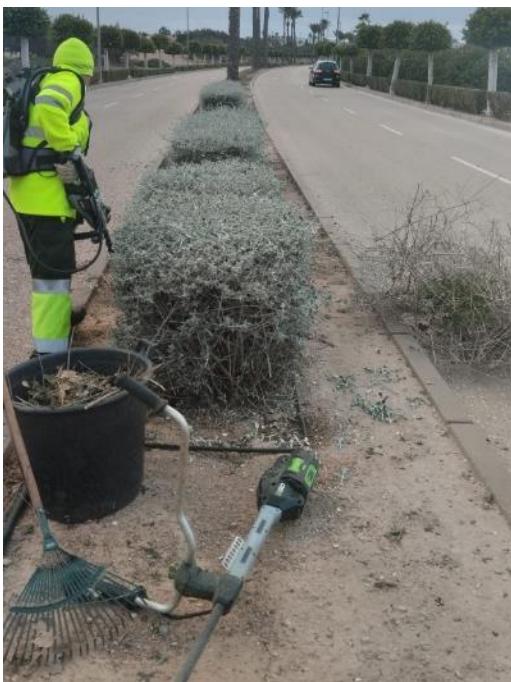
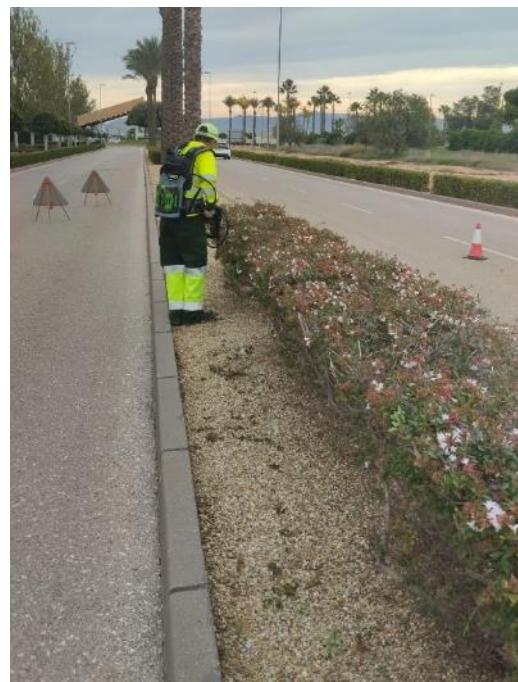
Weeding and trimming of hedge and ficus trees along the main road from the entrance to the EUM (median).

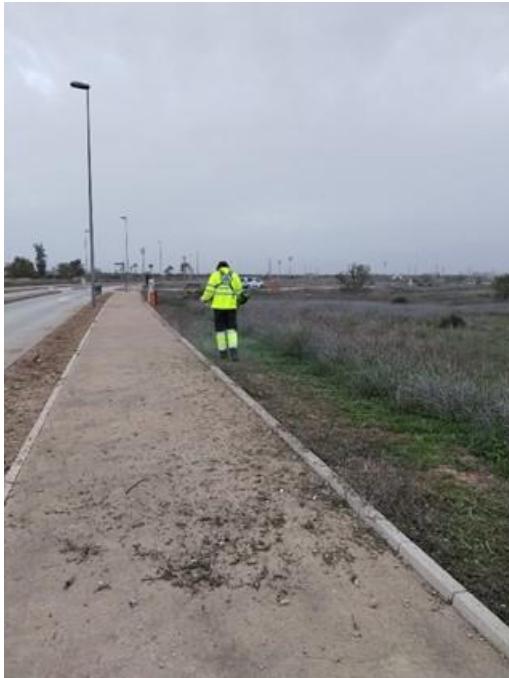
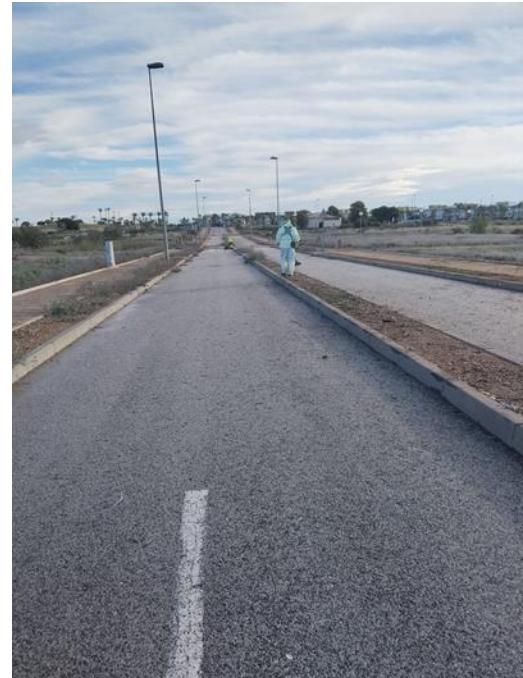
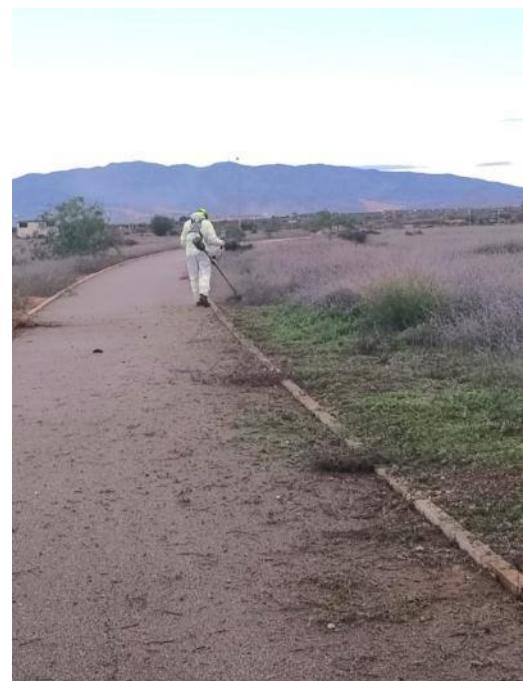
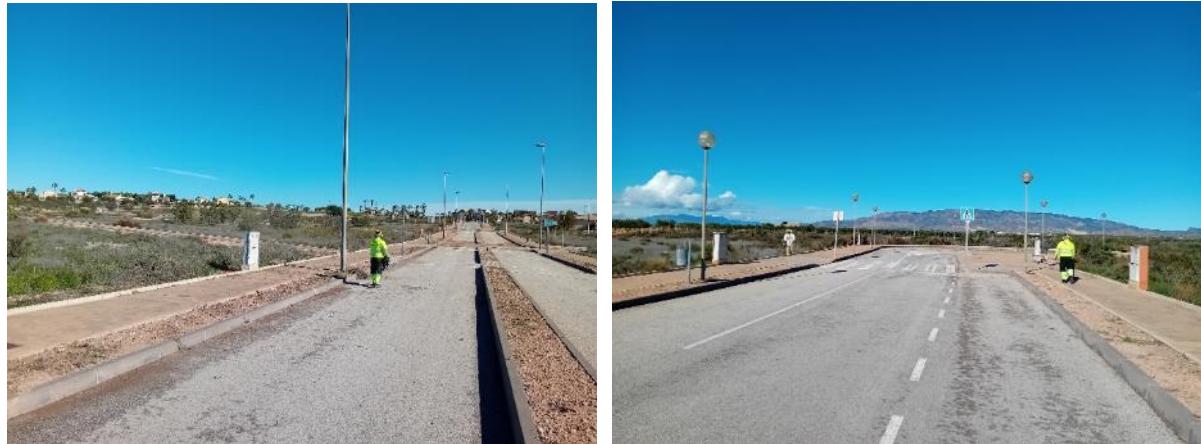
Weeding completion of UA4 (Panama, Paraguay, Noruega and Nigeria streets)

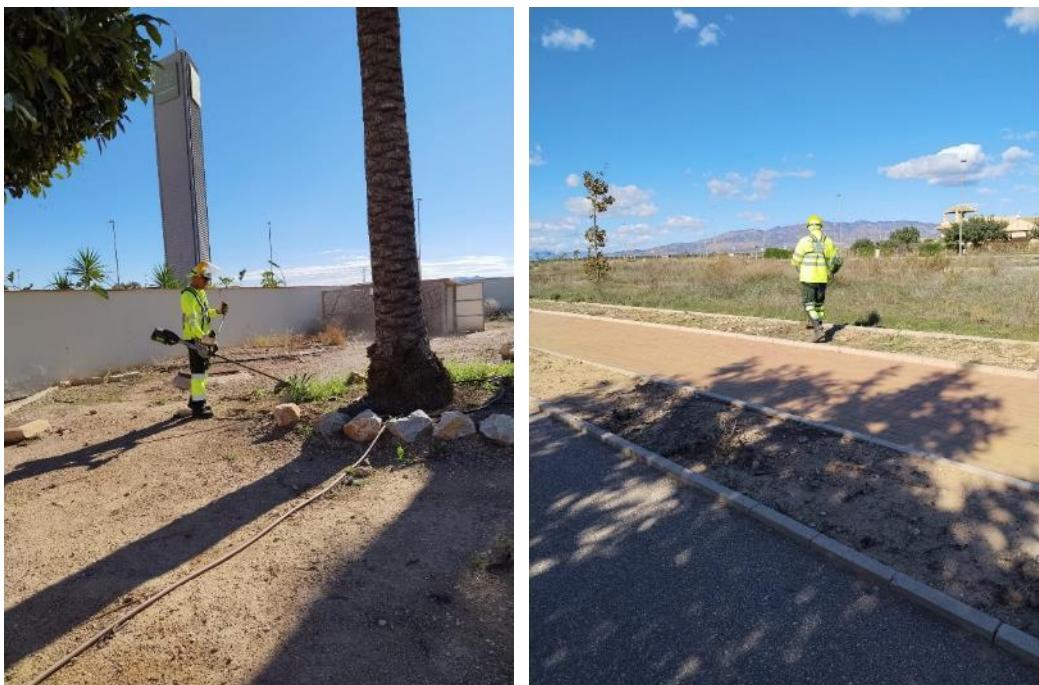
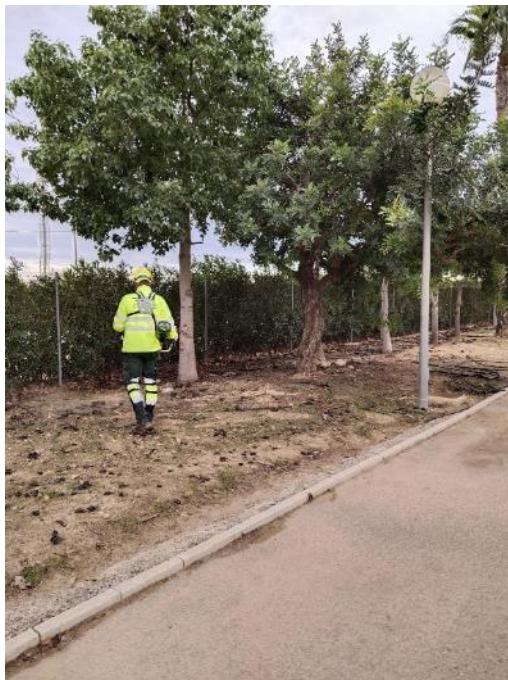
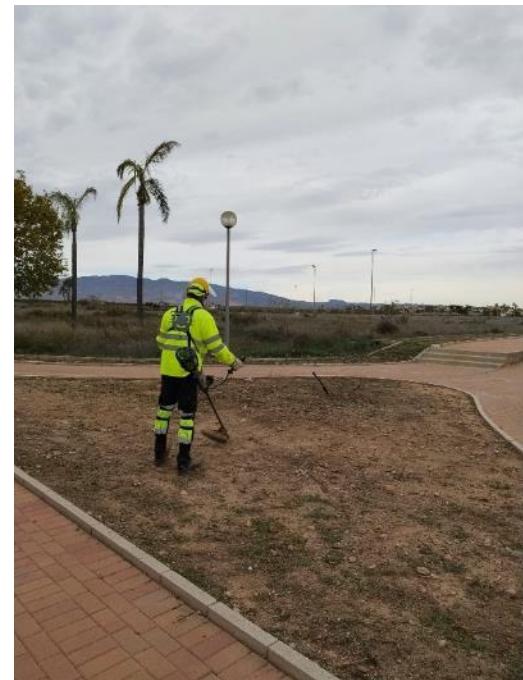
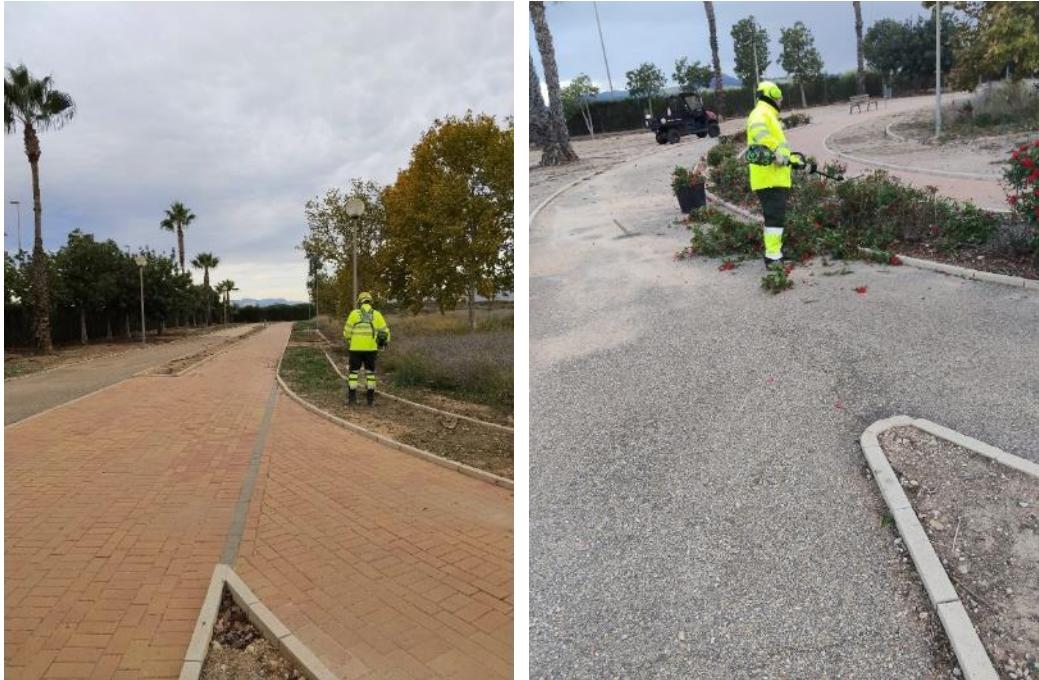
Weeding and cleaning in the back garden of the guardhouse:

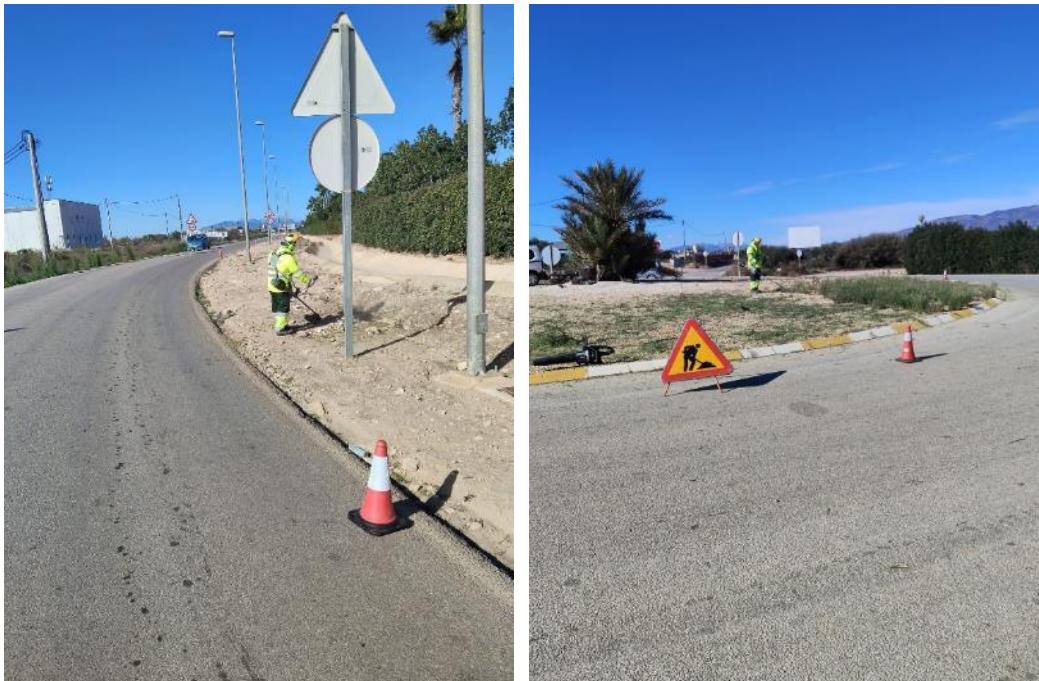
Desbroce y limpieza de cuneta y rotonda exterior en Camino del Escobar:

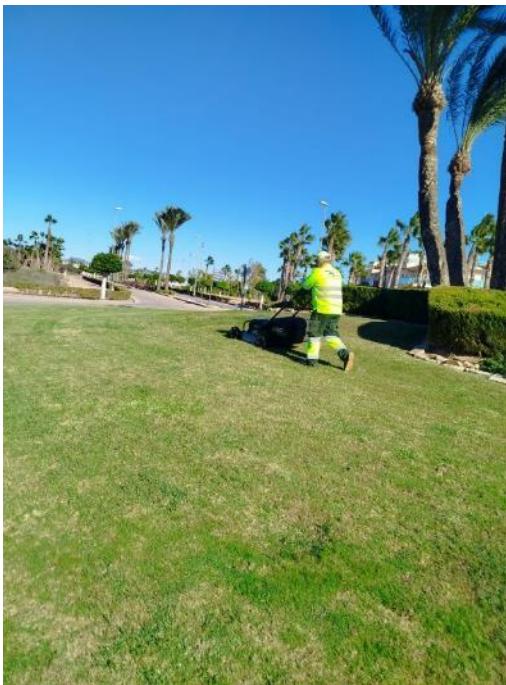
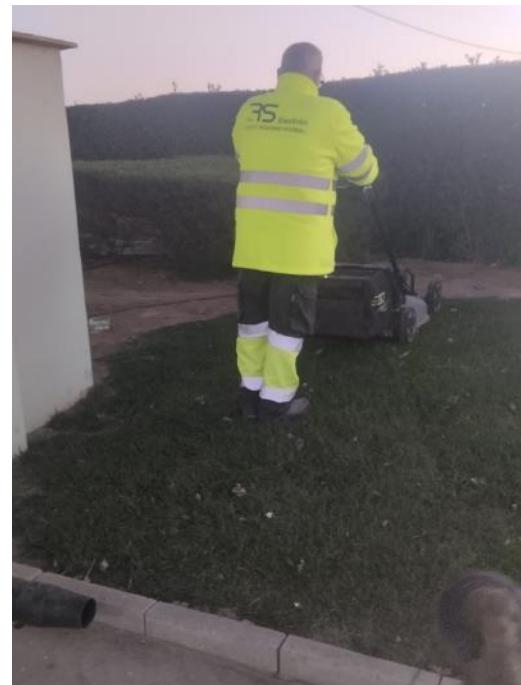
Mowing of the entrance lawn, the garden pictures, the entrance roundabout, the Phase 6 roundabout, and the roundabout next to the Multipurpose Building (MPB):

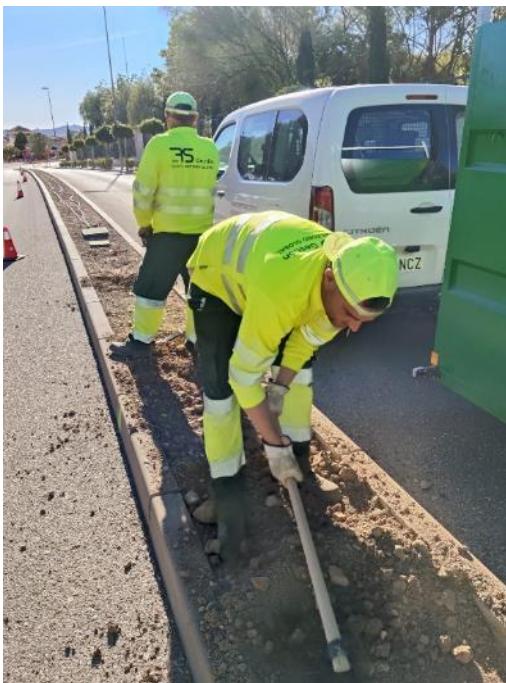
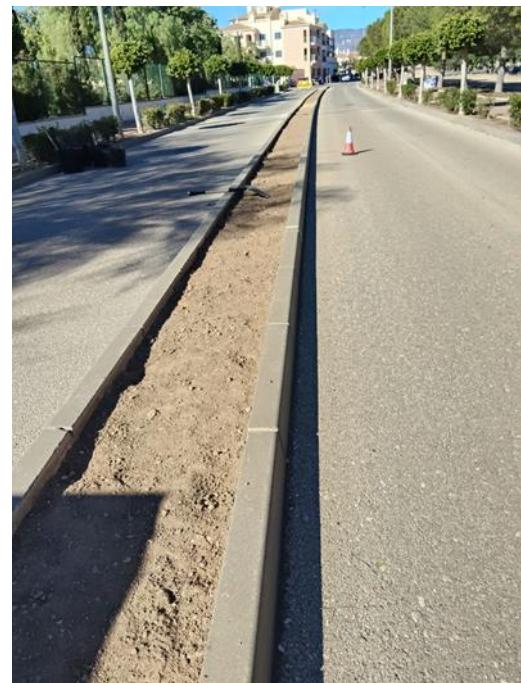
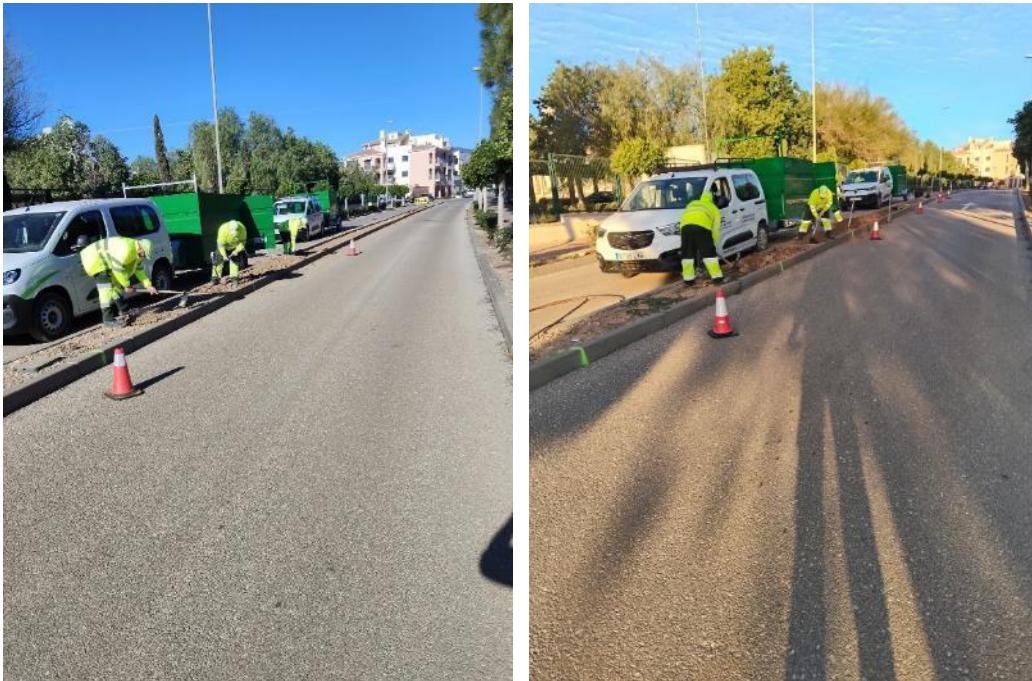
Medium preparation of entrance to a Pueblo Español for a new plantation:

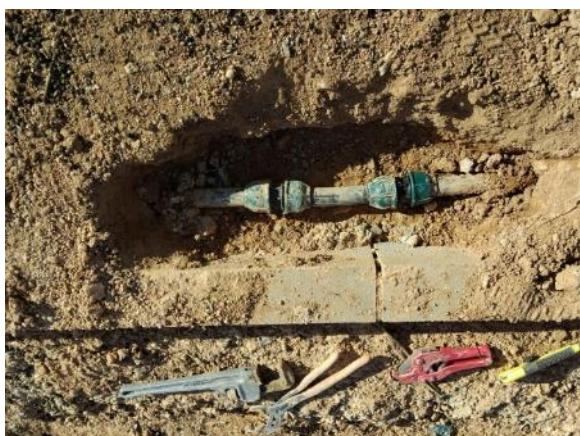
Back Garden Phase 6 (0,5 ml PE Ø32 y 2 links)

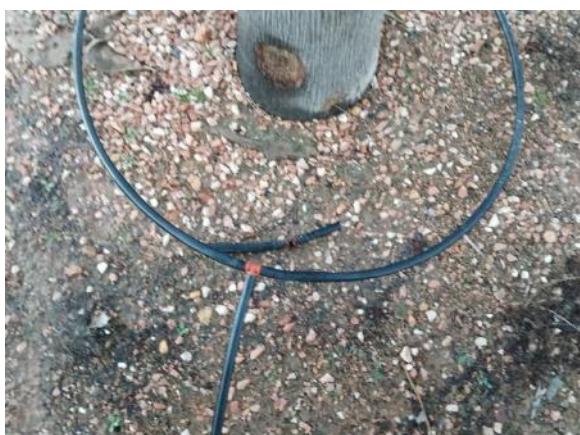
Garden by squares (T Ø16 mm)

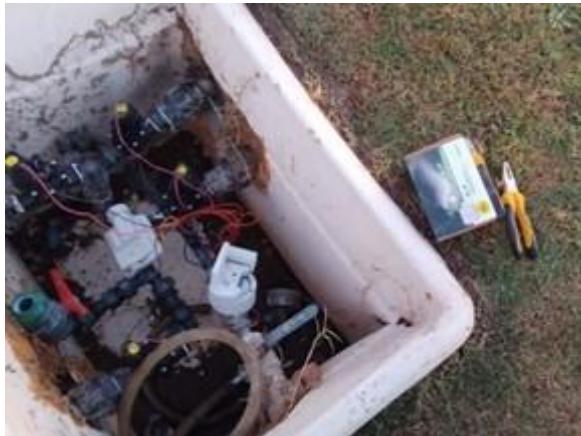
Phase 6 groundabout (change programmer
Solem 4 stations and 1 solenoid valve 1")

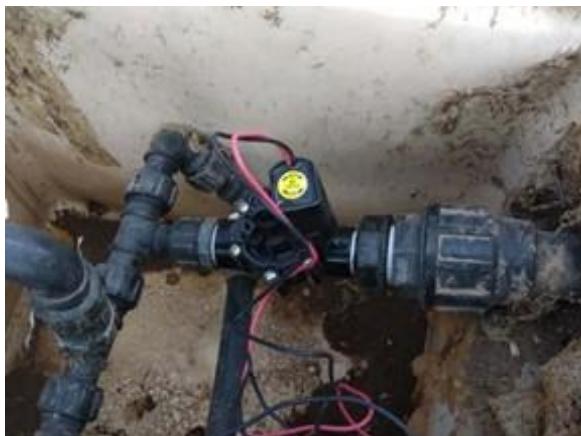
Phase 6 groundabout (change programmer
Solem 4 stations and 1 solenoid valve 1")

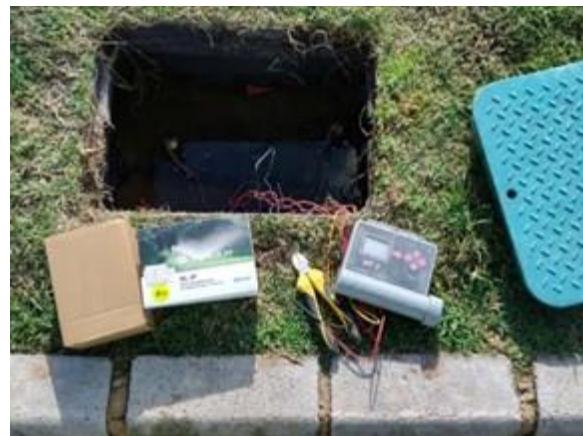
Phase 1 groundabout (change programmer
Solem 4 stations)

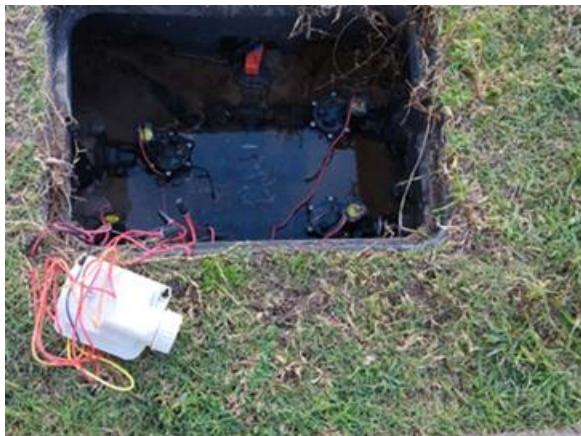
Phase 1 groundabout (change programmer
Solem 4 stations)

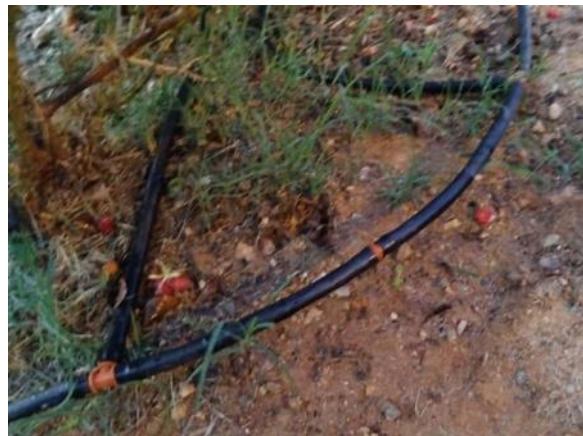
Back garden Phase 6 (5 breaks in PE Ø16-
links)

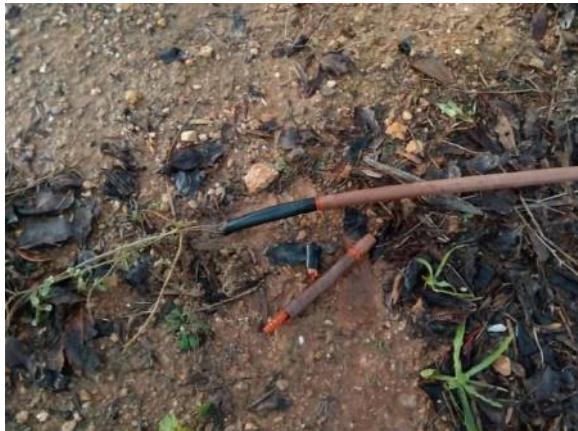
Back garden Phase 6 (5 breaks in PE Ø16-links)

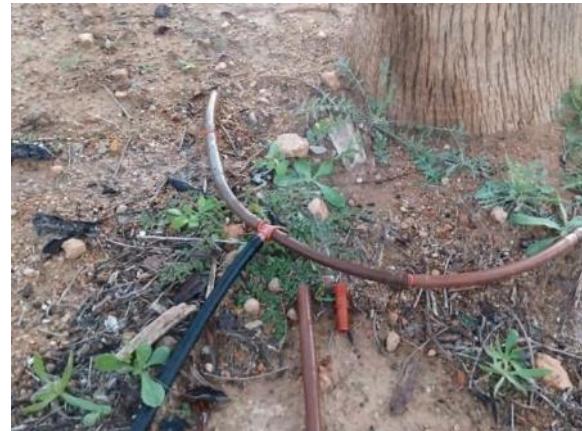
Back garden Phase 6 (5 breaks in PE Ø16-links)

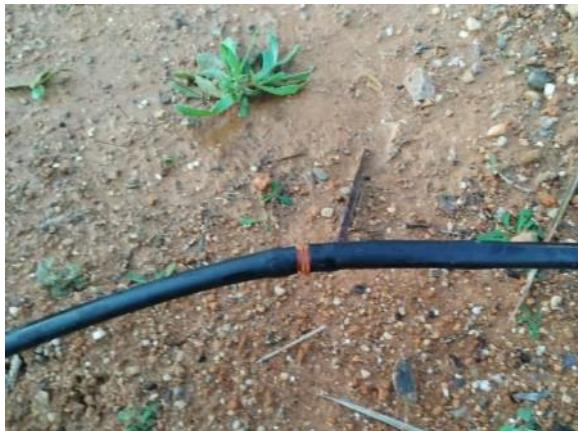
Back garden Phase 6 (5 breaks in PE Ø16-links)

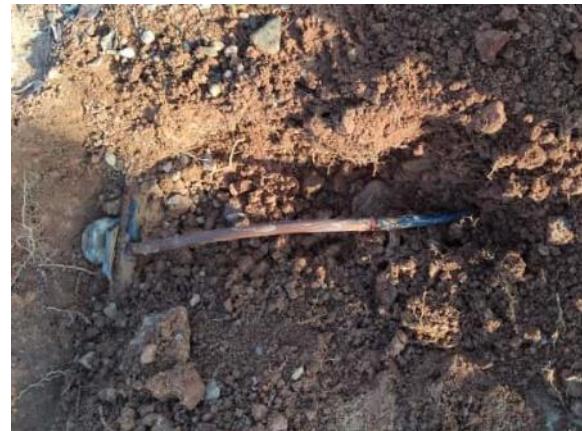
Back garden Phase 6 (5 breaks in PE Ø16-links)

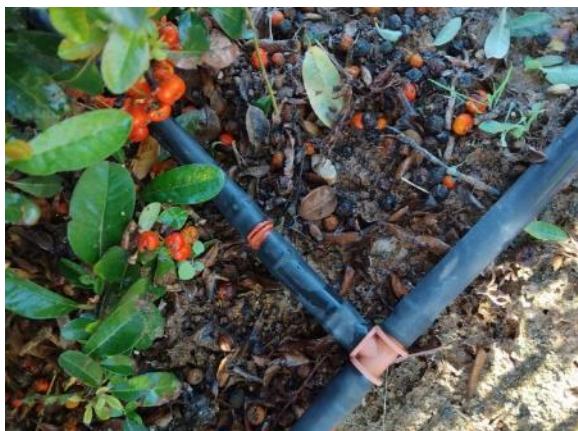
Main road median (4 breaks in PE Ø16-links)

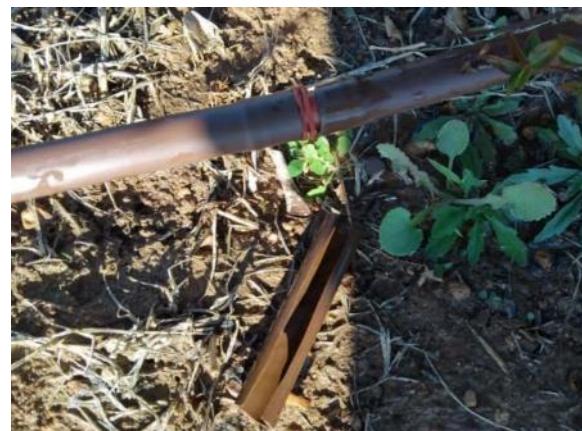
Main road median (4 breaks in PE Ø16-links)

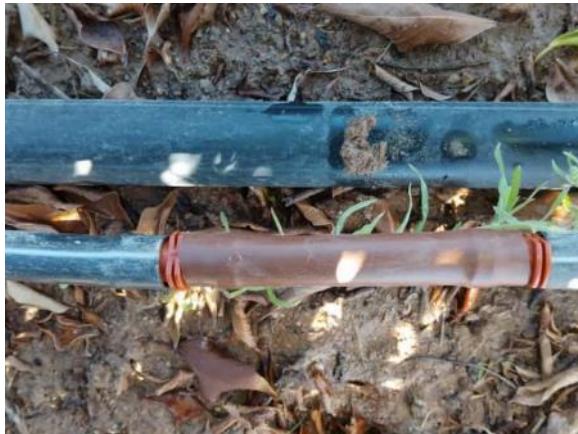
Main road, left side (9 breaks in PE Ø16 - pipe and 2 links)

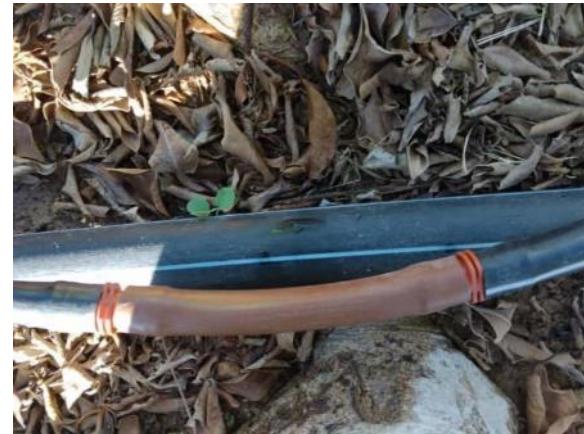
Main road, left side (9 breaks in PE Ø16 - pipe and 2 links)

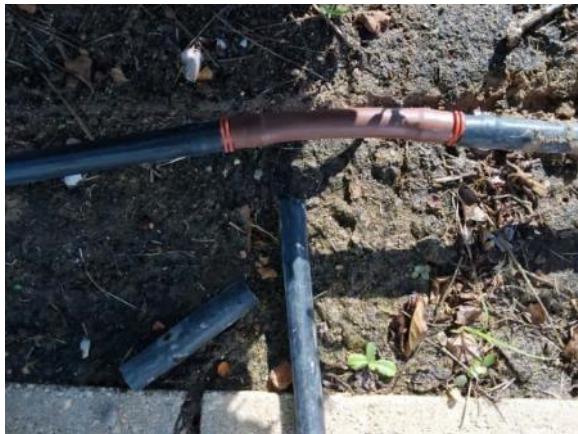
Main road, left side (9 breaks in PE Ø16 - pipe and 2 links)

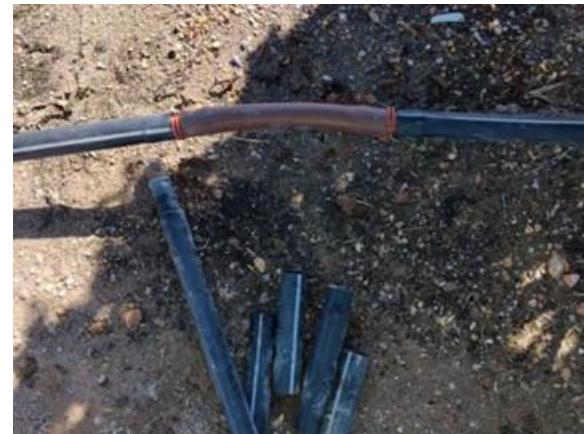
Main road, left side (9 breaks in PE Ø16 - pipe and 2 links)

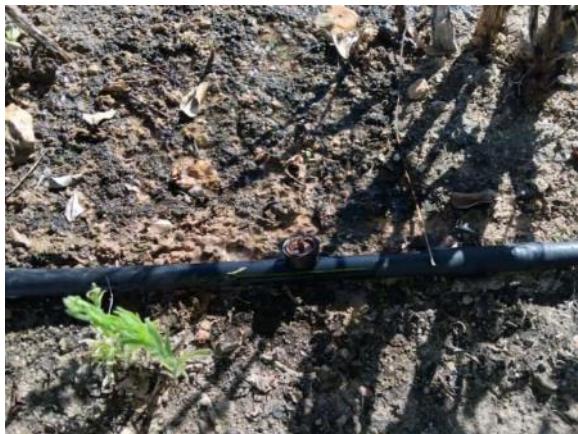
Main left road. Sales Office (dripper change)

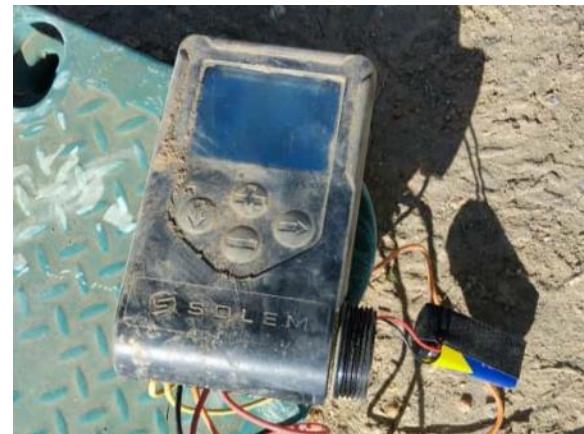
Main road, left side (battery change)

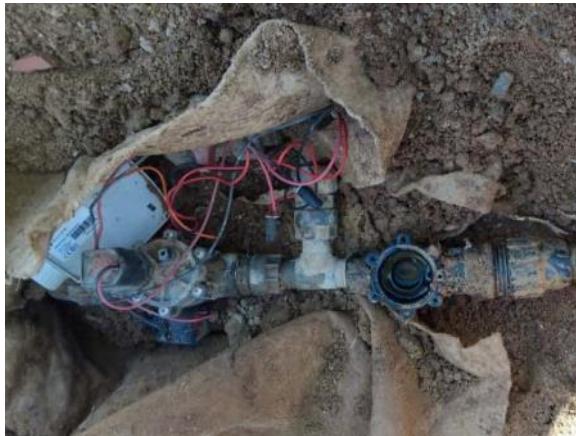
Main road right, near hotel (valve change)

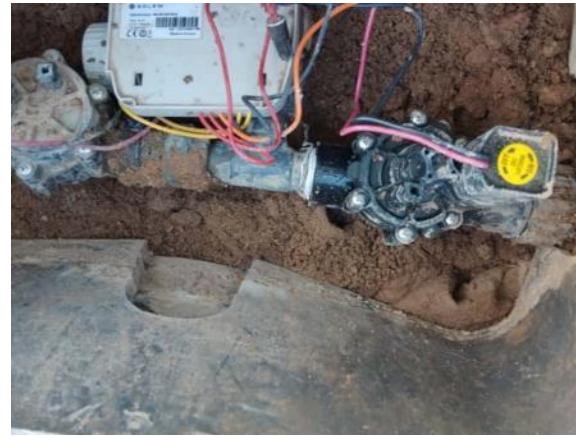
Main road right, near hotel (valve change)

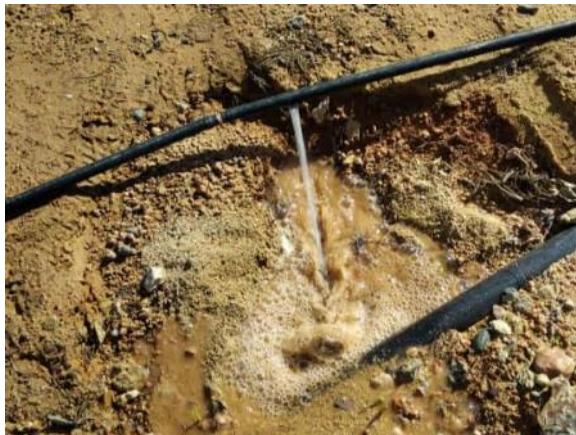
Italian Park Breakage Warning EUC (0,5 ml
PE Ø16 and 2 links)

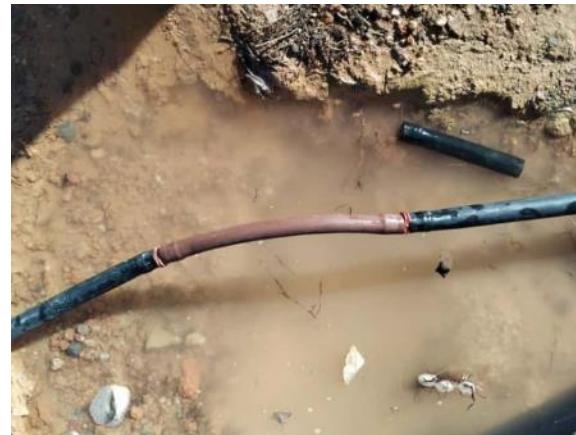
Italian Park Breakage Warning EUC (0,5 ml
PE Ø16 and 2 links)

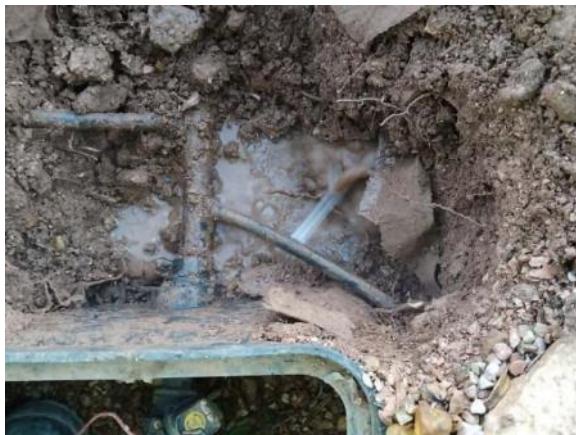
Rotonda C/ Bahamas (0,5 ml PE Ø16 y 1
enlace)

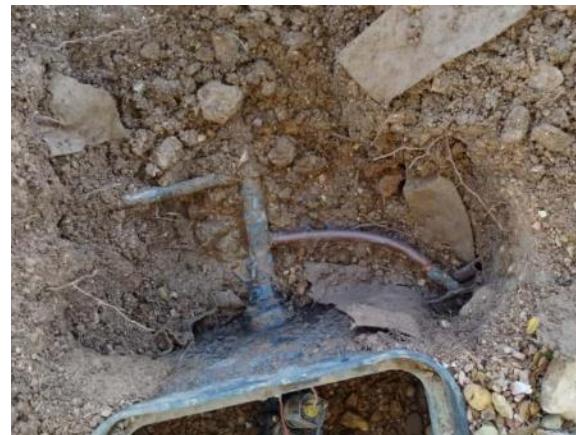
Roundabout C/ Bahamas (0,5 ml PE Ø16 and
1 link)

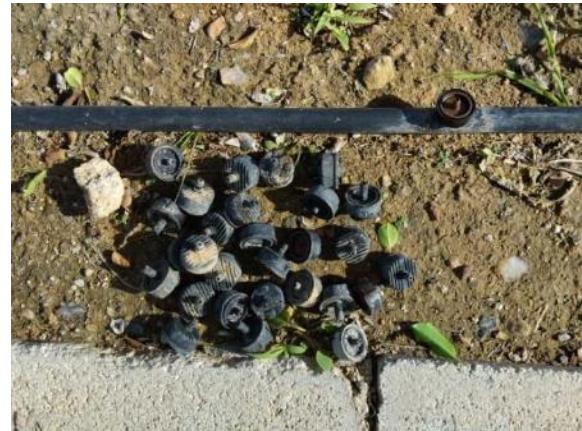
**Black Gravel Roundabout - ext. ficus (28
drippers change)**

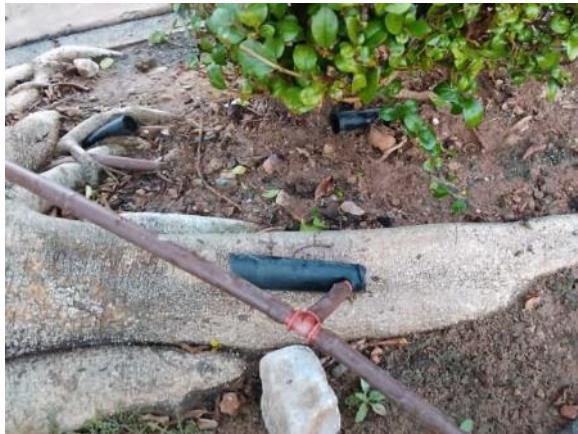
EUM roundabout (2 ml PE Ø16 y 2 links)

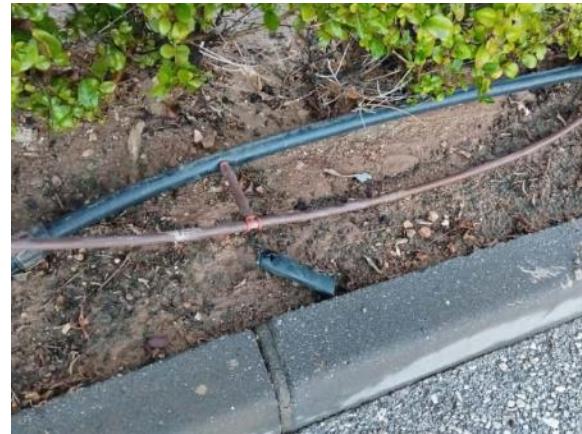
EUM roundabout (2 ml PE Ø16 y 2 links)

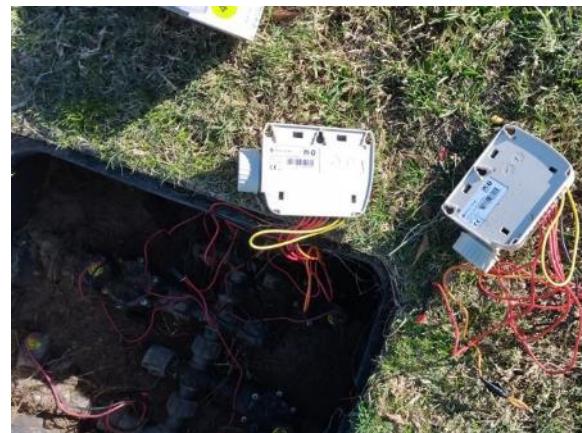
Phase 6 Roundabout (new Solem programmer not working; change with another) **NOT ACCOUNTING**

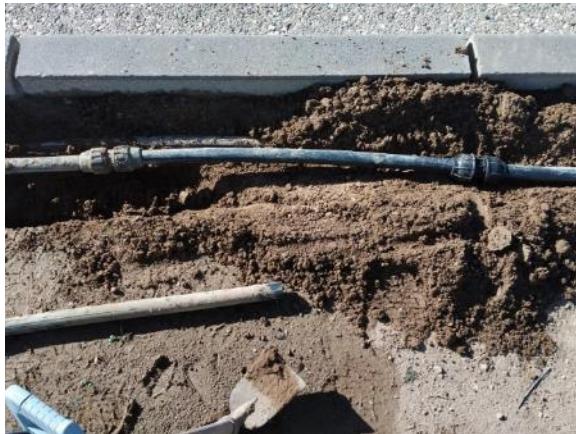
Main median in front of football field (1 ml PE Ø32 and 1 link)
