1. DESCRIPTION OF WORKS AND PHOTOGRAPHIC REPORT

Listed below are all the works carried out by **3RS GESTIÓN** for the Urban Solid Waste Collection Service, Street Cleaning and Maintenance of the Green Areas of the urban entity "Hacienda del Álamo Golf Resort", in **DECEMBER 2025**.

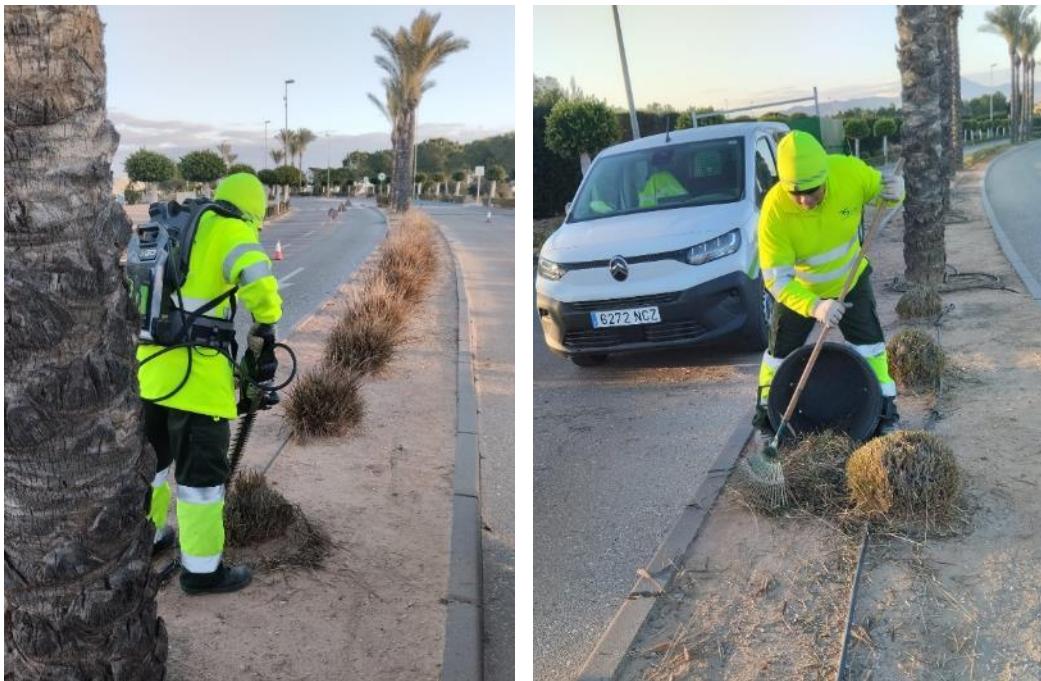
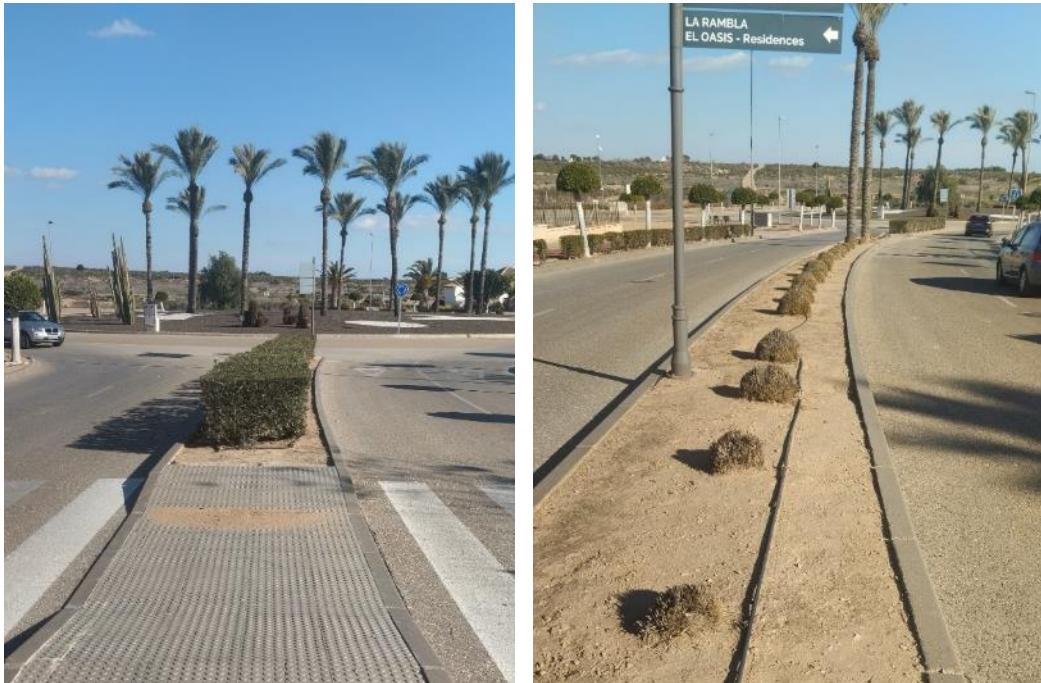
Weeding and trimming of hedges along the median of the main road from the Entrance to the Black Gravel Roundabout

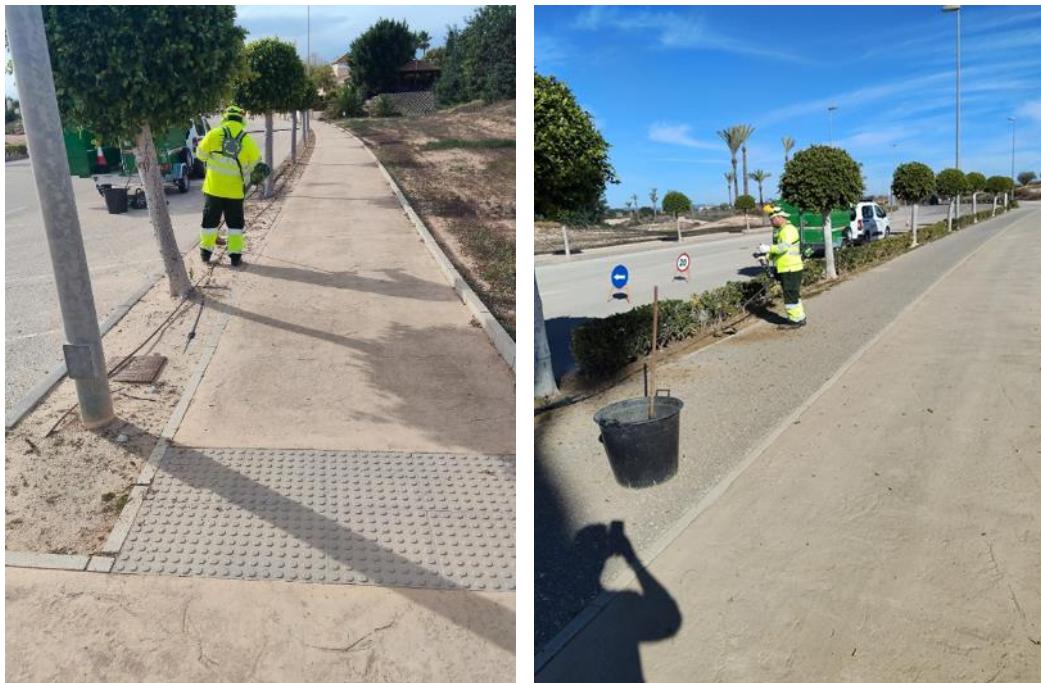
Weeding and trimming of hedges and ficus trees in Phase 1 - Paseo Alameda (right/left)

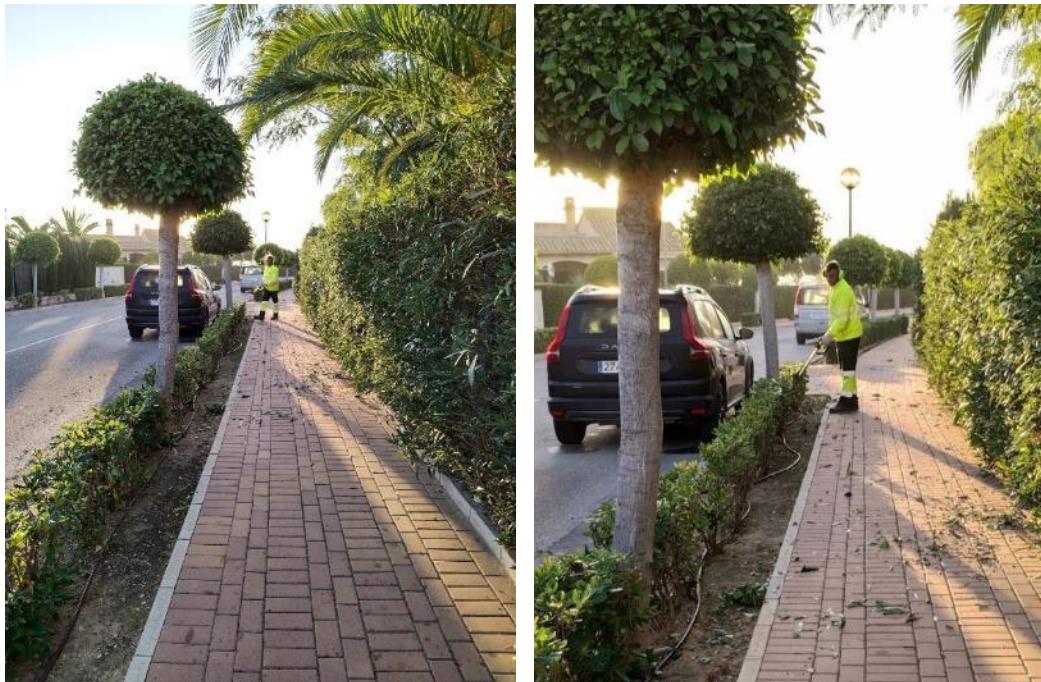
Weeding and trimming of hedges and ficus trees in Phase 1 - Austria and Alemania St.

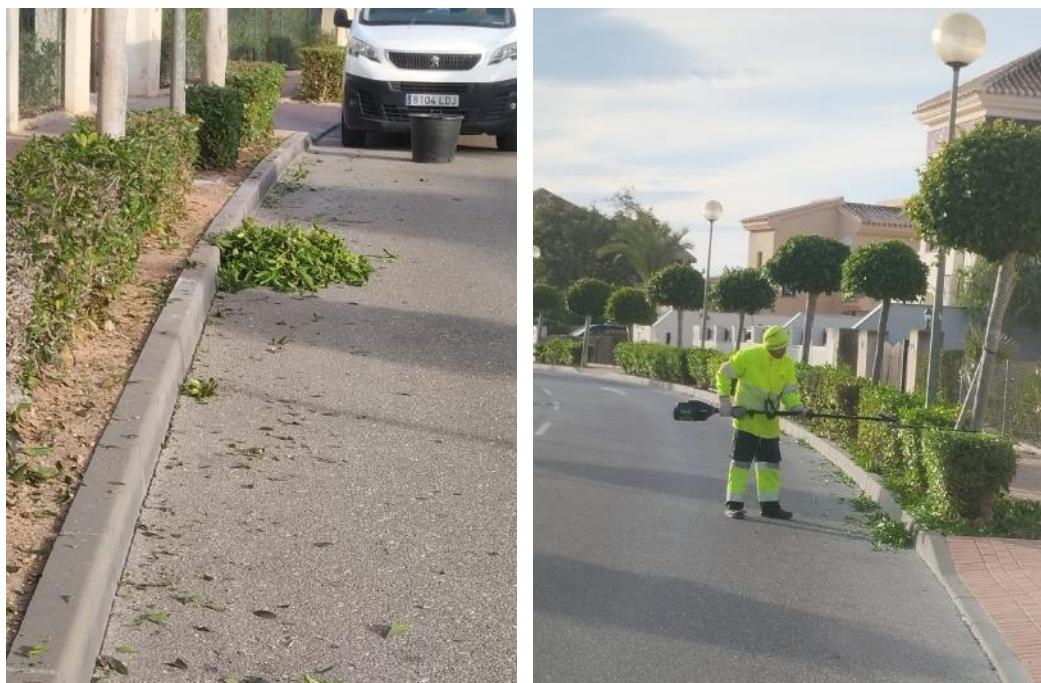
Weeding and trimming of hedge and ficus trees in Phase 2 - Belgium St. (right/left)

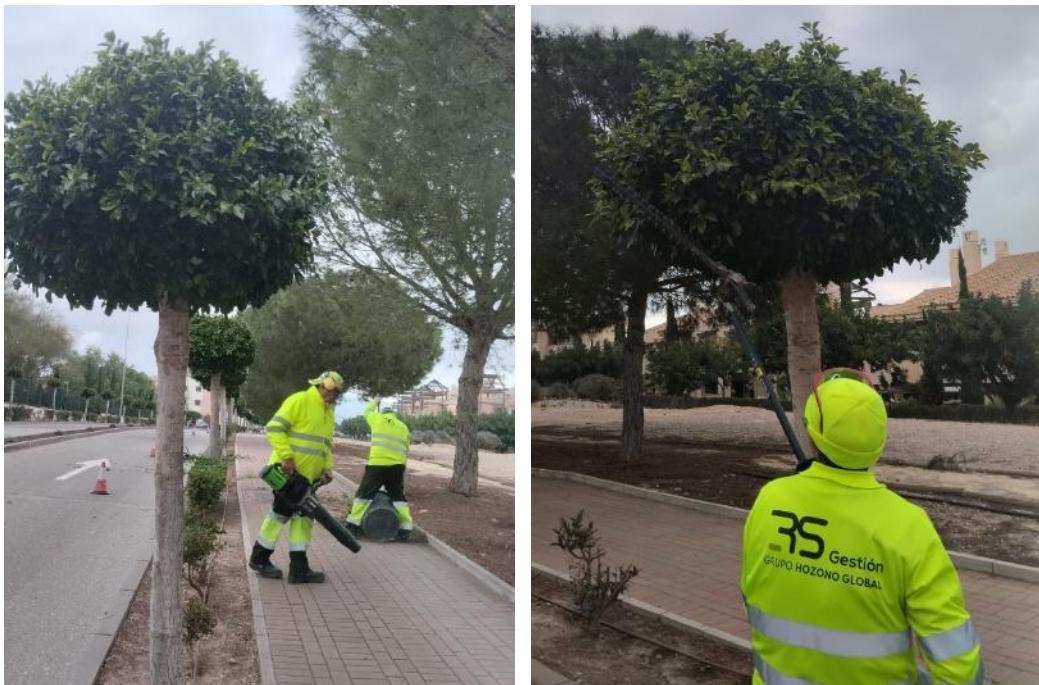
Weeding and trimming of hedges and ficus trees in Phase 8 (Pueblo Español) - Calabardina St.

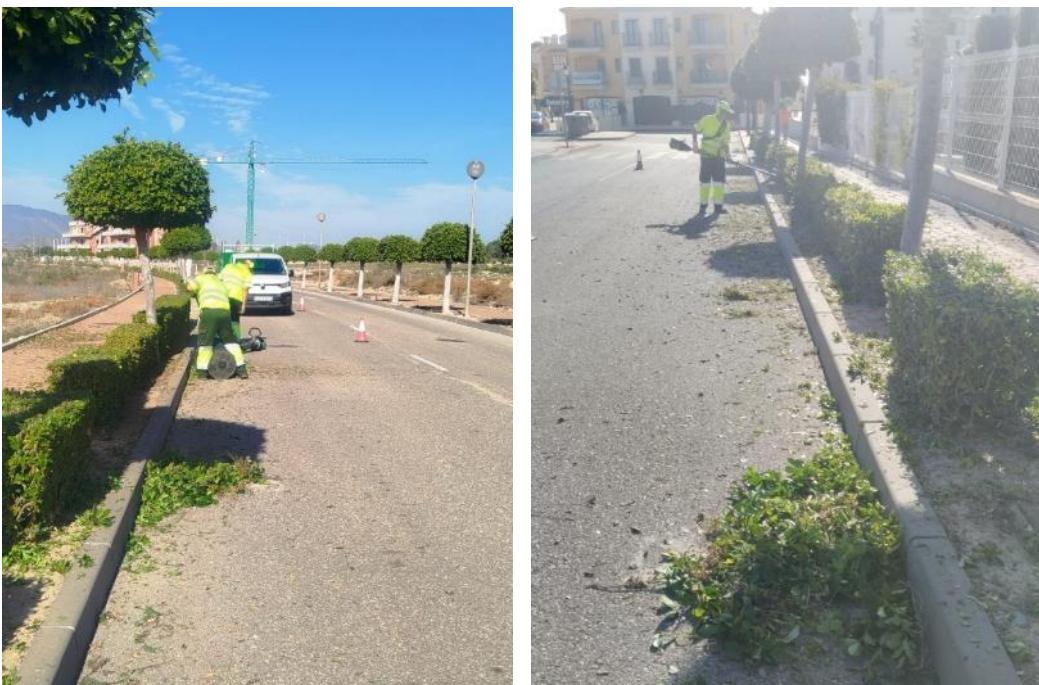
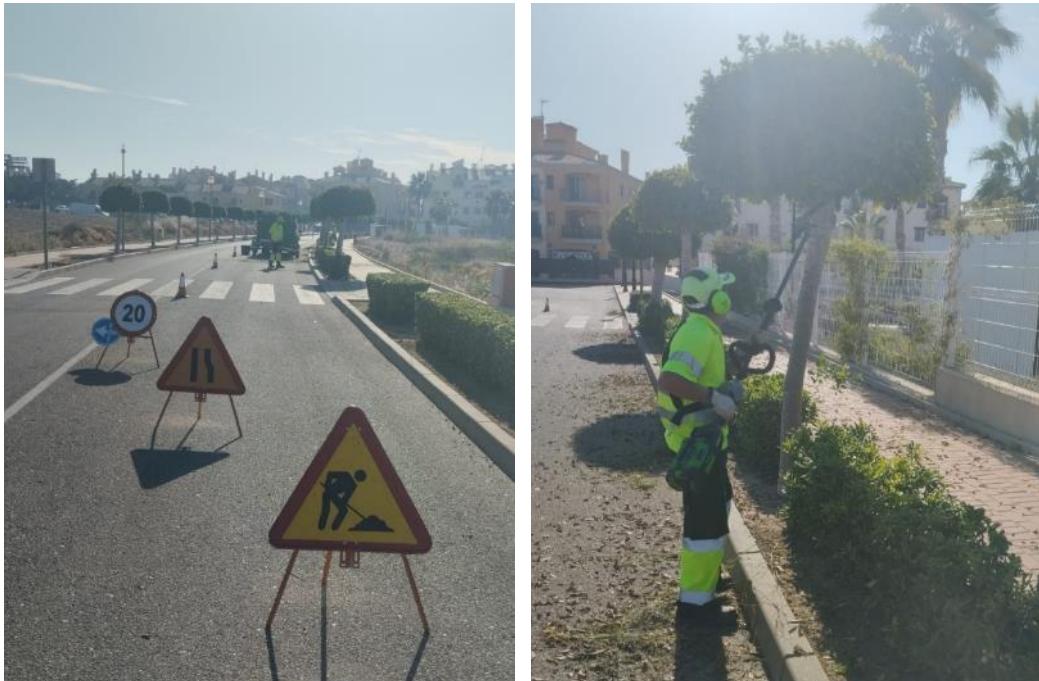
Weeding and trimming of hedges and ficus trees in Phase 8 (Pueblo Español) - Lituania St.

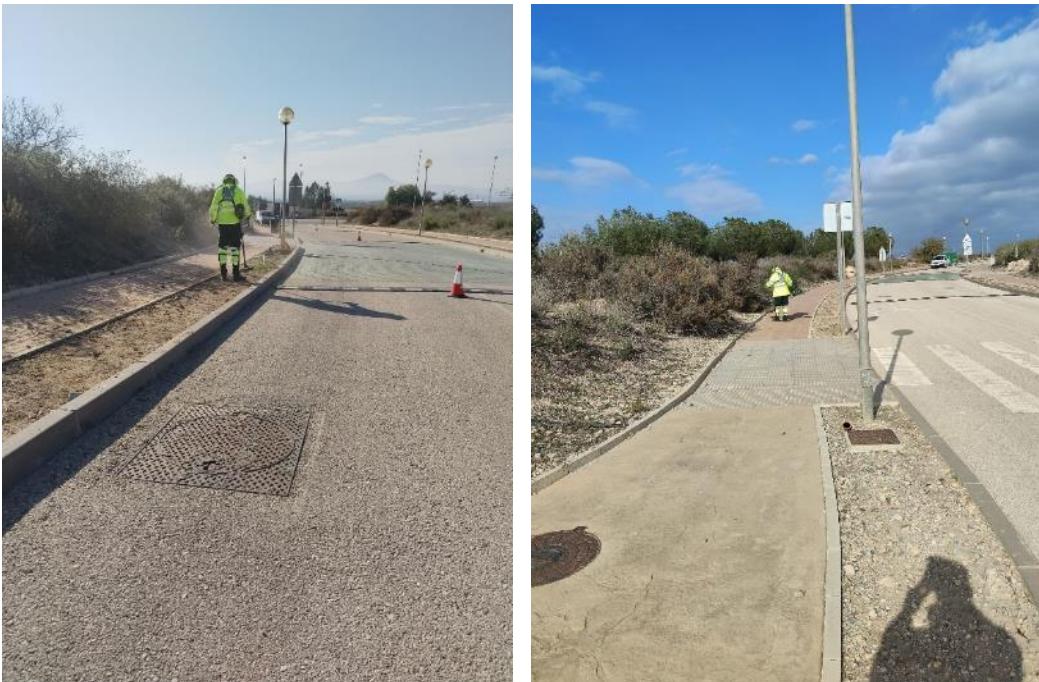
Weeding of vegetation on the roadway, sidewalks and interior of undeveloped plots on Hungría St. (COMPLETION)

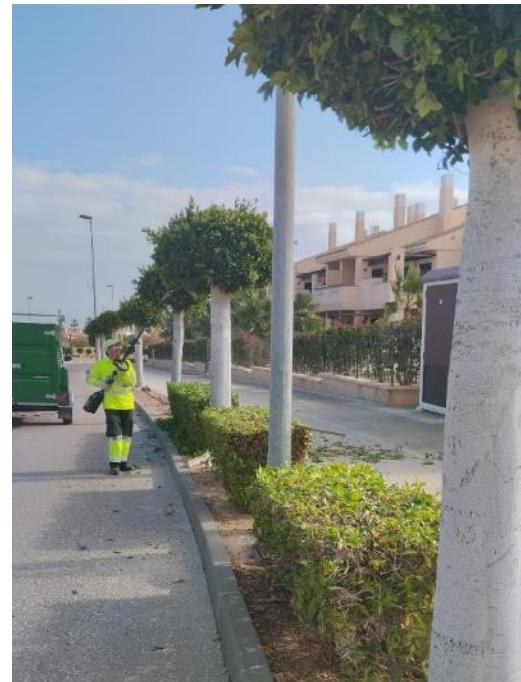
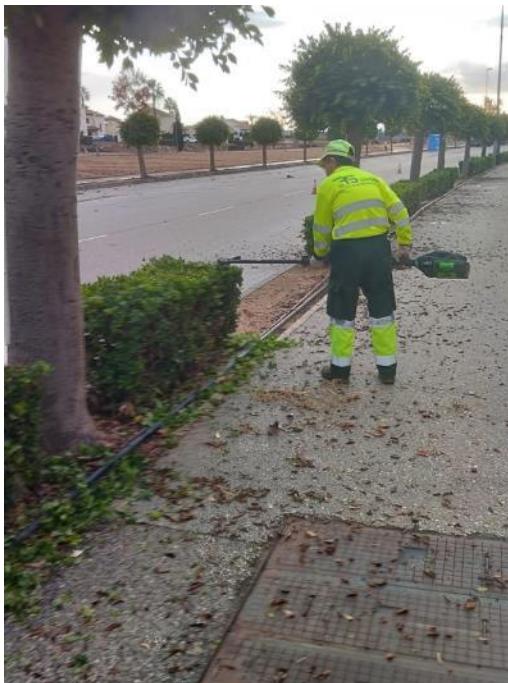
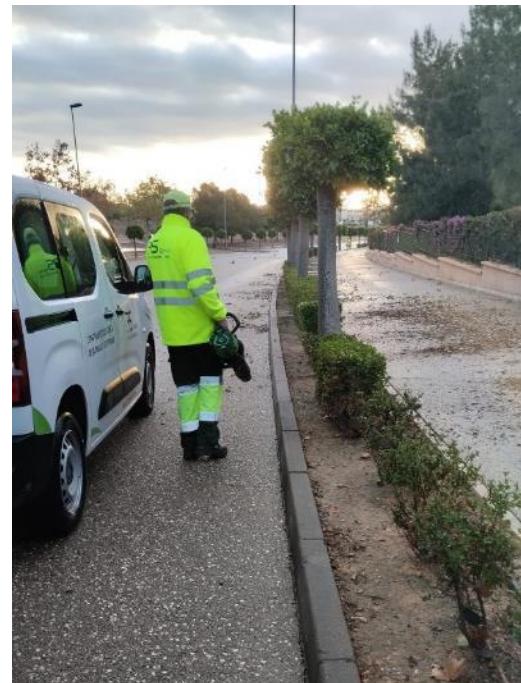
Weeding and trimming of hedges and ficus trees in Phase 7 - Paseo Alameda (right/left)

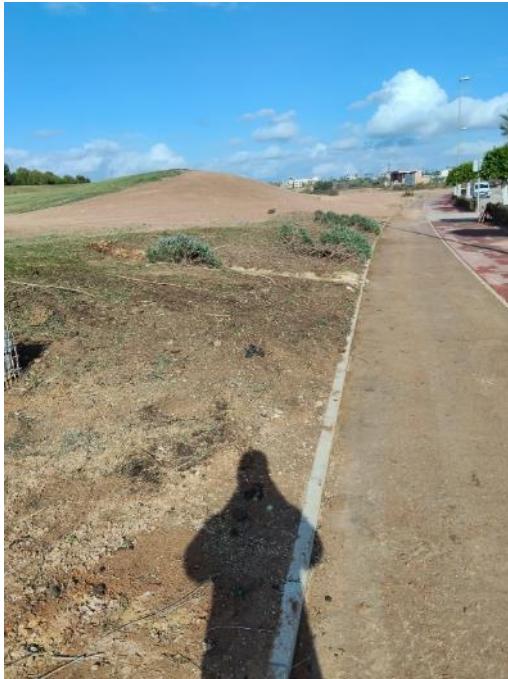
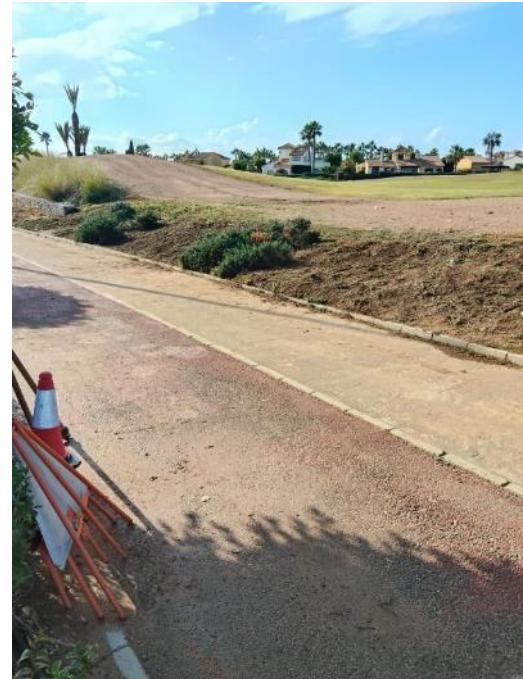
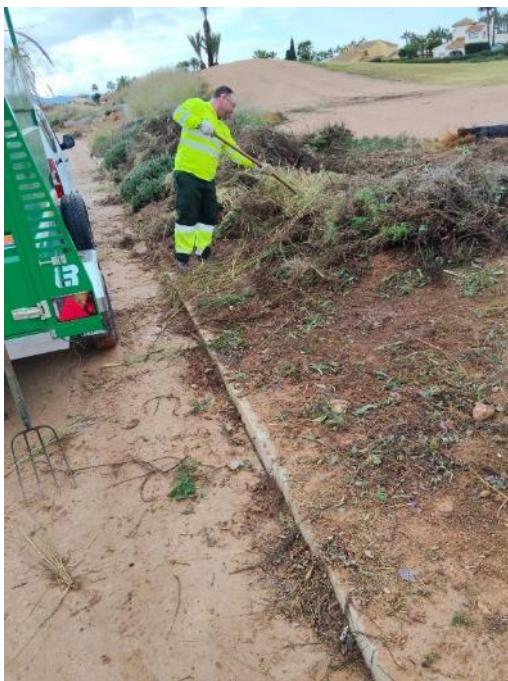
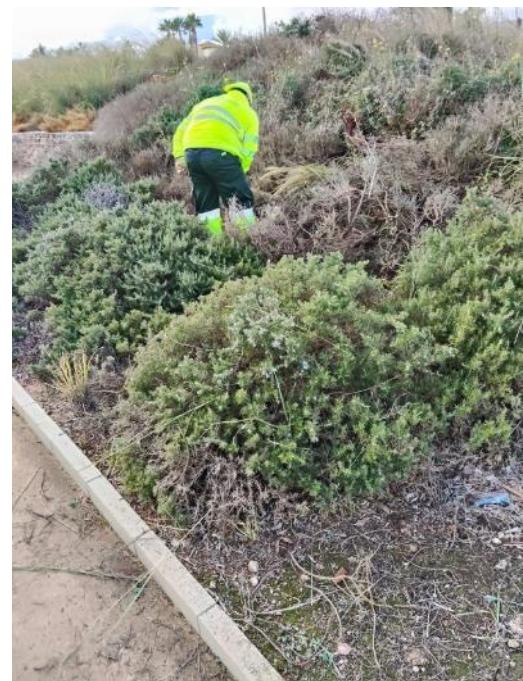
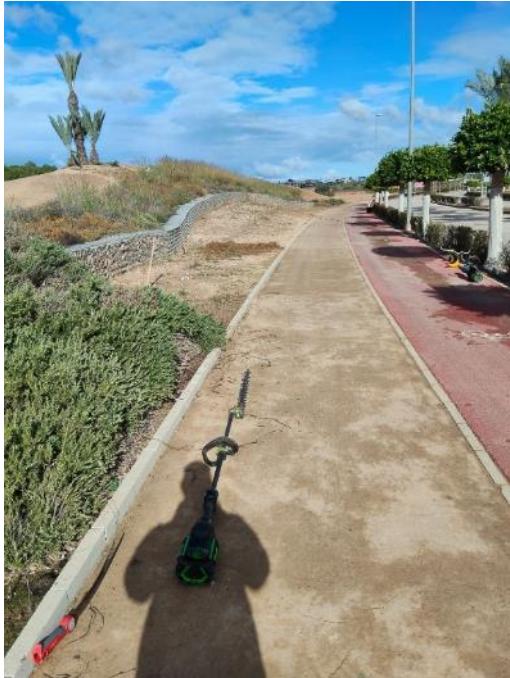
Weeding of the left-hand sidewalk section from the Maintenance Zone to the Entrance Roundabout

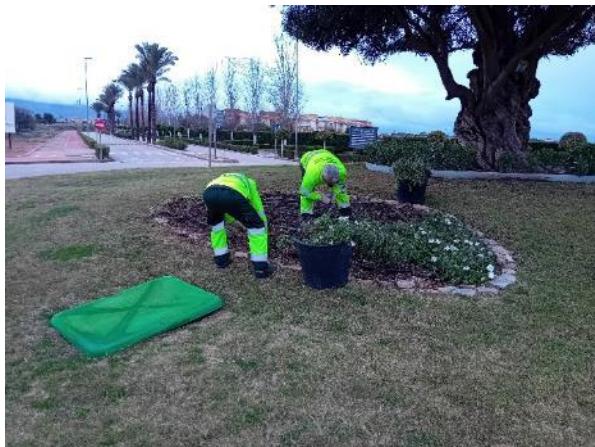
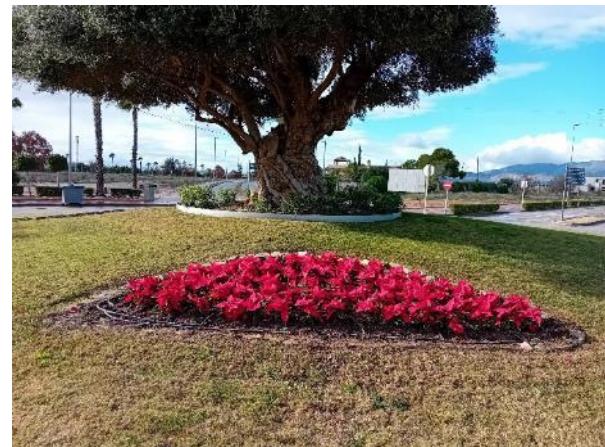
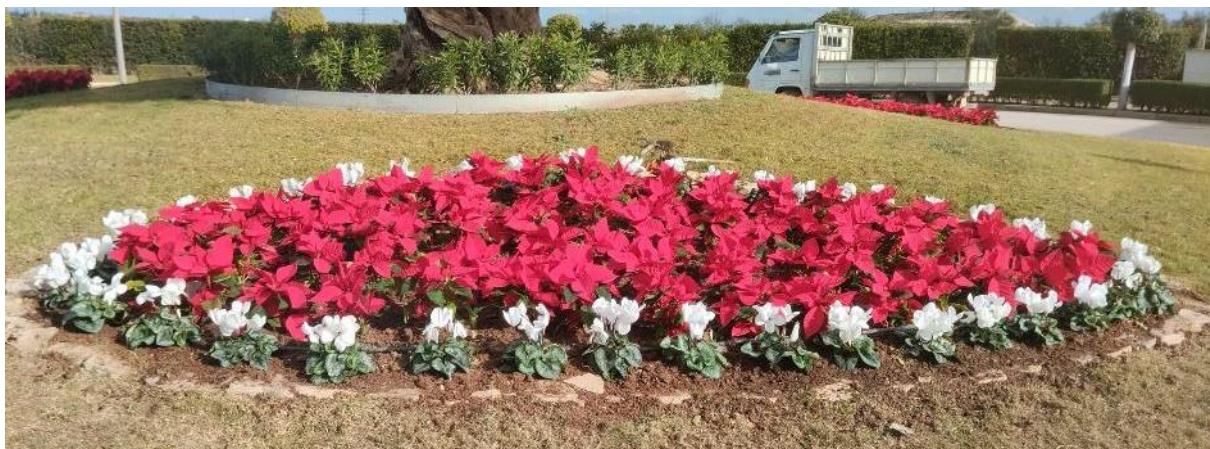
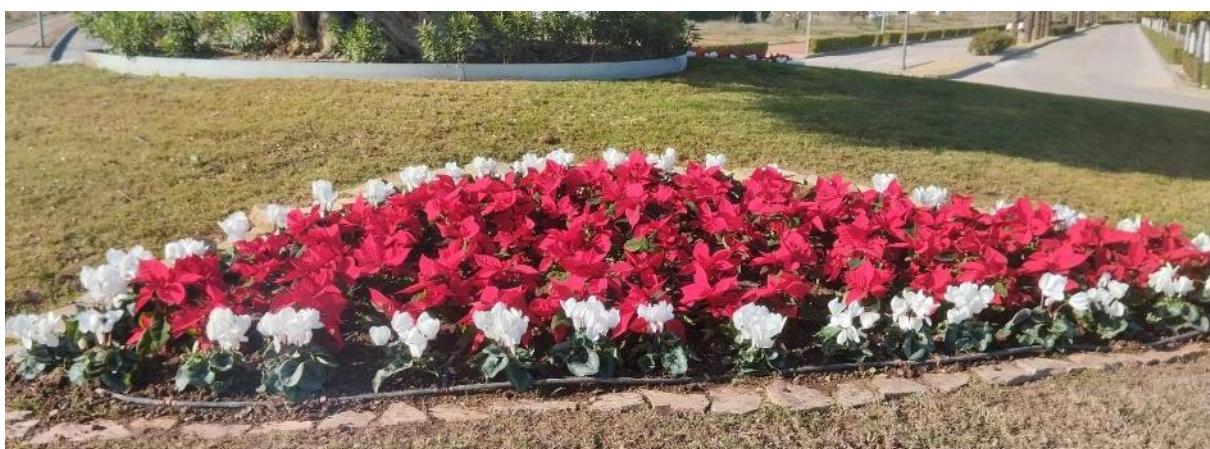
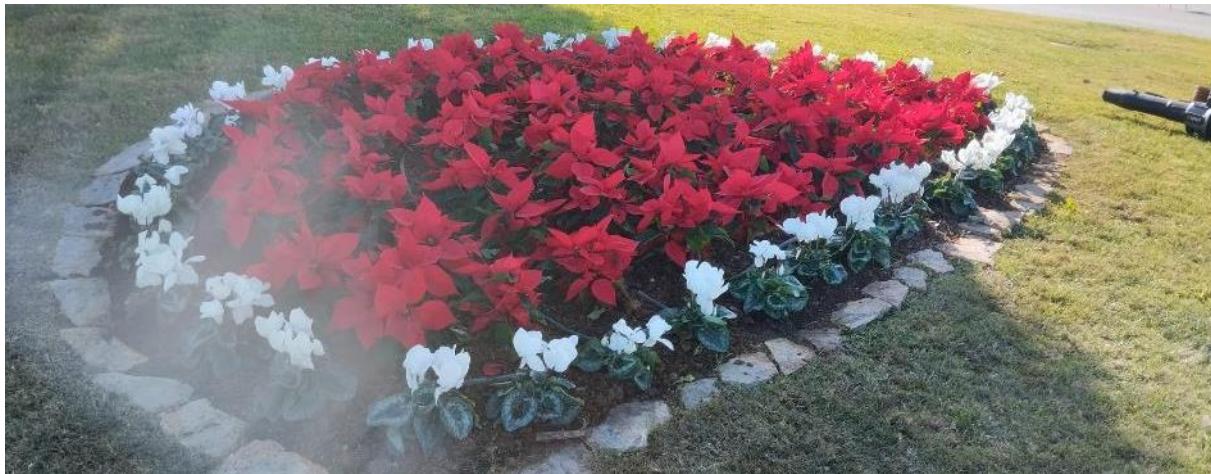
Christmas flower planting in the entrance roundabout. Removal of existing plants, addition of organic matter, tilling, and new Christmas planting consisting of red poinsettias and a border of white cyclamen.

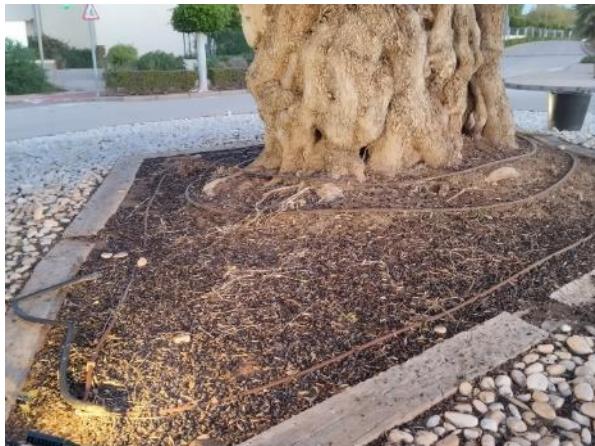
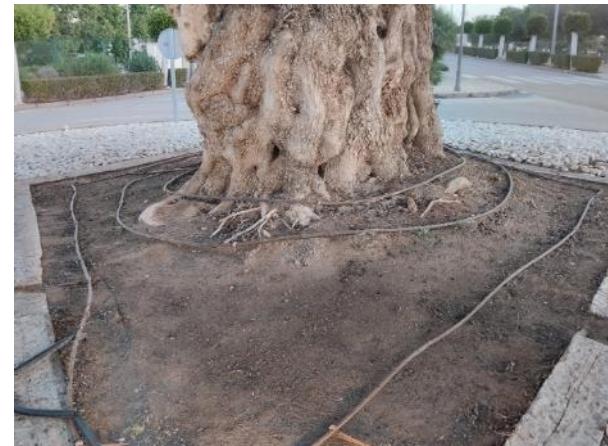
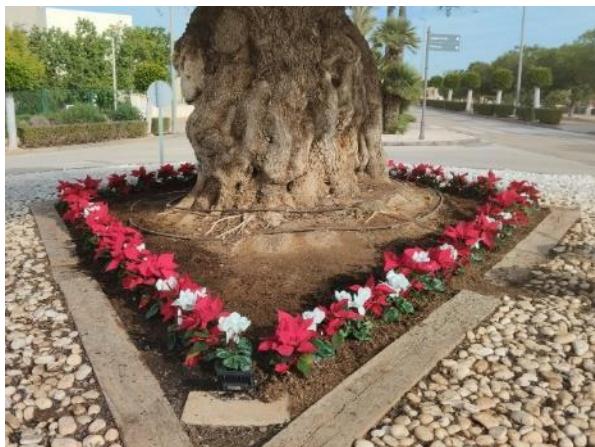
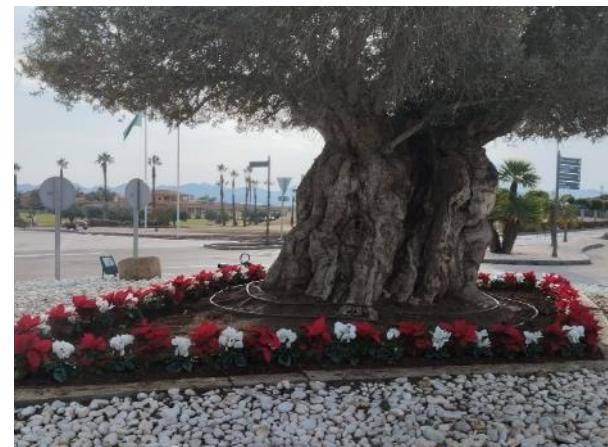
Christmas flower planting in the Club House roundabout. Addition of organic matter, tilling, and new Christmas planting consisting of red poinsettias and a white cyclamen

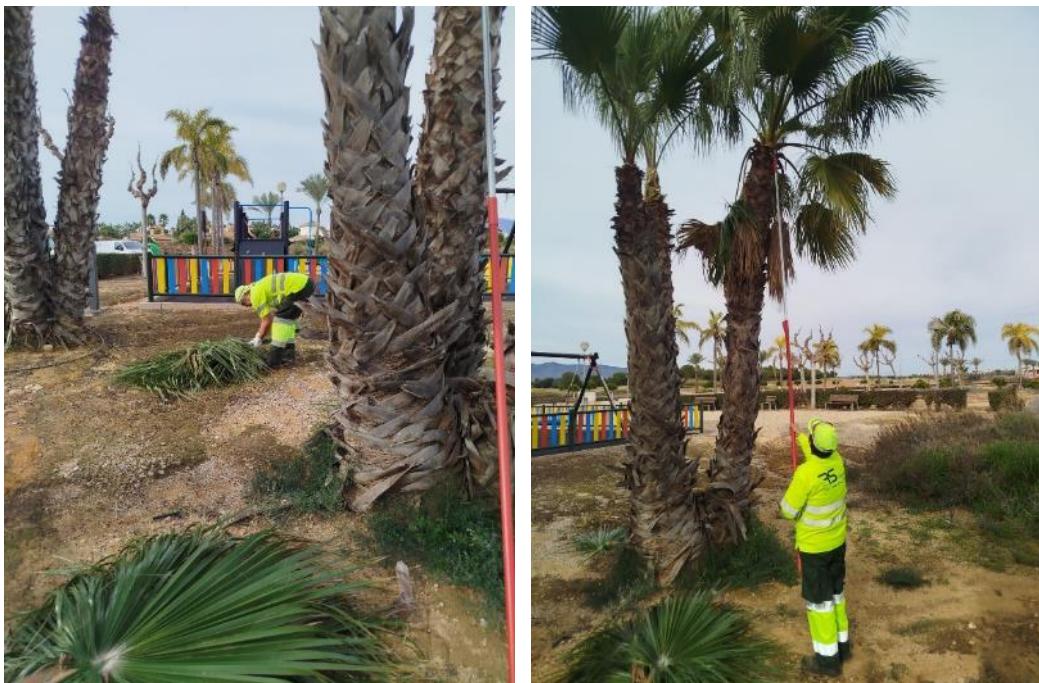
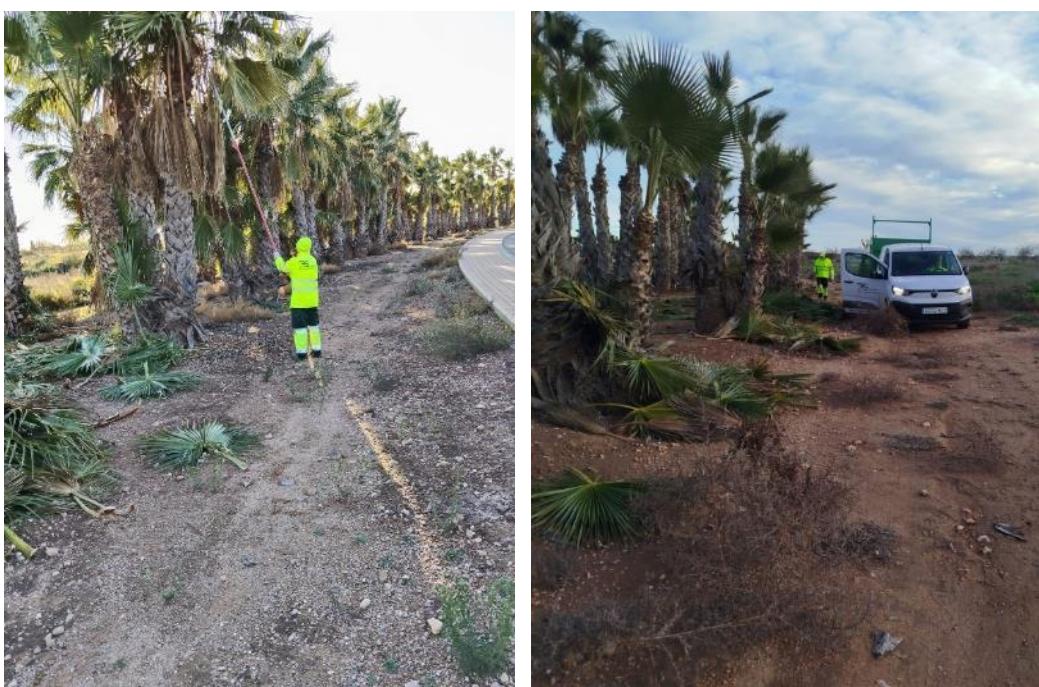
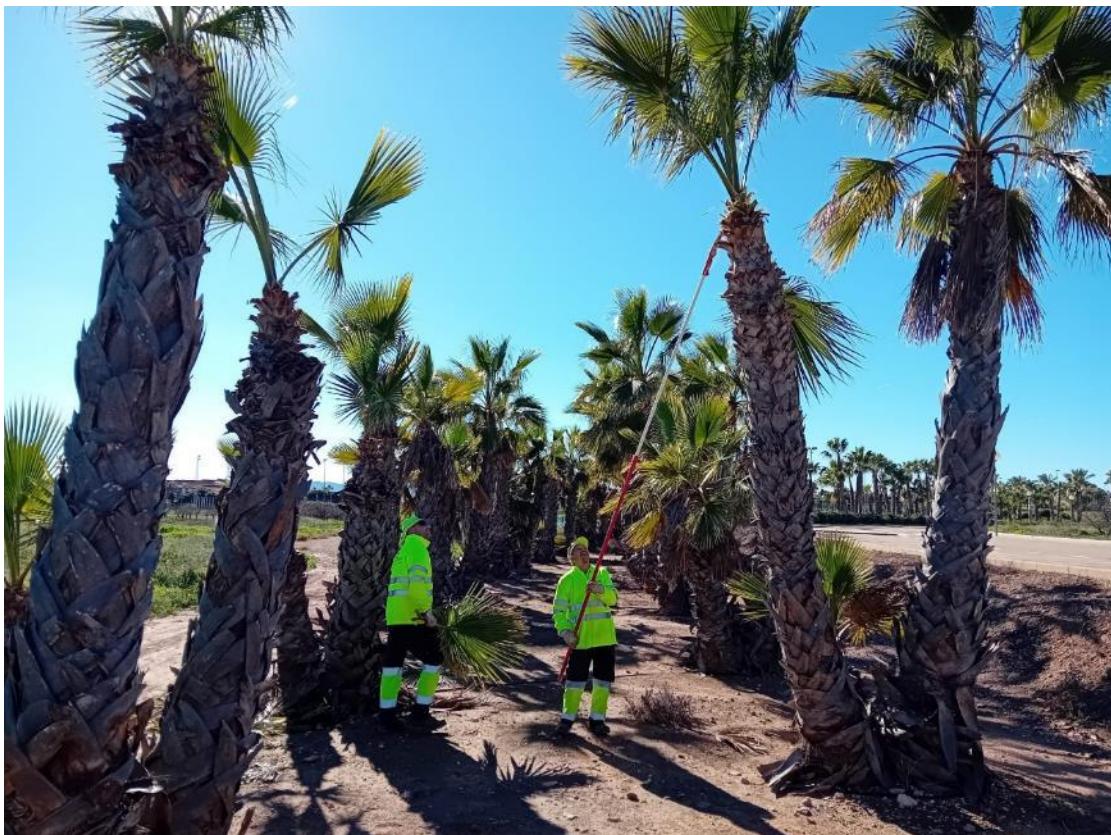
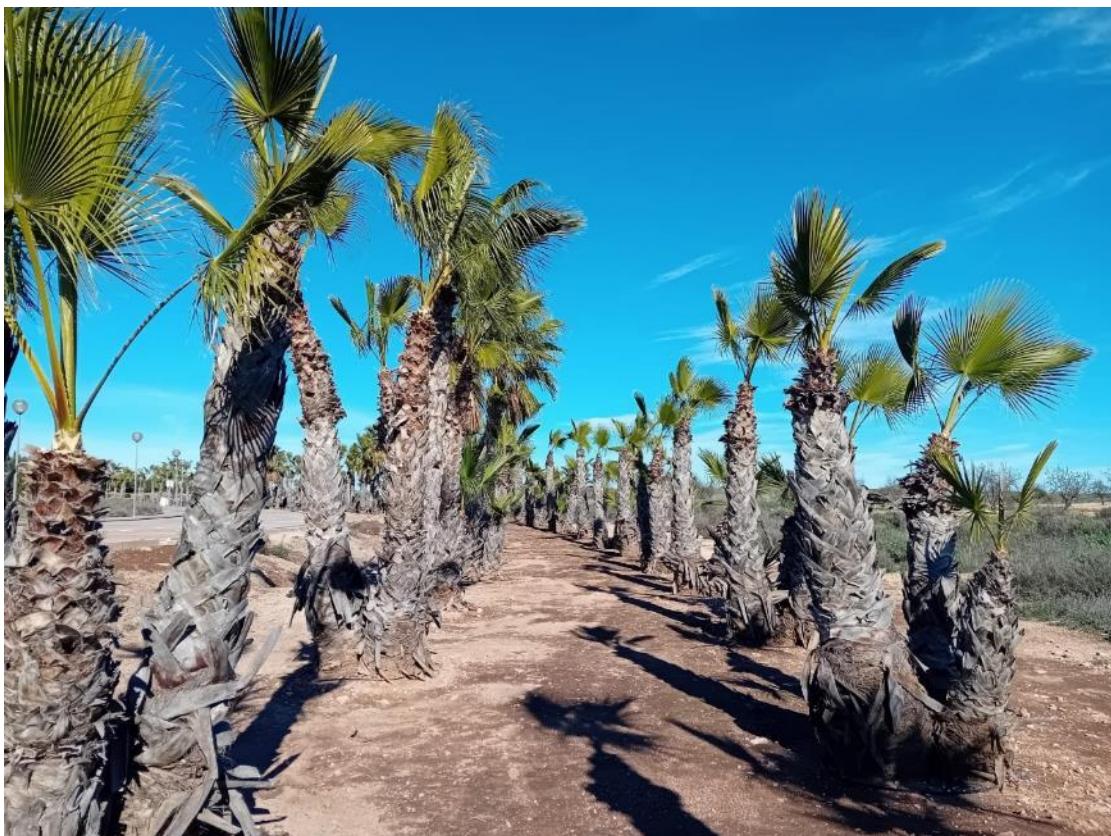
Pruning Washingtonia palm trees 1-3 meters tall in EUM

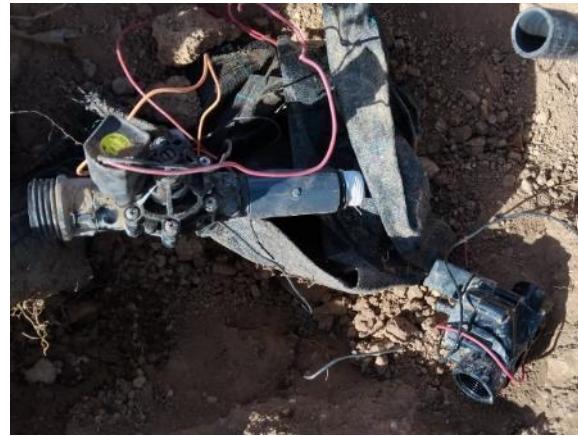
Main Road left near the hotel (change solenoid valve 1")

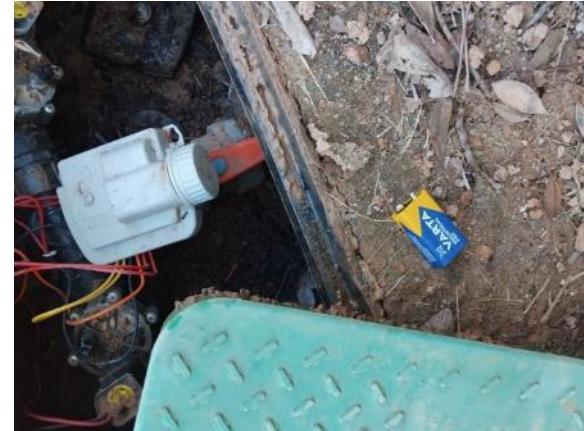
Garden Security (1 ml PE Ø16 and 1 T link)

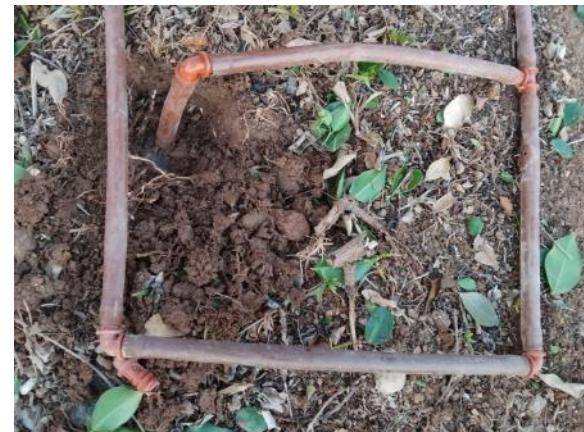
**Canadá St. near parking 1 (1 ml PE Ø16 y 1
elbow)**

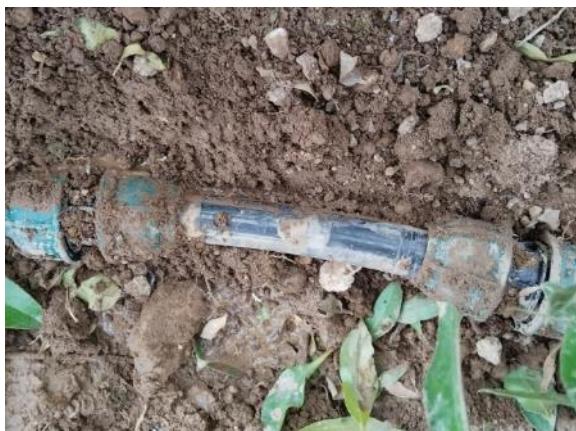
Bélgica St, 5 (0,5 ml PE Ø32 y 2 links)

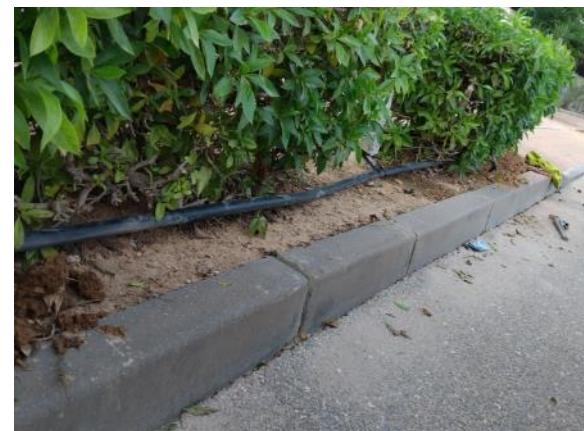
Bélgica St, 19 (4 ml PE Ø32 y 2 links)

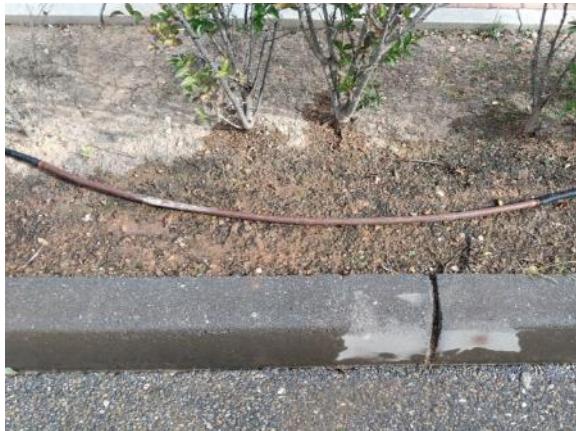
Bélgica St, 28 (1 ml PE Ø16 y 2 links)

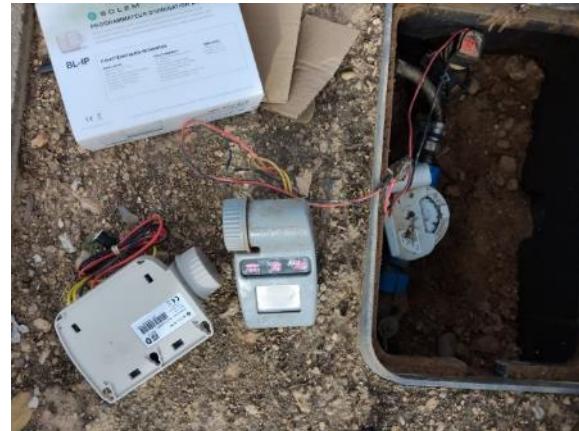
Opposite Bélgica St, 19 (change programmer
Solem 1 station)

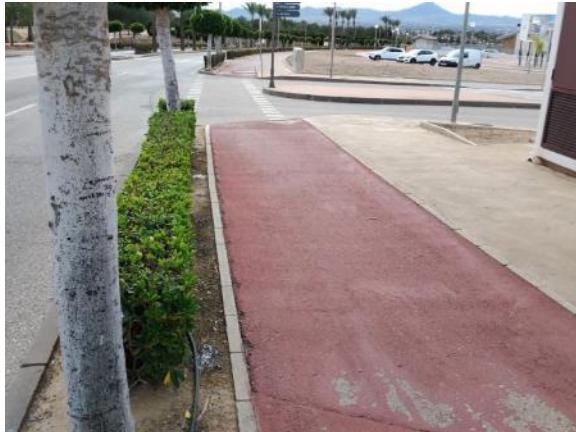
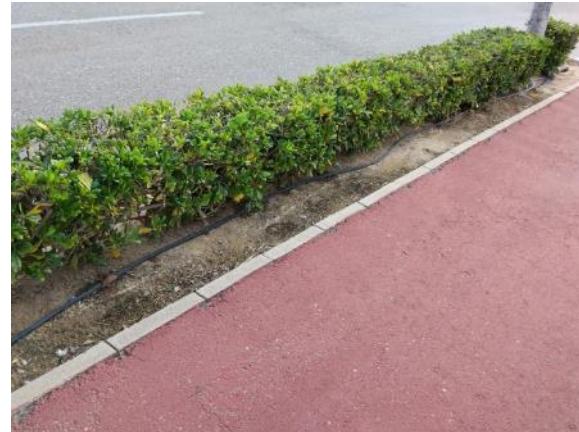
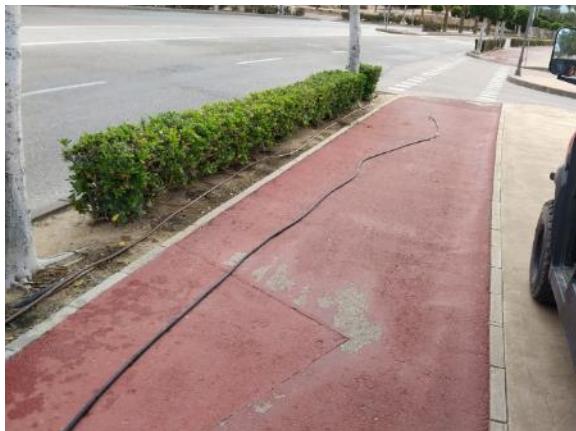
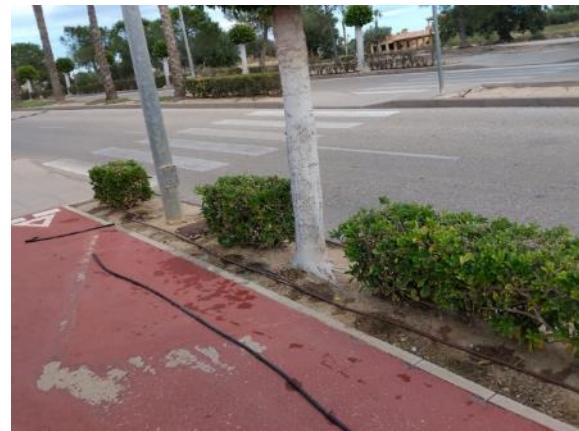
Main road left. Between Sales Booth and Clubhouse (16 ml PE Ø16 y 2 links)

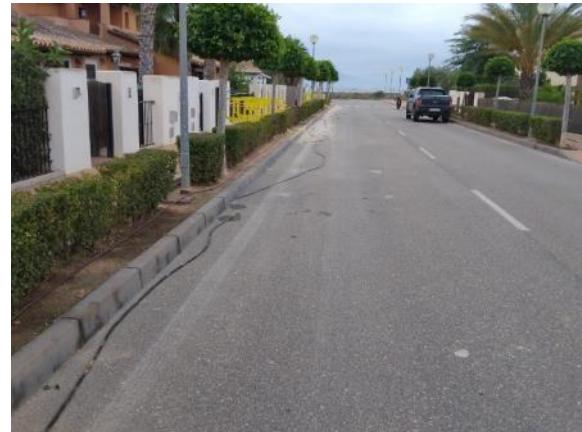
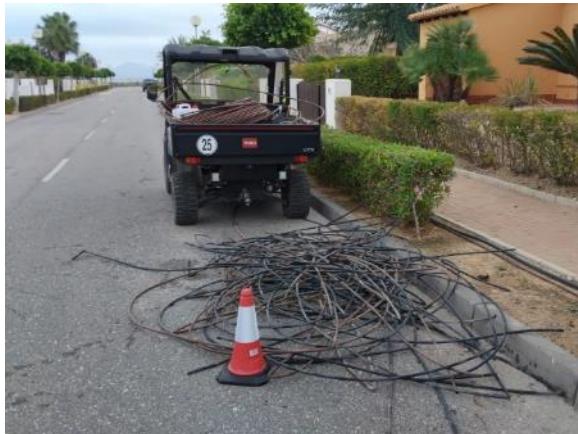
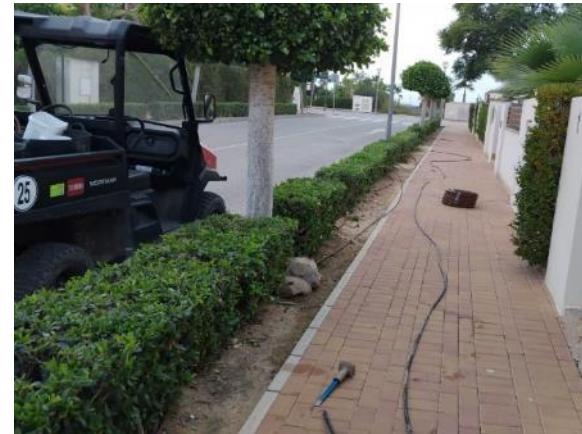
Phase 2 - Belgium St. Num. 21-1 and 40-2
(400 ml PE Ø16 and 6 links)

Phase 1 - Austria St. Num. 5-7
(35 ml PE Ø16 and 2 links)

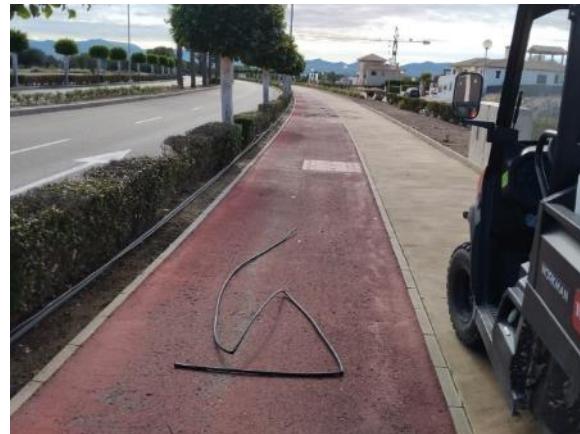
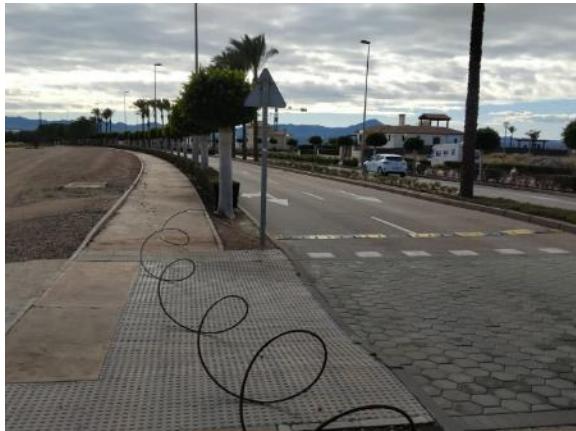
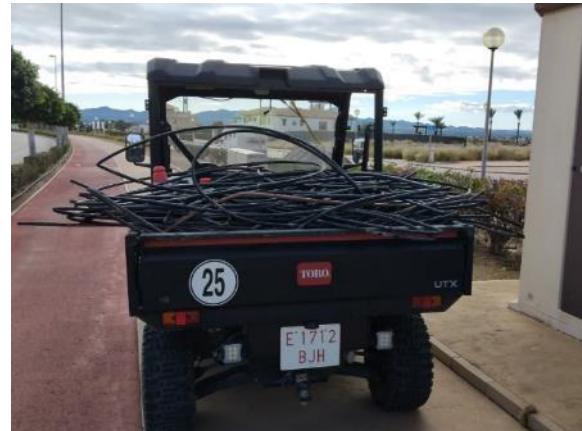
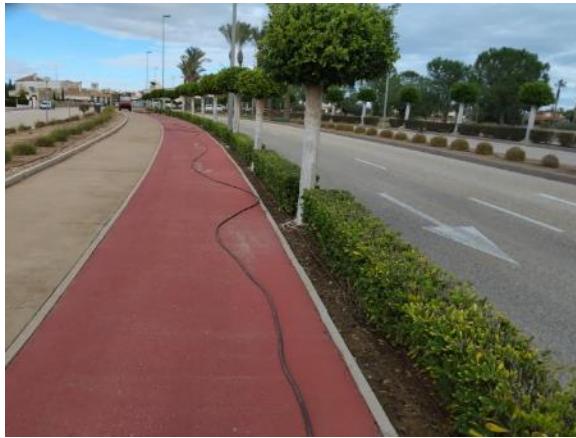
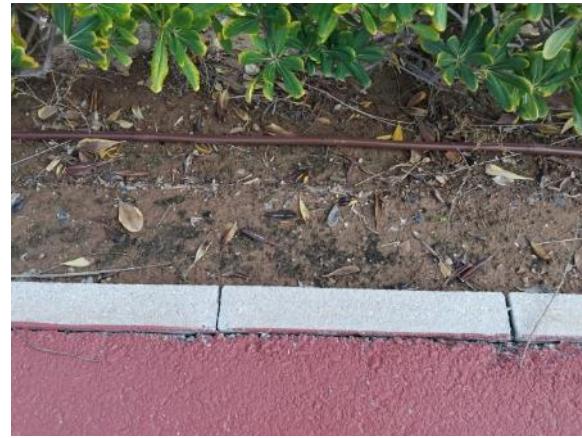
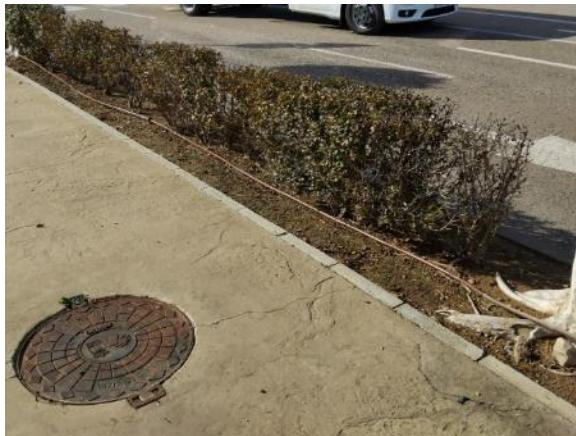
**Main Road - From Sales Booth to Black
Gravel Round. (870 ml PE Ø16 & 31 links)**

Main Road - From Sales Booth to Black Gravel Round. (870 ml PE Ø16 & 31 links)
